Hazardous Building Materials Assessment

Window and Door Replacement
Lake Avenue Elementary
School

157 Lake Avenue North,
Hamilton, Ontario

February 10, 2021

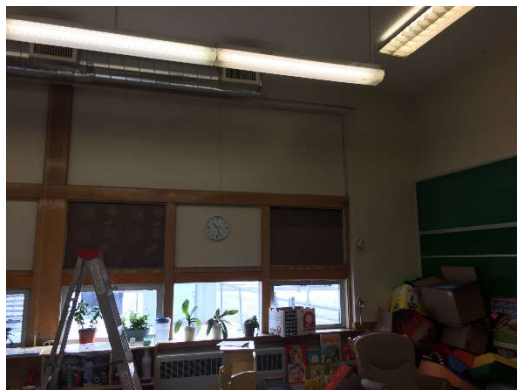
Photo 1

Plaster present on walls and ceilings throughout the assessed area does not contain asbestos (samples 0001A-C; lab report reference 1710017 and 2975-32-C01-C07, photo 1).

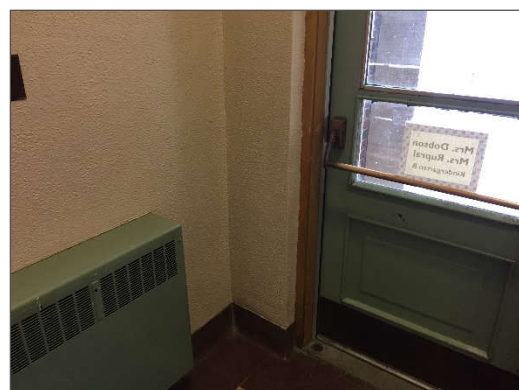
Photo 2

Textured plaster present on the walls in the corridor does not contain asbestos (Location 3, sample 0002A-C, photo 2).

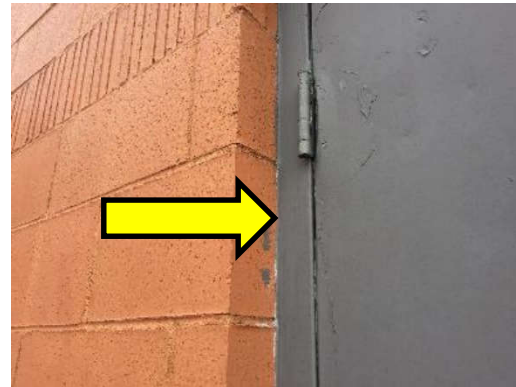
Photo 22

Caulking, grey, photo 22	On exterior doors, 1971 (Location 1)	S0029A-C	None Detected
Caulking, white, Photo 23	At exterior windows, 1951 (Location 3)	S0030A-C	Chrysotile

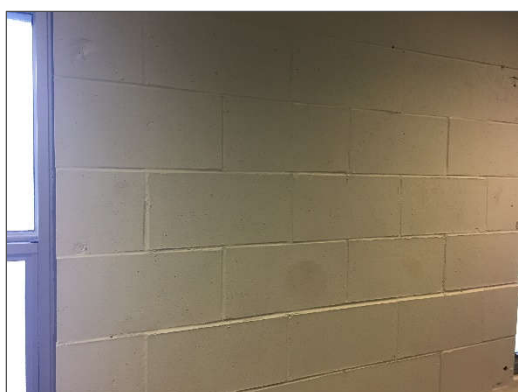
Photo 5

White paint present on the masonry block walls does not contain asbestos (Location 1, samples S0034A-C, photo 5).

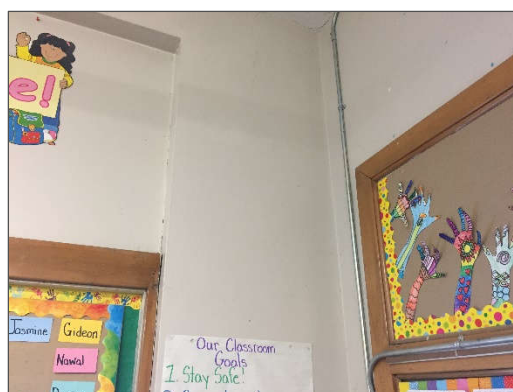
Photo 6

Beige paint present on the plaster walls does not contain asbestos (Location 3, samples S0035A-C, photo 6).

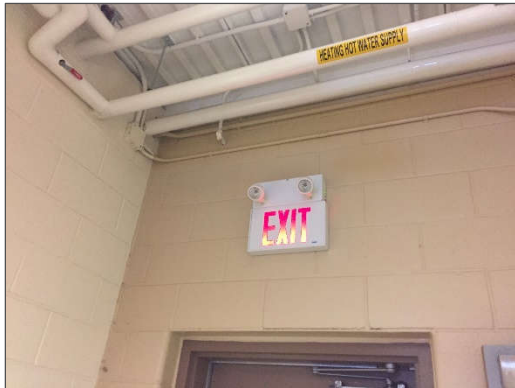
Photo 1

Lead-containing batteries are present in emergency lighting.
