LIMITED DESIGNATED SUBSTANCE SURVEY REPORT (RENOVATION AREAS)

**Joseph Gould Public School
144 Plank Lane,
Uxbridge, Ontario**

February 9, 2021

Maple Project No. 19261

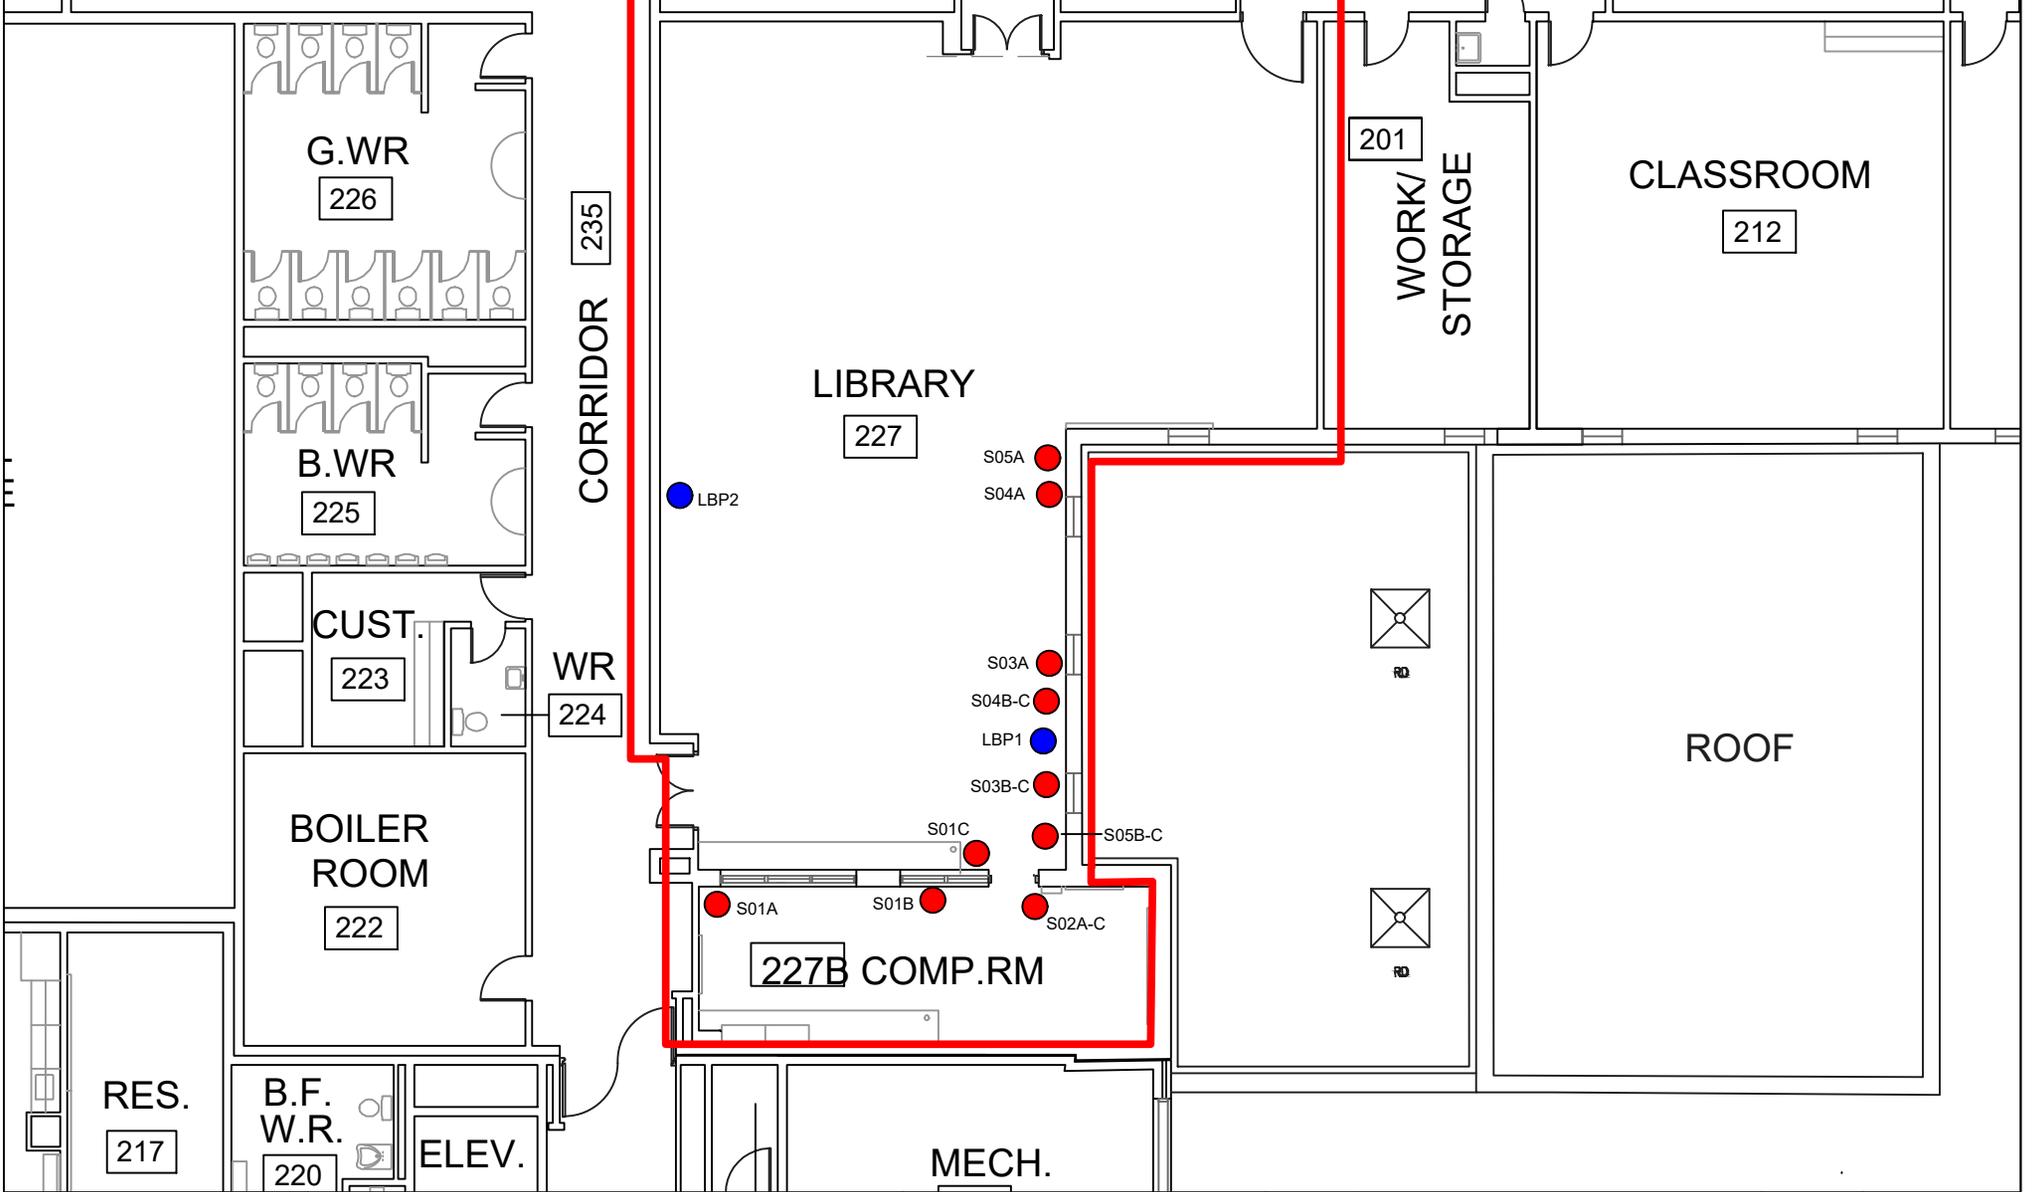
Black caulking was observed to be applied at the top of the window between the metal frame and the masonry block walls.

Three (3) representative bulk samples of black caulking were collected (Sample Set S03A-C) and analyzed for asbestos. Analysis of Set S03A of the mortar was found to contain **3% Chrysotile Asbestos**. As a positive asbestos sample was determined in the set, the remaining samples of the set were not analyzed due to the "Stop Positive Analytical Protocol". The material was observed to generally in GOOD condition.

Note: Asbestos-containing black window caulking is present on tops of windows.

- Remove all asbestos-containing materials that may be disturbed during the planned renovation using the appropriate asbestos abatement procedures as outlined in Section 5.0 of the Report.
