**Addendum No. 1**

**RFT 22-107 HVAC & Ventilation Upgrades - Rolling Meadows PS**

**REVISED PRE-RENOVATION  
DESIGNATED SUBSTANCES AND  
HAZARDOUS MATERIALS SURVEY**

ROLLING MEADOWS PUBLIC SCHOOL

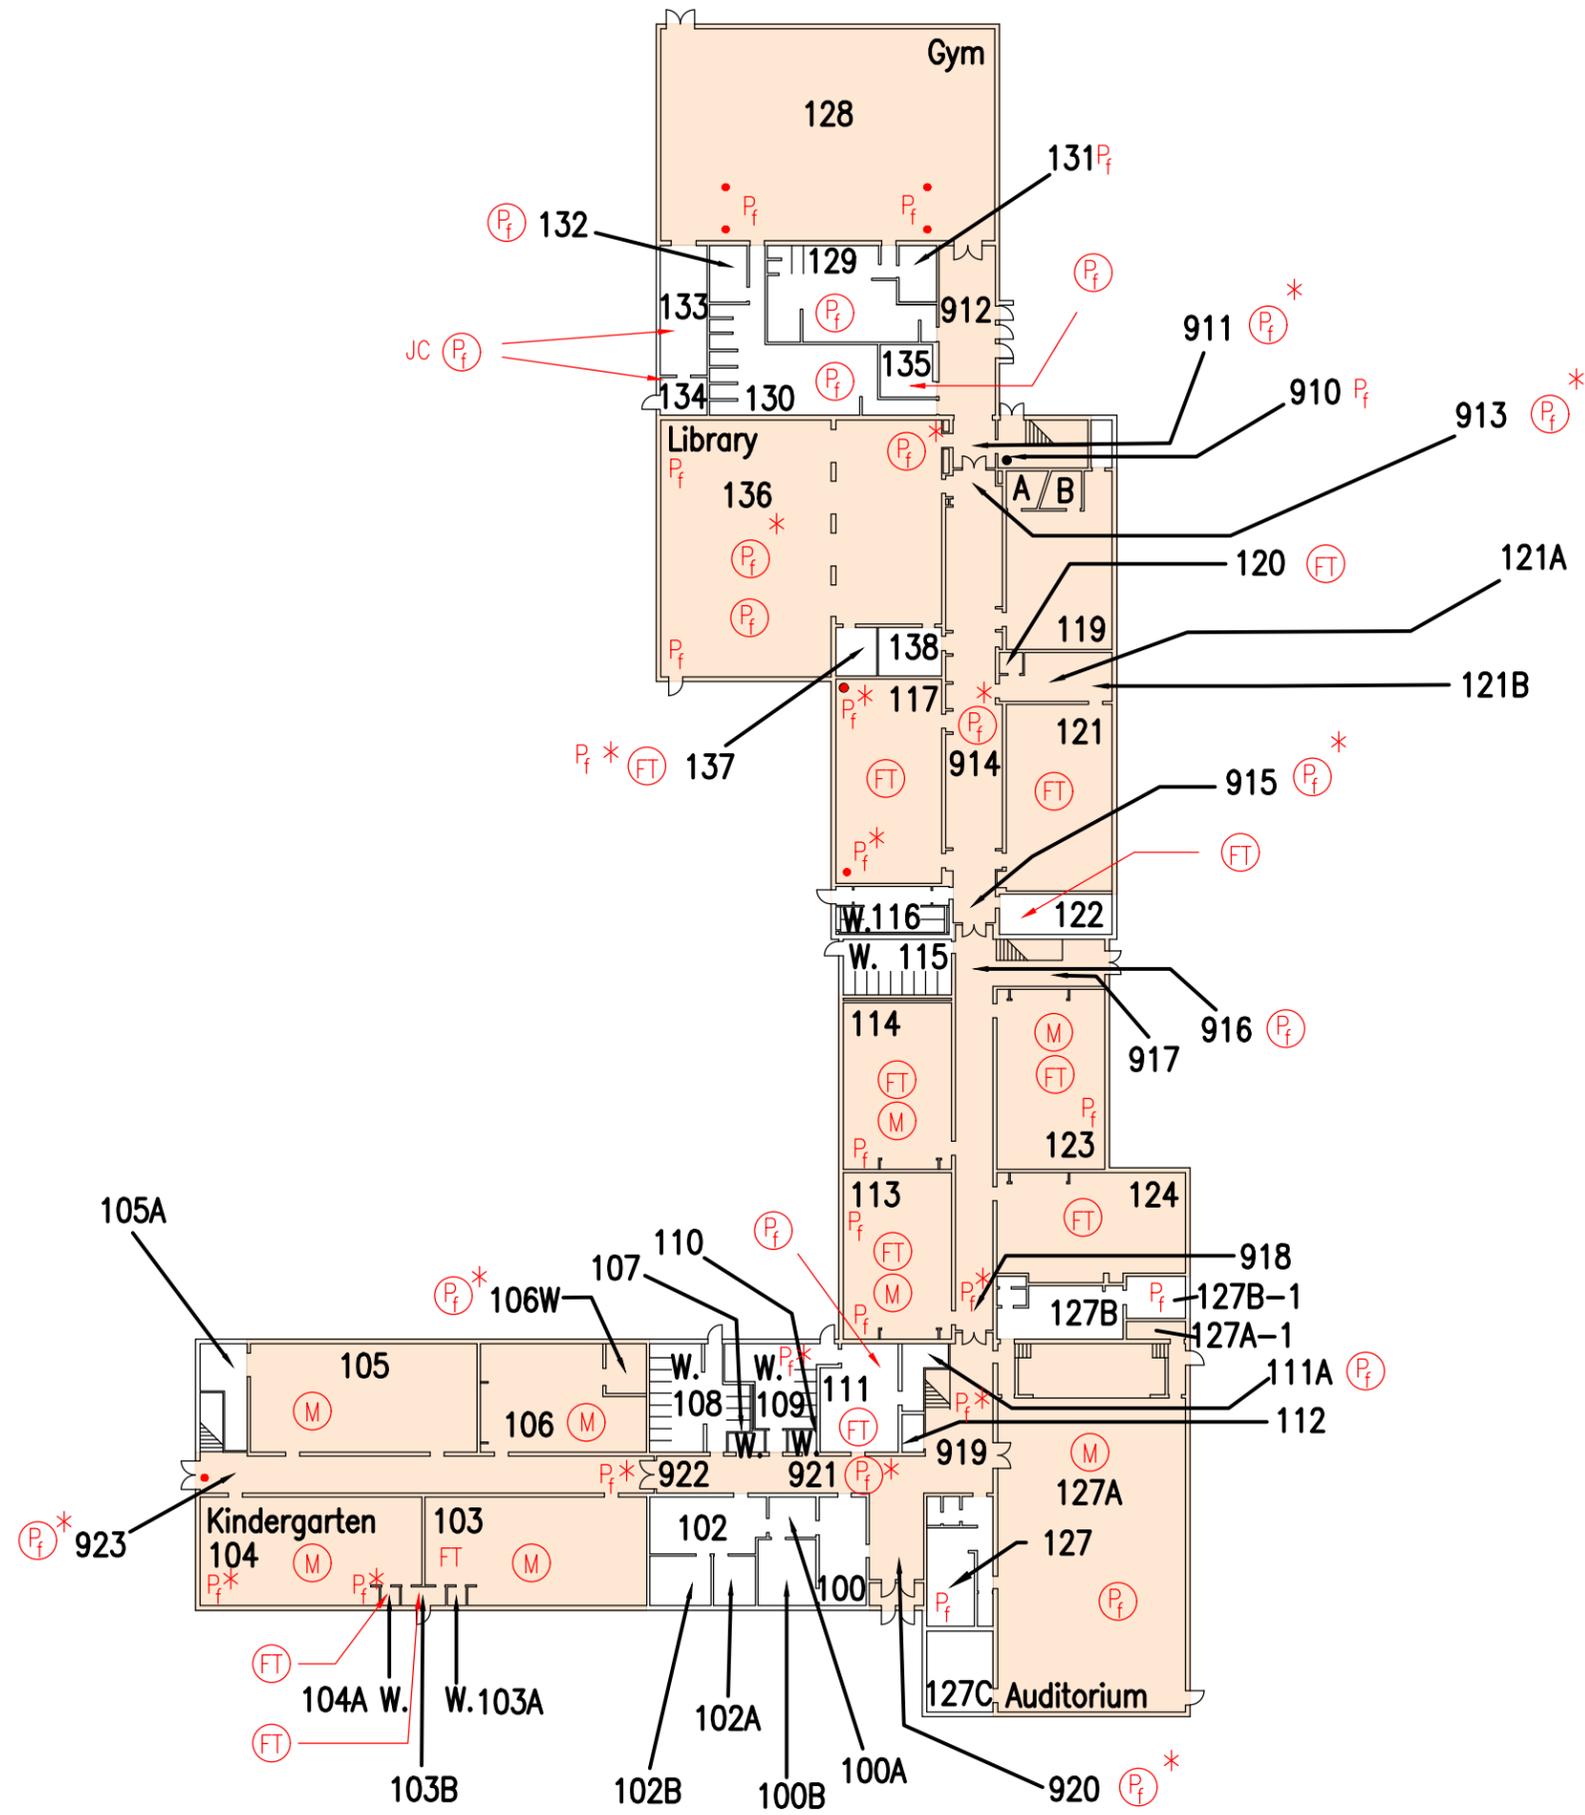
Drawn By: D.K	Approved By: A.N.	Project No: 30065539
Date: APRIL 2022	Scale: N.T.S	Drawing No: 30065539-1

ROLLING MEADOWS PUBLIC SCHOOL  
1522 MOUNTAIN GROVE AVE, BURLINGTON, ON  
FIRST FLOOR

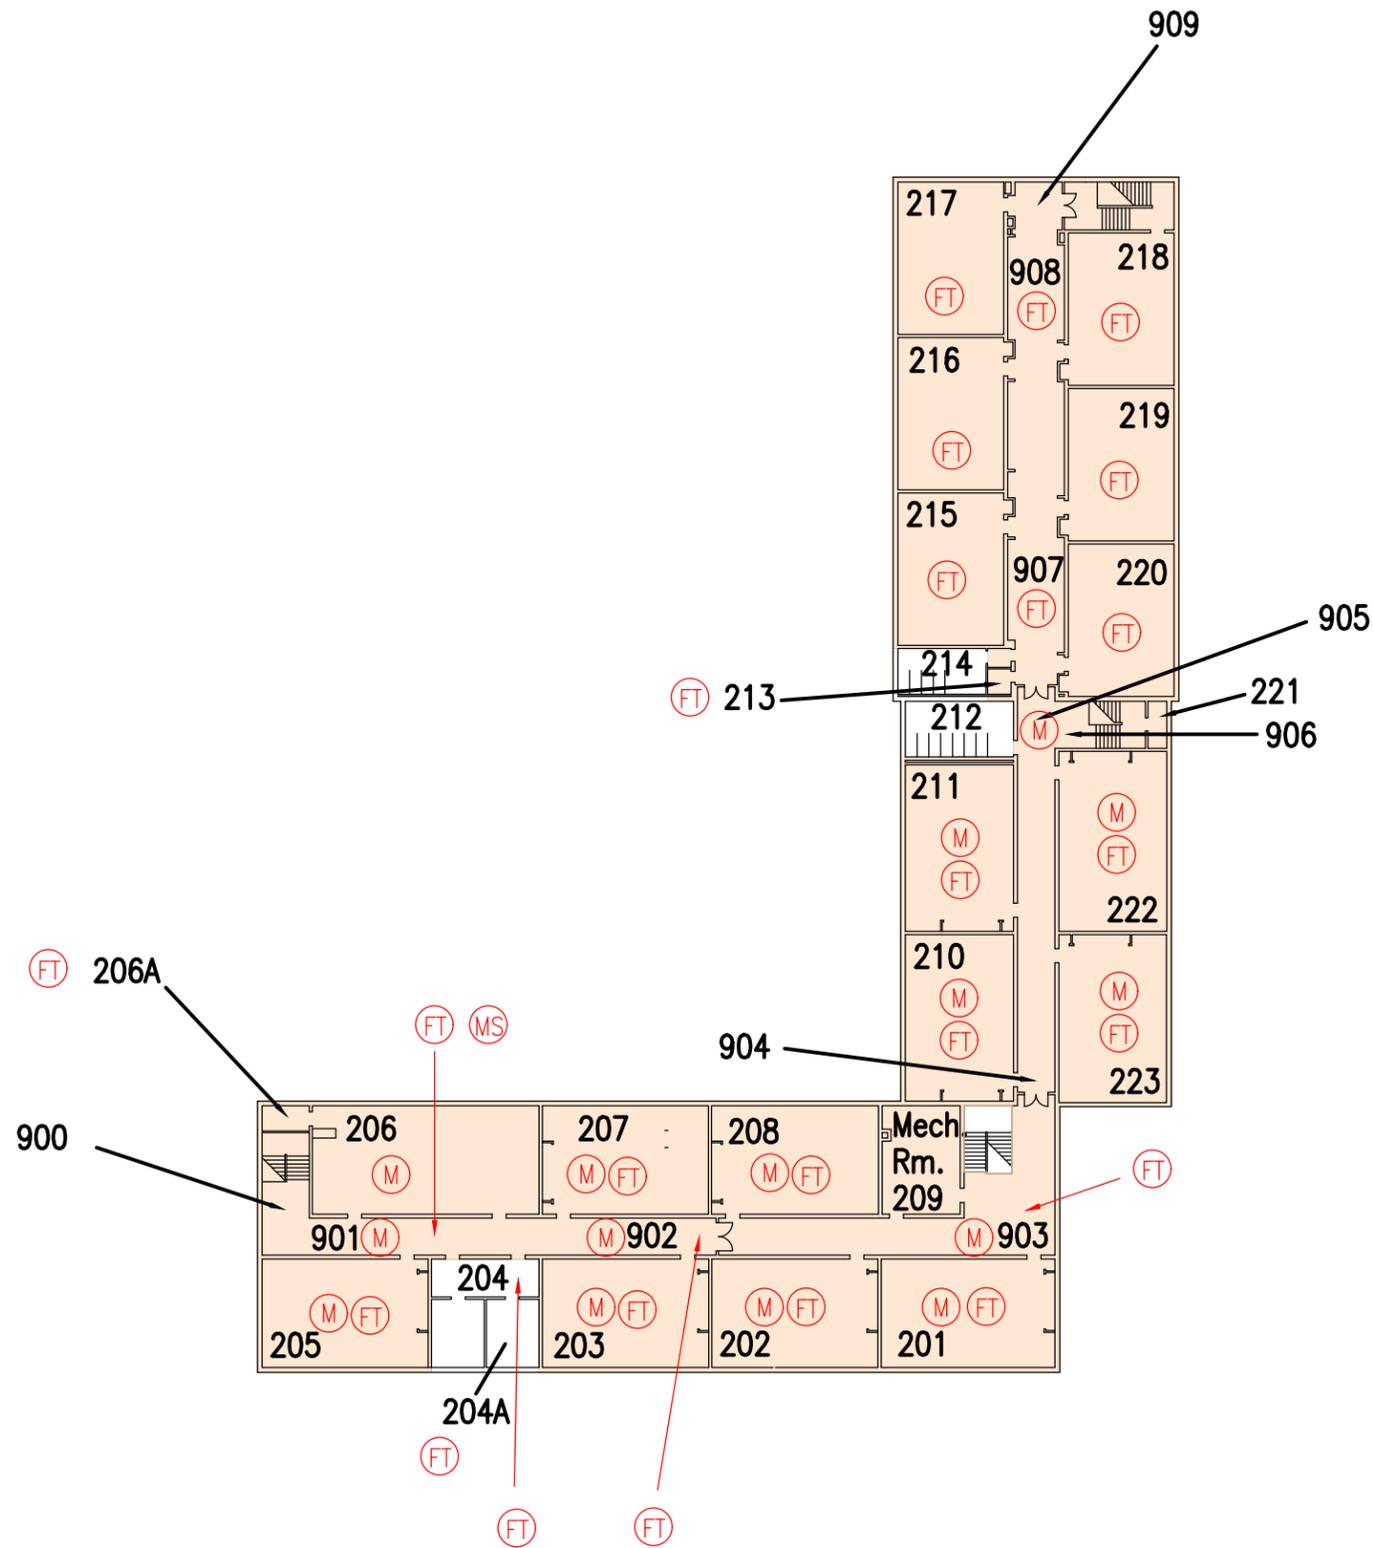
**HALTON DISTRICT SCHOOL BOARD**  
**PRE-RENOVATION DESIGNATED SUBSTANCES AND HAZARDOUS MATERIALS SURVEY**  
 LOCATIONS OF ASBESTOS-CONTAINING MATERIALS AND STUDY AREAS  
 ROLLING MEADOWS PUBLIC SCHOOL  
 1522 MOUNTAIN GROVE AVE, BURLINGTON, ON  
 SECOND FLOOR
