**LIMITED DESIGNATED SUBSTANCE
SURVEY REPORT RV. 1
(FLOORING, WINDOWS, & INTERIOR DOOR REPLACEMENT)**

**Holy Family Catholic Elementary School
1420 Grosvenor Street
Oakville, Ontario**

January 29, 2024

Maple Project No. 21384

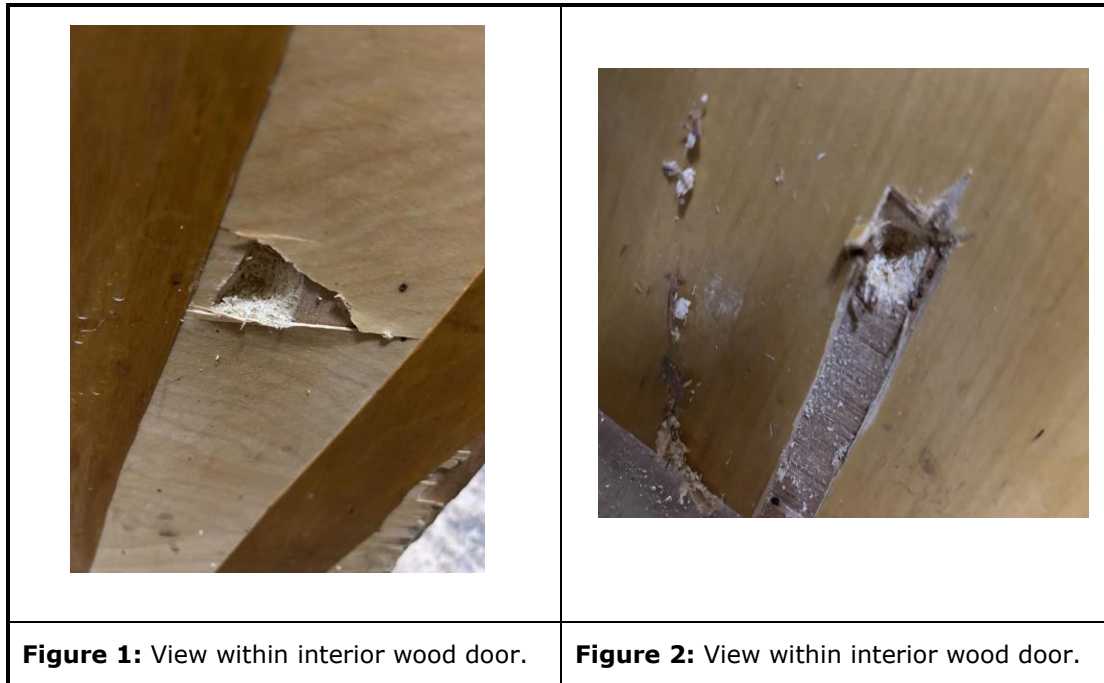
Interior wood doors are present throughout the project area and are scheduled to be replaced as part of the proposed renovations.

Limited intrusive investigations into representative wood doors were made by Maple in an attempt to check for possible concealed materials. Findings of the investigations confirmed that the doors consist of wood and do not contain materials suspected of containing asbestos. Refer to Figures 1 and 2 below for representative views within wood doors.

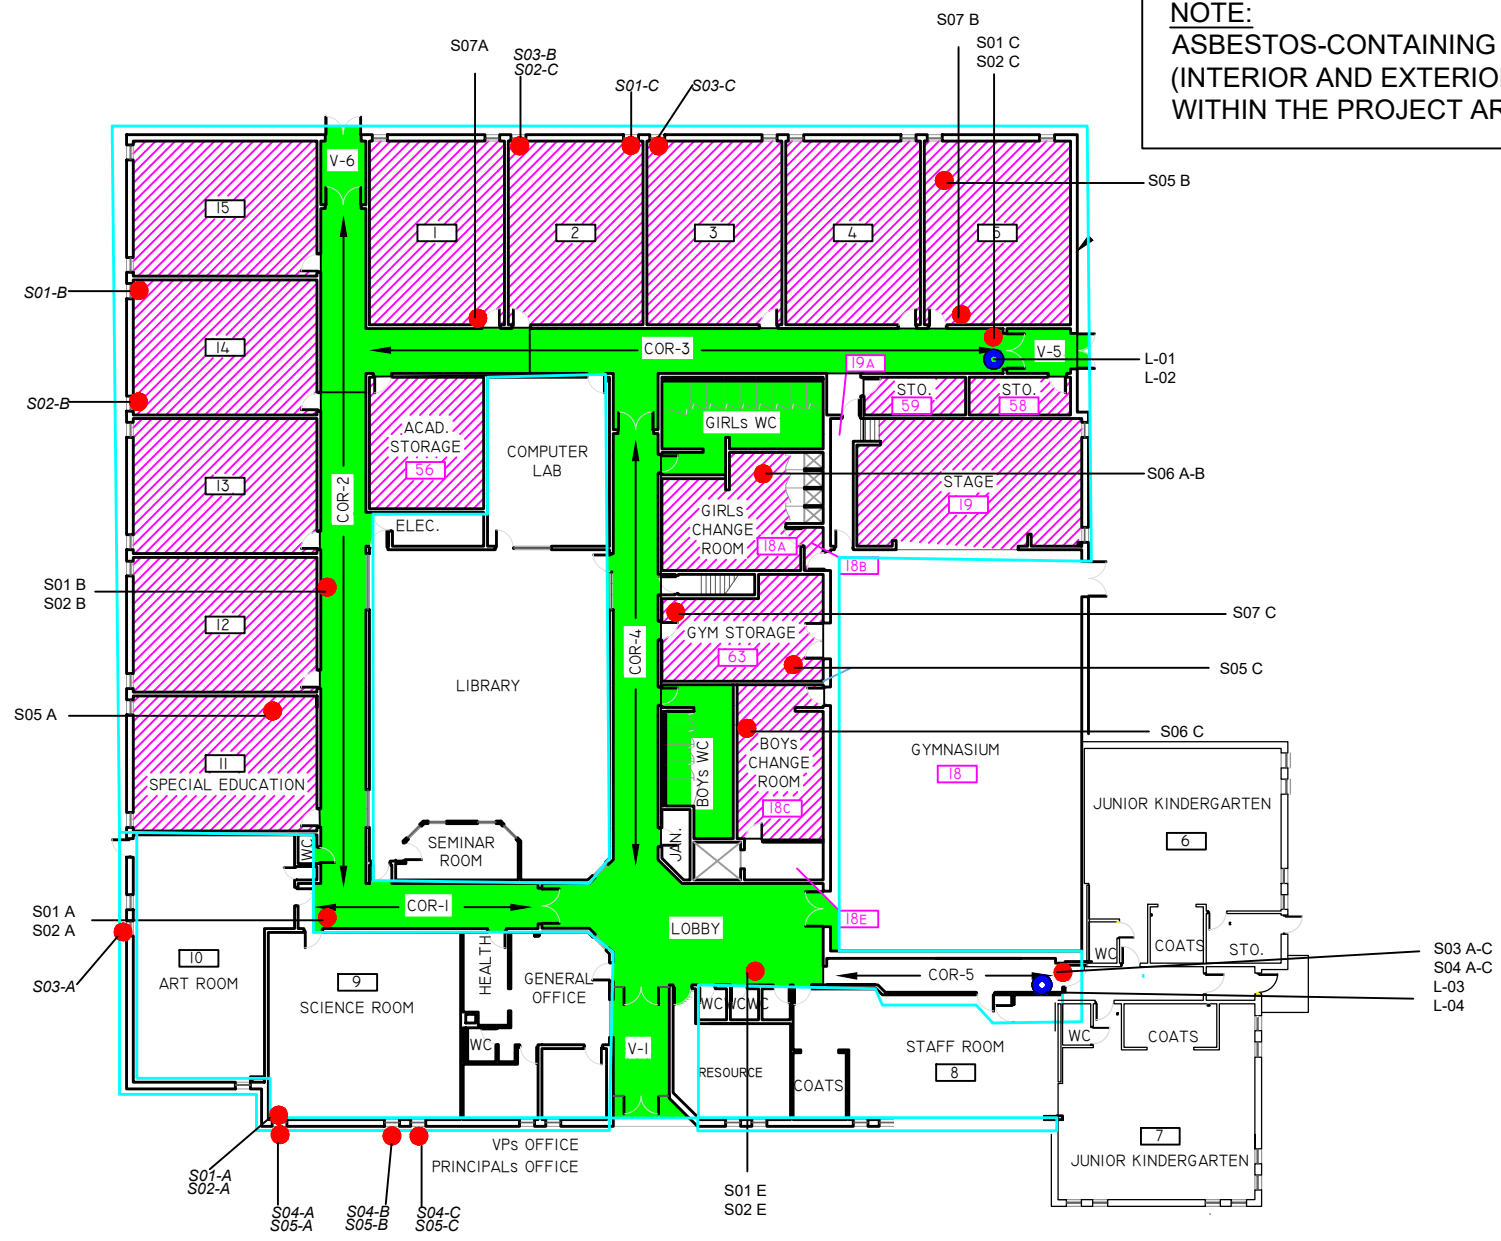
APPENDIX III
DRAWINGS

NOTE:
 ASBESTOS-CONTAINING WINDOW PUTTY
 (INTERIOR AND EXTERIOR) IS PRESENT
 WITHIN THE PROJECT AREA.
