Nelson Secondary School Mechanical Upgrades

Designated Substance Audit Report

4181 New Street, Burlington, ON

MTE File No.: 43920-102

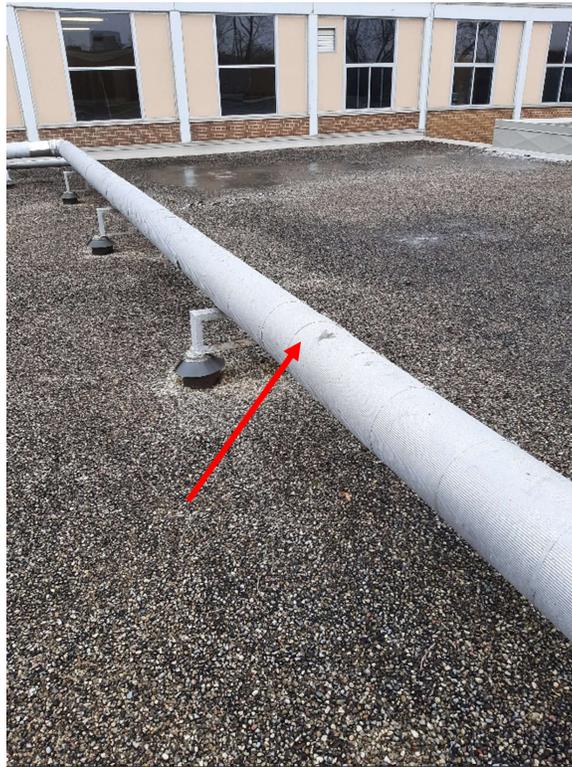
Photograph No. 1 – The insulation within the large steam pipe on roof section 102 was sampled (S01A,B,C) and is asbestos-containing.

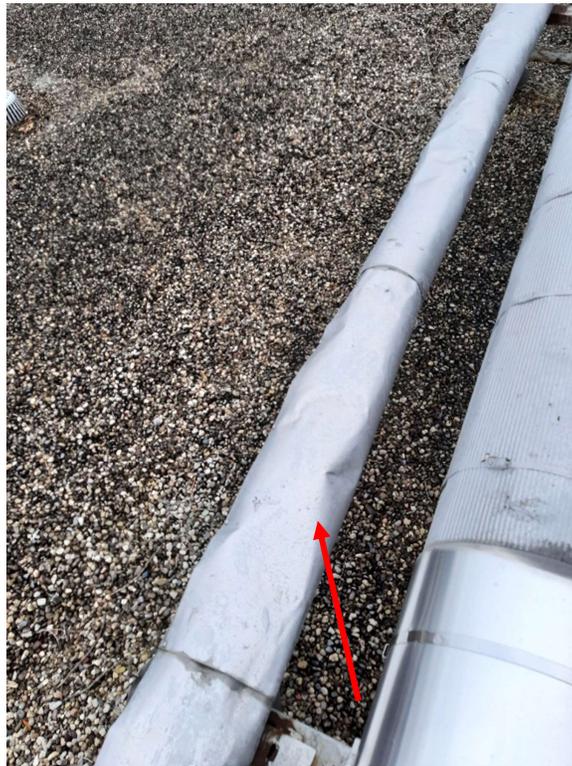
Photograph No. 2 – The insulation within the smaller steam pipe adjacent to the large steam pipe was inaccessible and therefore is suspected to contain asbestos.

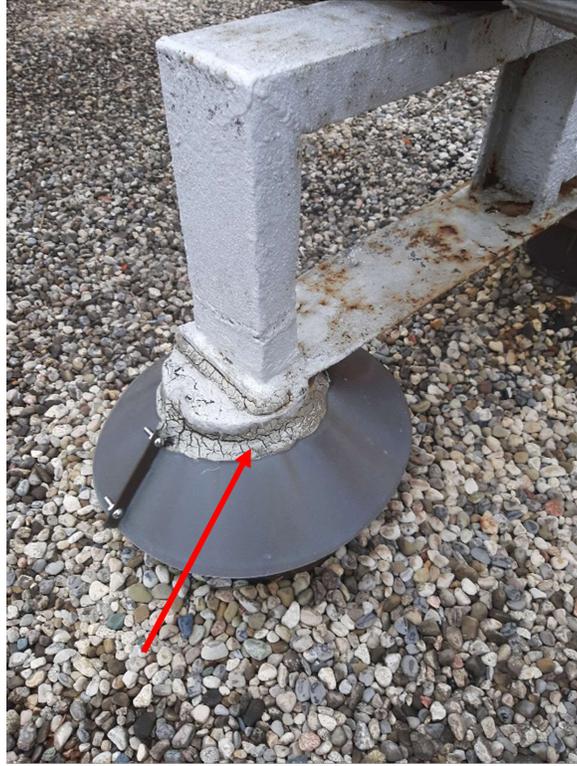
Photograph No. 3 – The sealant associated with the steam pipe mounting was sampled (S02A,B,C) and is not asbestos-containing.

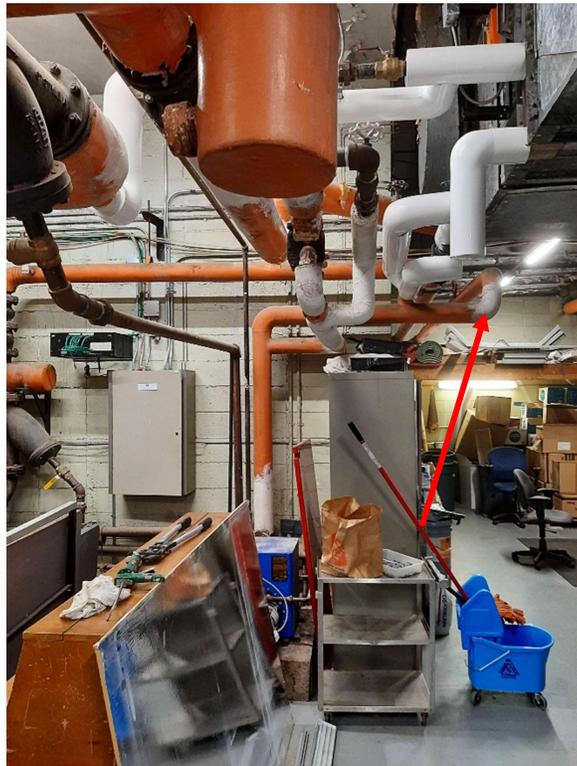
Photograph No. 4 – Pipe elbows within the secondary boiler room were sampled (S03A,B,C) and are asbestos-containing.

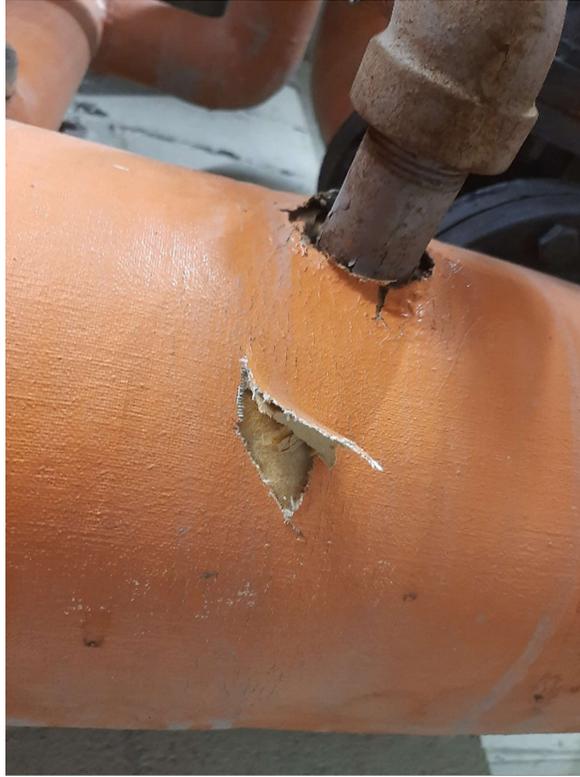
Photograph No. 5 – Pipe straights were inspected within the secondary boiler room and were comprised of fiberglass.

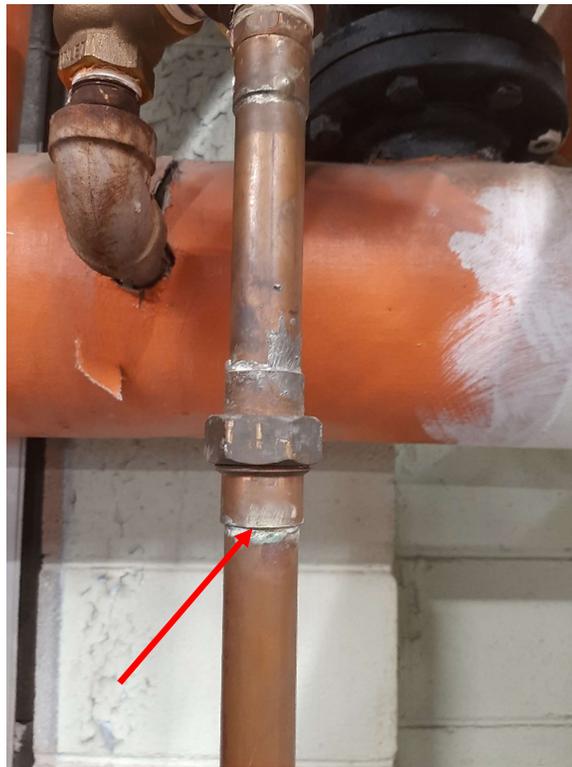
Suspect lead-containing solder on plumbing connections were identified. As such special requirements for the management, handling and disposal of lead-containing materials by the owner, constructor, contractor, sub-contractors and workers apply. The abatement contractor should consult Environmental Abatement Council of Canada's (EACC) *Lead Guideline for Construction, Renovation, Maintenance or Repair (October 2014)* for the procedures and methods required to remove and dispose of lead-containing materials.

Photograph No. 6 – Suspect lead containing solder on copper pipe connections were observed within the secondary boiler room.

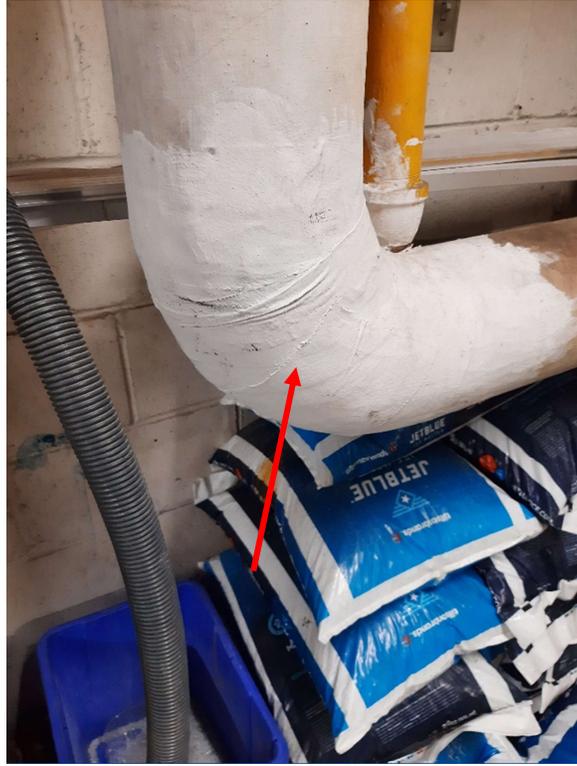
Photograph No. 7 – Pipe elbows within the primary boiler room were sampled (S06A,B,C) and are asbestos-containing.

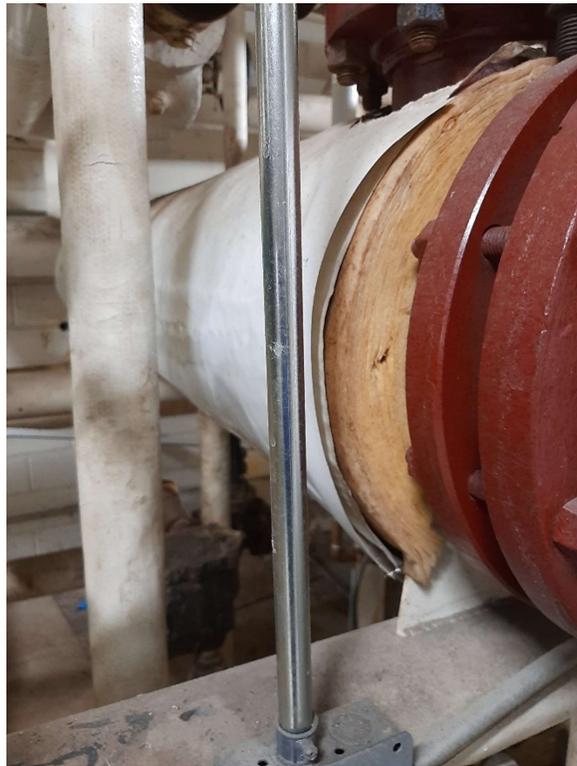
Photograph No. 8 – Pipe straights throughout the primary boiler room were observed to be comprised of fiberglass.

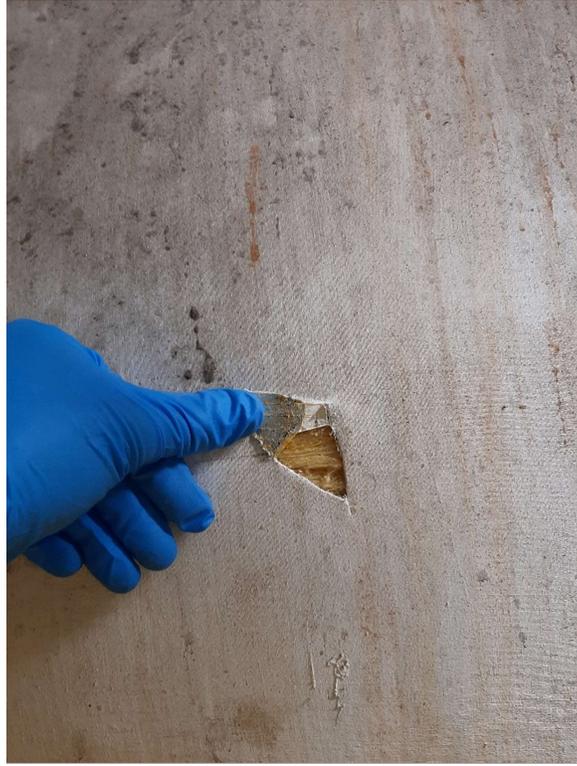
Photograph No. 9 – The insulation on the large white heat exchanger/storage tank was observed to be fiberglass.

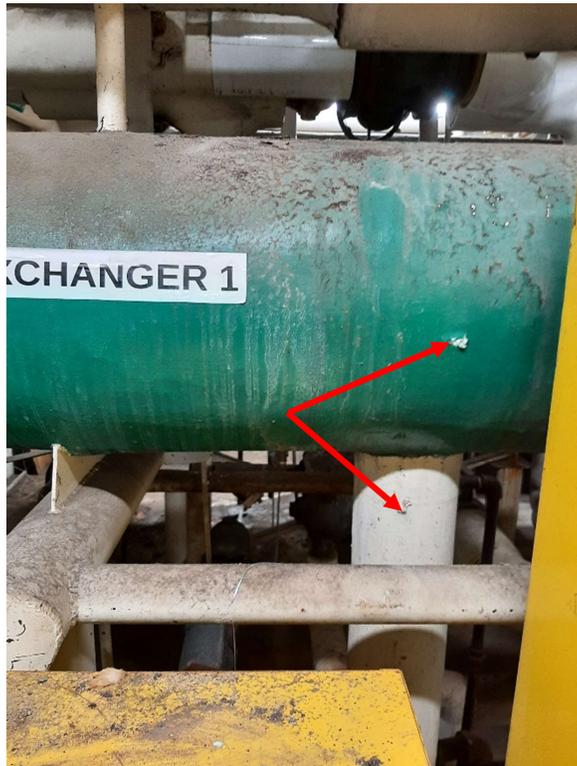
Photograph No. 10 – The insulation on the small green heat exchanger and associated pipe straight was sampled (S07A,B,C) and is asbestos-containing.

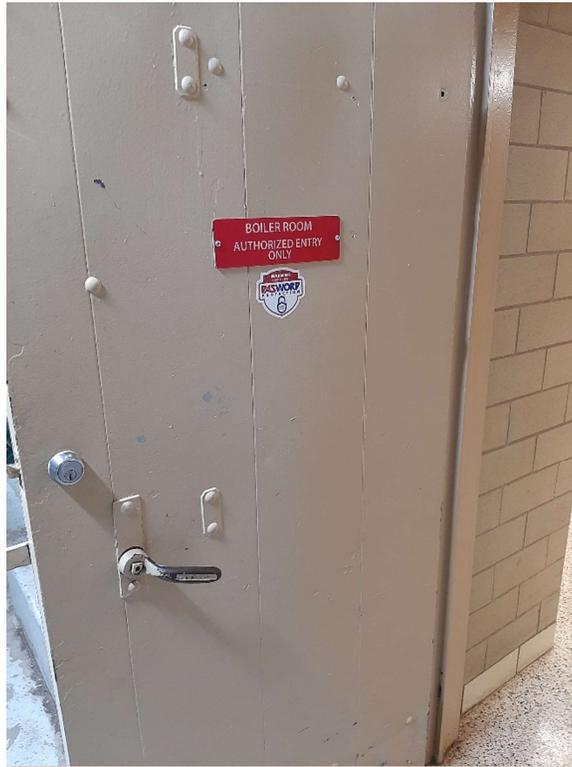
Photograph No. 11 – Fire doors were observed at the primary boiler room and are suspected to contain asbestos insulation.

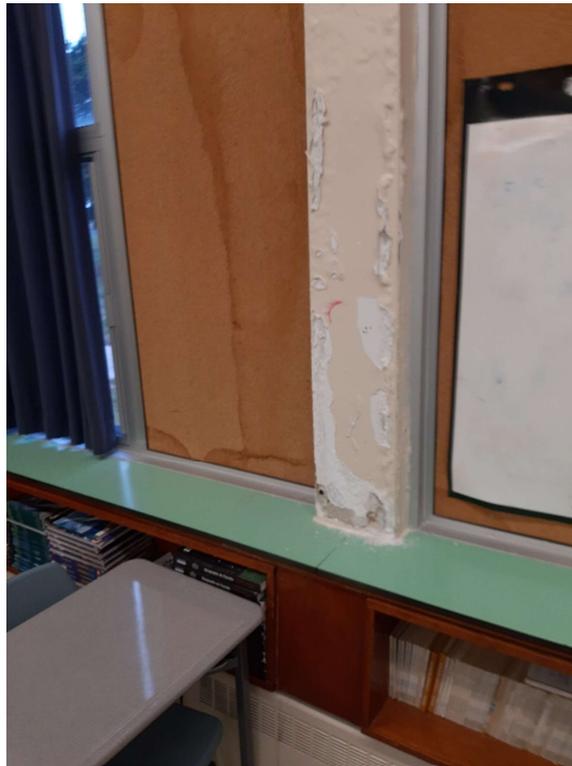
Photograph No. 12 – Plaster was sampled from room 126 (S15A,B,C) and is asbestos-containing.

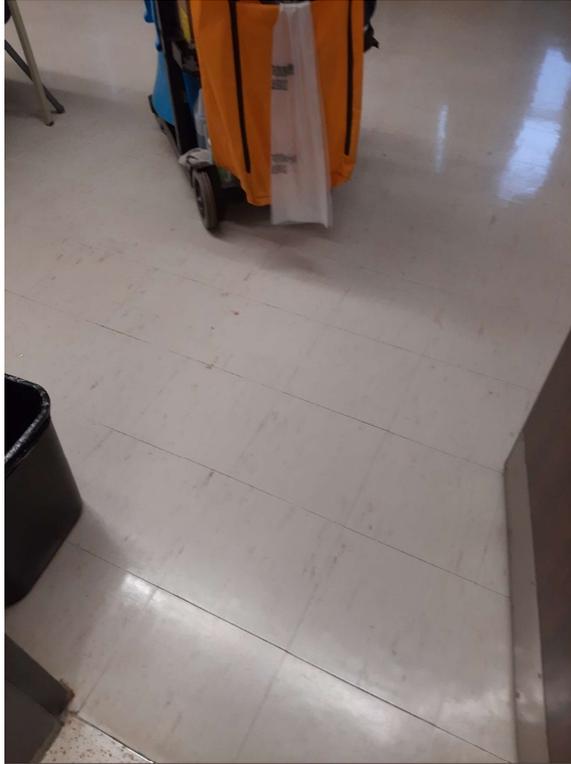
Photograph No. 13 – 12”x12” Vinyl Floor Tile was sampled from room 123 (S16A,B,C) and are not asbestos-containing; however, the associated mastic is asbestos-containing.

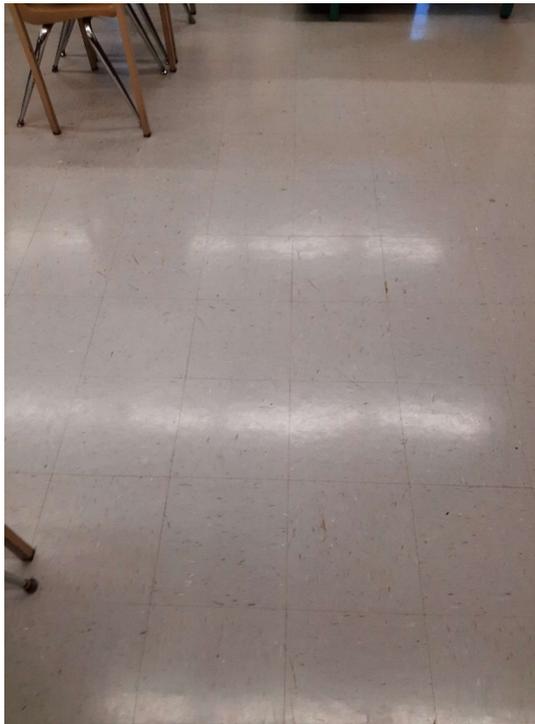
Photograph No. 14 – 12”x12” Vinyl Floor Tile was sampled from room 126 (S17A,B,C) and is not asbestos containing; however, the mastic is asbestos containing.

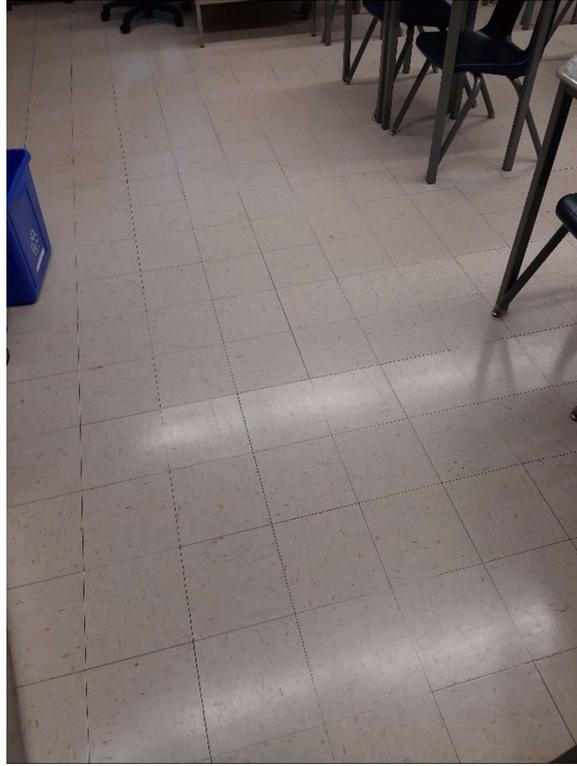
Photograph No. 15 – 9”x9” Vinyl Floor Tile was sampled from room 230 (S22A,B,C) and is asbestos-containing. The associated mastic is also asbestos containing.

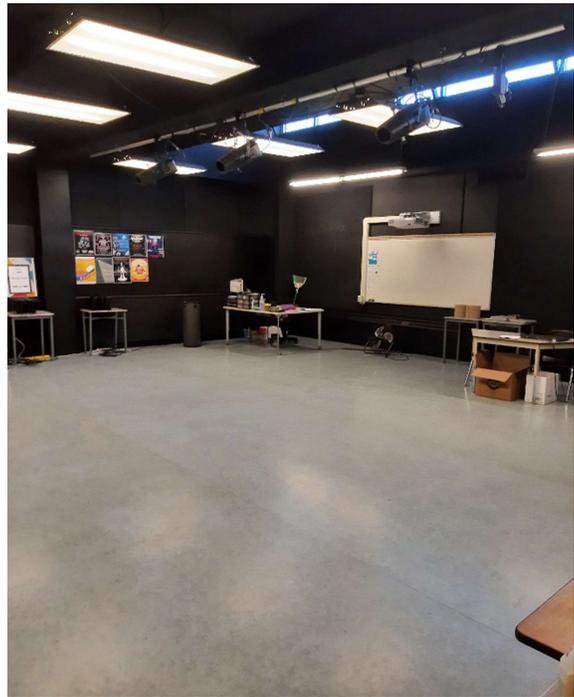
Photograph No. 17 - Vinyl sheet flooring was sampled from classroom 244 and is not asbestos containing; however, the mastic/backing is asbestos containing. The black paint was also sampled (LP07) and is low level lead-containing.

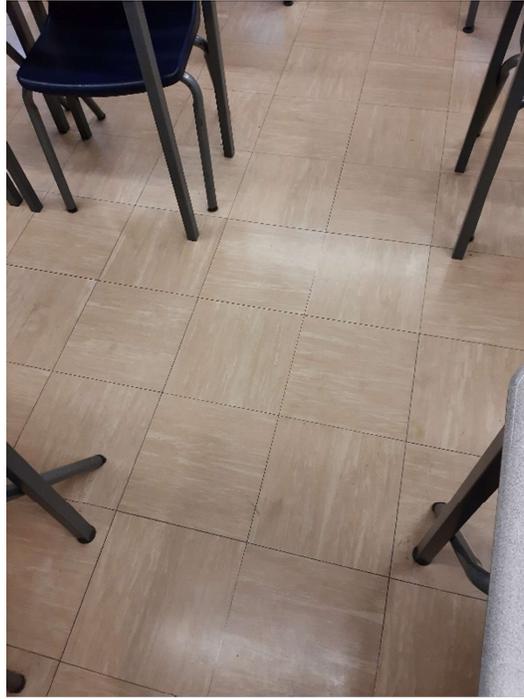
Photograph No. 18 - 12"x12" Vinyl Floor Tile was sampled from room 2011 (S40A,B,C) and is not asbestos-containing. The mastic is also not asbestos-containing

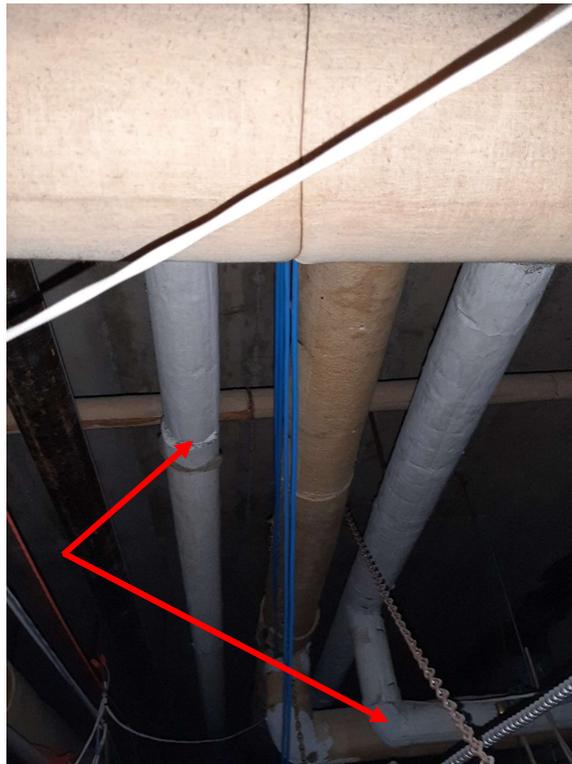
Photograph No. 19 – Asbestos-containing pipe straights and elbows were observed above the drop ceiling in corridor 1C3.

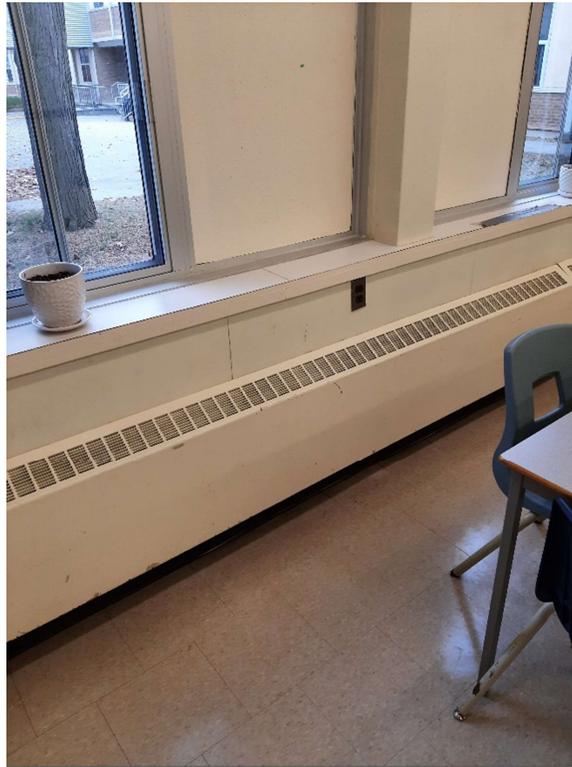
Photograph No. 20 - Interior sealant was sampled (S10A,B,C) and is not asbestos-containing. The cream paint on interior walls was sampled (LP04) and is low level lead-containing.

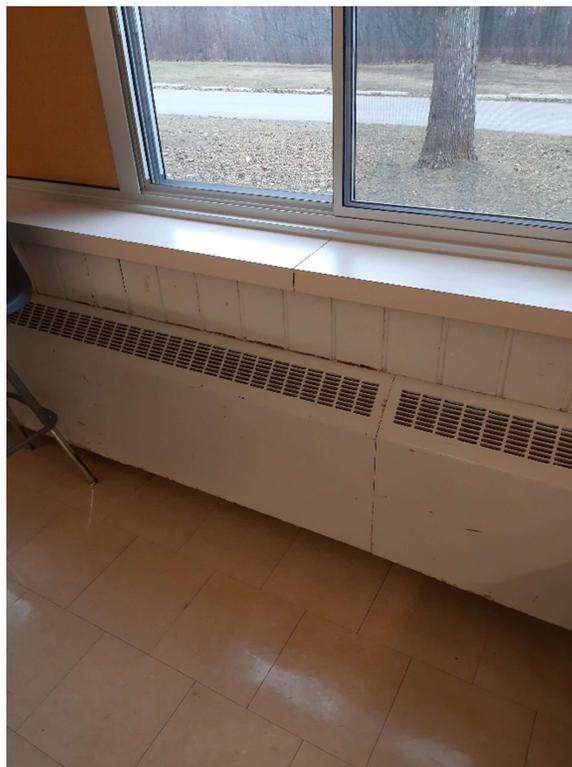
Photograph No. 21 - The gray paint on interior walls was sampled (LP01) and is low level lead-containing.

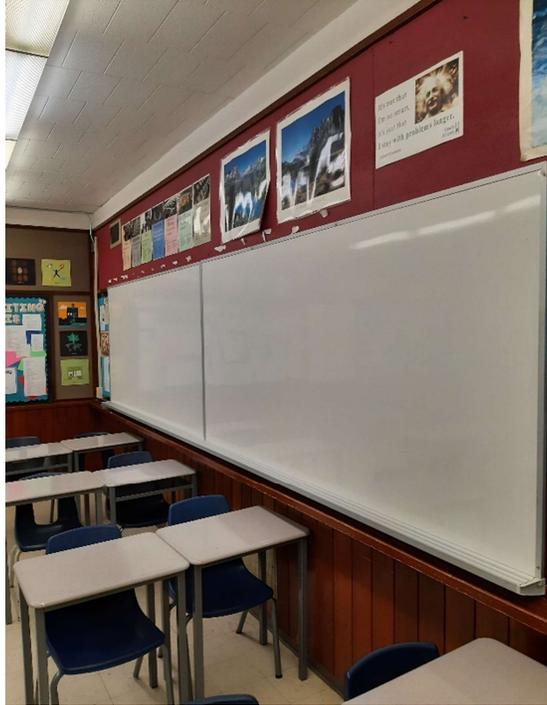
Photograph No. 22 - Suspect asbestos-containing mastics may be present underneath classroom whiteboards and tackboards.

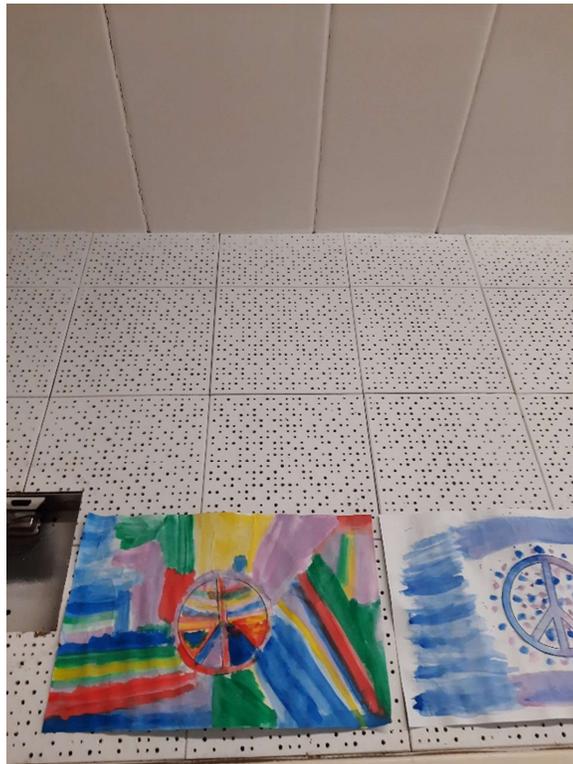
Photograph No. 23 - Suspect asbestos containing mastics may be present underneath 1'x1' acoustic panels within classrooms.

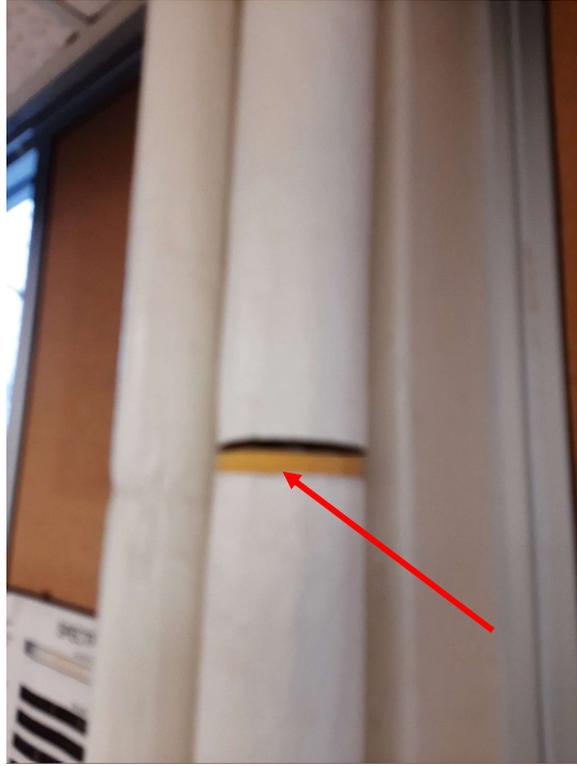
Photograph No. 24 - Fibreglass pipe straights were observed in classrooms throughout the interior.

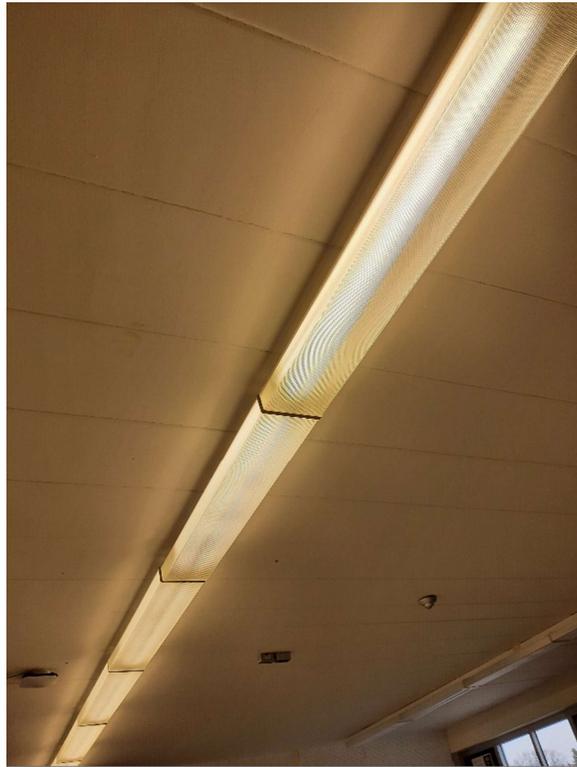
Photograph No. 25 – Mercury-containing fluorescent light tubes were observed throughout the interior. Associated light ballasts may potentially contain PCBs.

Mercury-containing materials were identified. All mercury containing materials or sources should be removed, intact, prior to any work which may disturb or damage them and cause worker exposure to mercury liquid and/or vapour.

On-site crushing of mercury-containing materials should not occur. Care should be taken to ensure safe storage of the above until recycling or disposal can be coordinated. Under current legislation, mercury waste requires handling and disposal in accordance with Ontario Regulation 490/09 of the OHSA and Ontario Regulation 347 of the Environmental Protection Act.

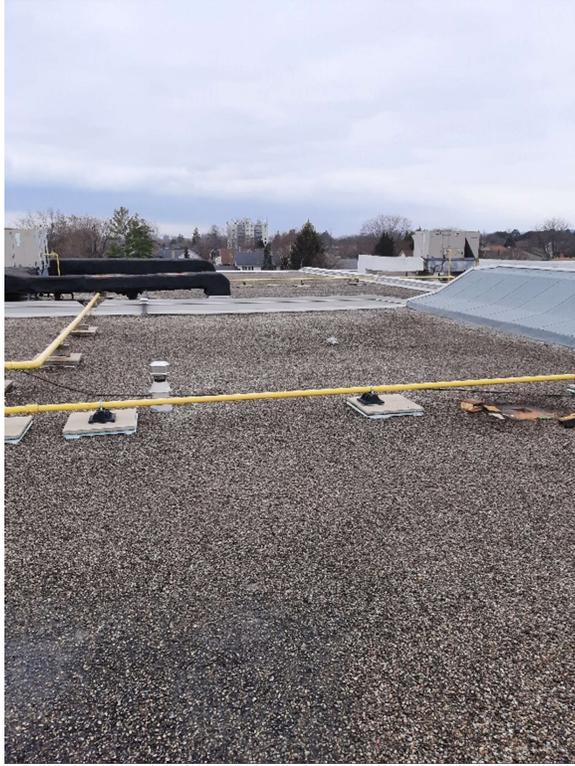
Photograph No. 26 - The roof system across sections 108, 301, 401, 403, and 404 were sampled. No asbestos materials were confirmed present.
