**RFT 22-132 Renovations - Gladys Speers PS**

**PROJECT:** Gladys Speers Public School  
2150 Samway Rd, Oakville, ON L6L 2P6

**ADDENDUM NO.:** 1

# PRE-RENOVATION DESIGNATED SUBSTANCES AND HAZARDOUS MATERIALS SURVEY

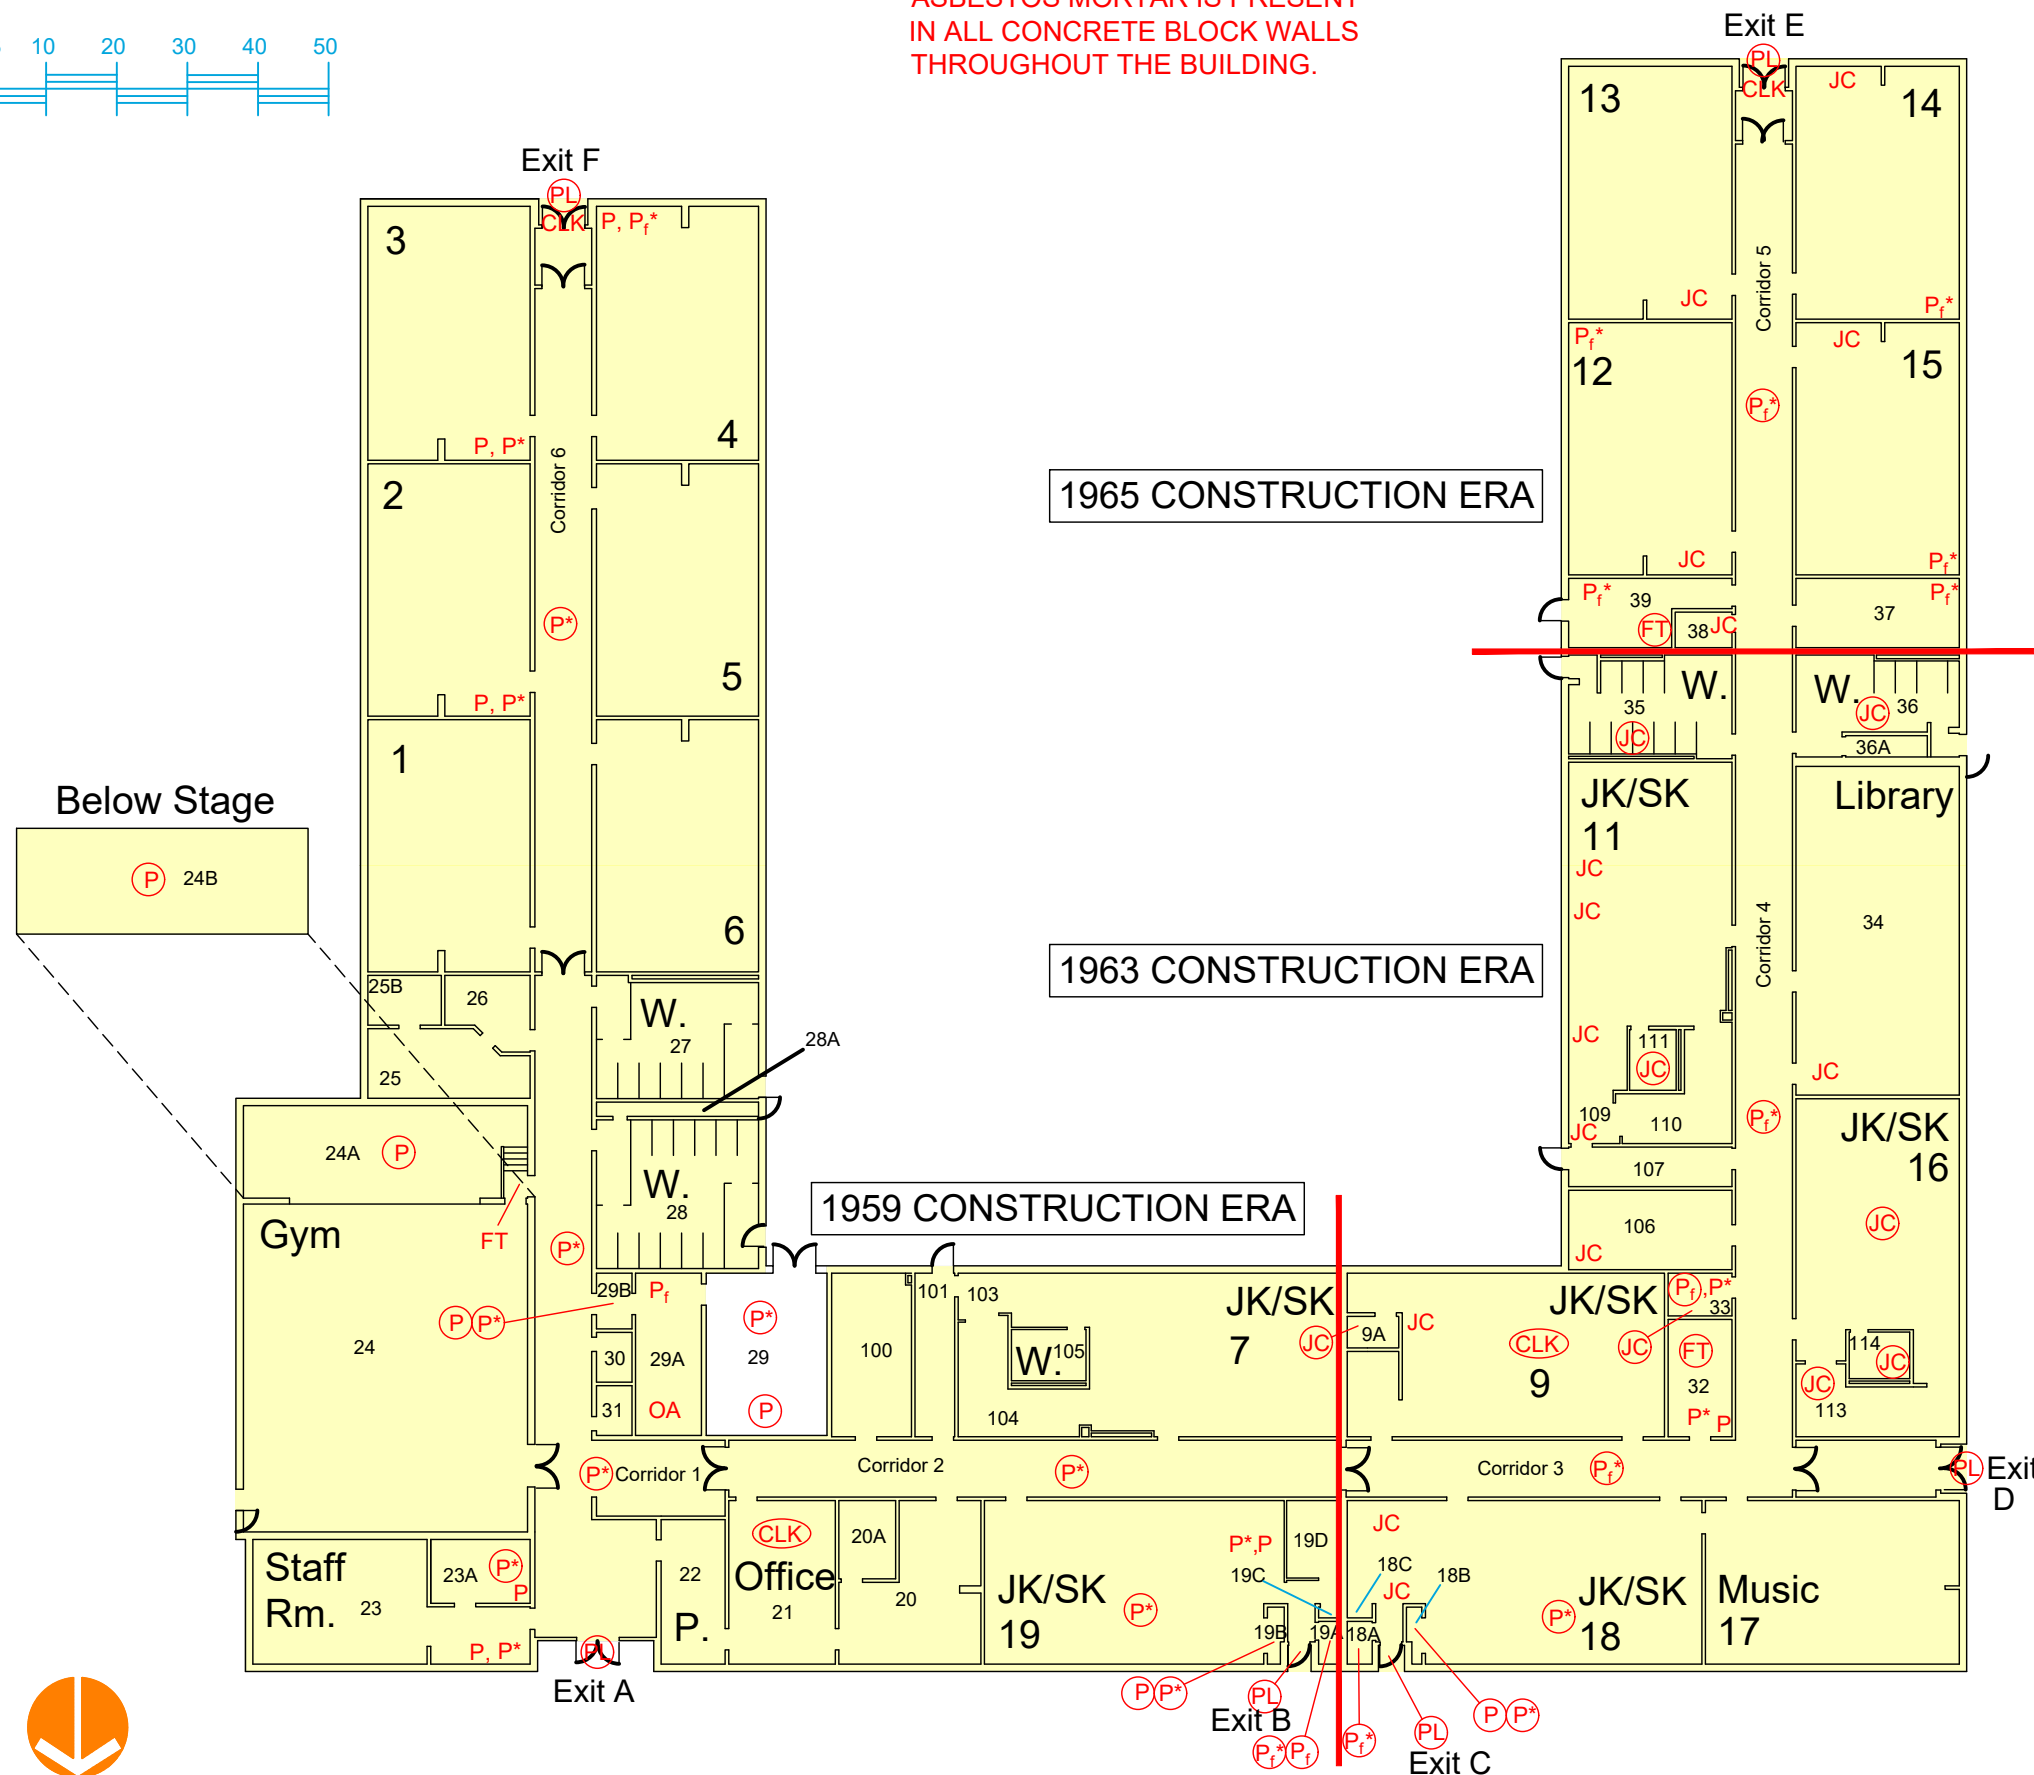
ASBESTOS MORTAR IS PRESENT  
IN ALL CONCRETE BLOCK WALLS  
THROUGHOUT THE BUILDING.
