RFT 25-055 - Washroom Renovation - Central Public School

Hazardous Building Materials Assessment (Pre-construction)

Washroom Renovation Project
Central Public School
638 Brant Street, Burlington,
Ontario

May 7, 2025

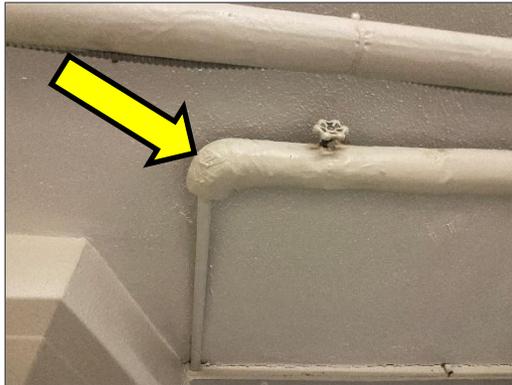
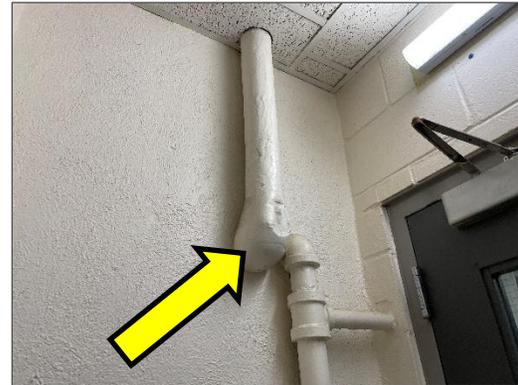
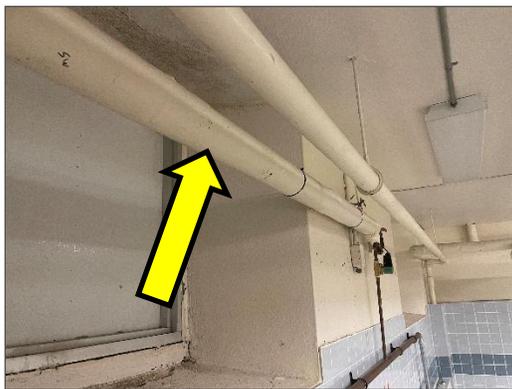
Remaining pipes in the assessed area are either uninsulated or insulated with non-asbestos fibreglass or other non-asbestos insulation such as mineral fibre or elastomeric foam insulation.

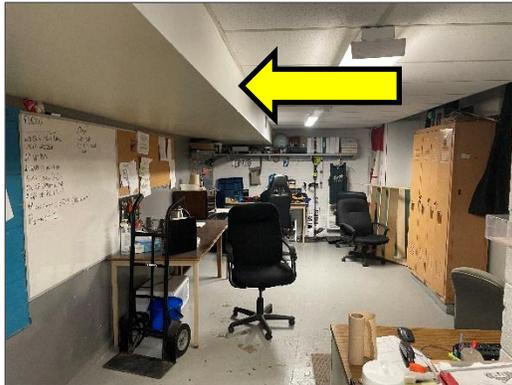
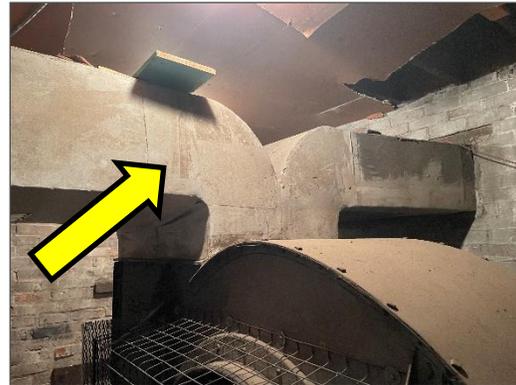
Remaining ducts are either uninsulated or insulated with non-asbestos fibreglass (foil-faced or canvas jacketing).

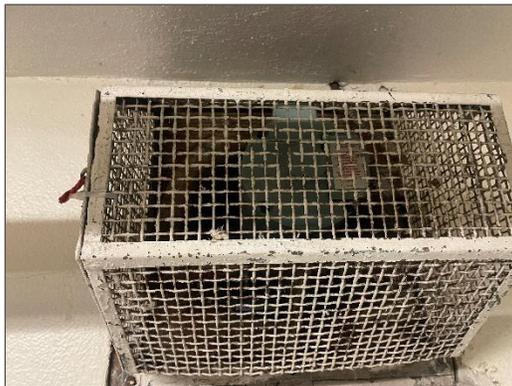
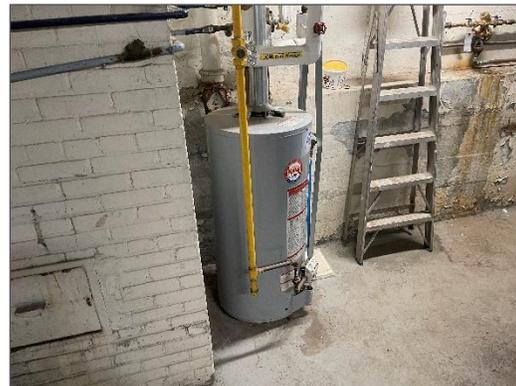
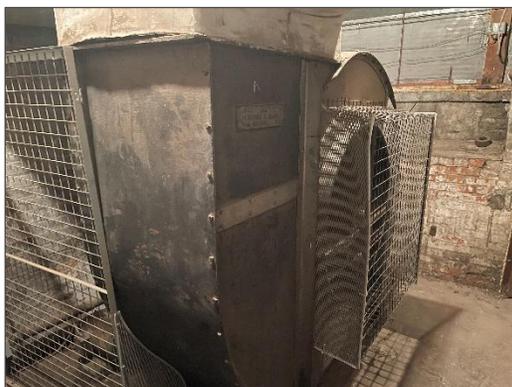
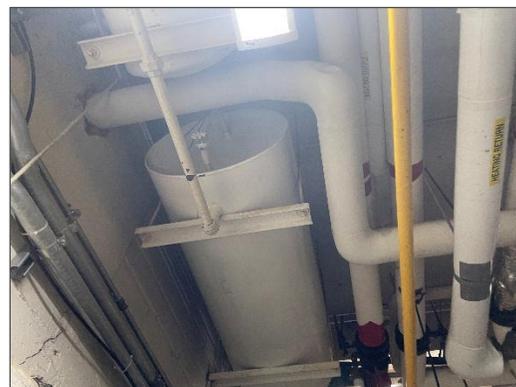
Mechanical equipment (furnace, hot water tanks, boilers) is either uninsulated or insulated with non-asbestos fibreglass (photos 1-4).

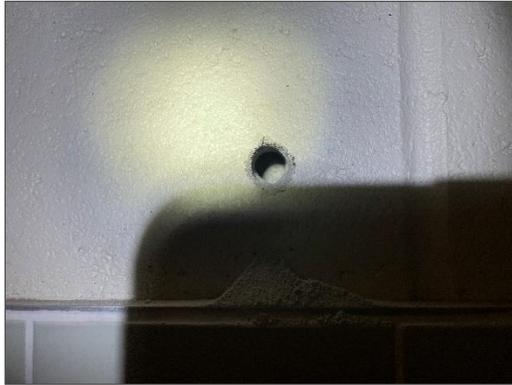
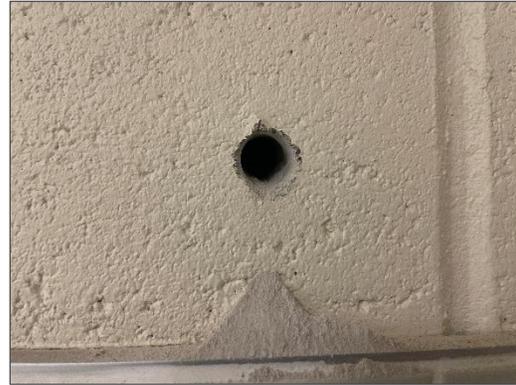
Loose fill vermiculite was not observed within the cavities (photos 1 and 2).

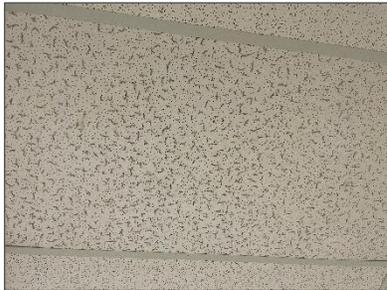
Description	Sample Location	Sample Number, Date Code or Material Composition	Asbestos	Photo
24"x48" lay-in, pinhole with deep fleck	Corridor (Location 20)	S0115A-C	No

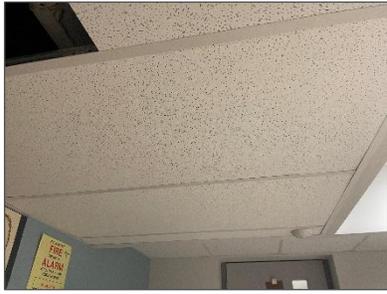
Description	Sample Location	Sample Number, Date Code or Material Composition	Asbestos	Photo
24"x48" lay-in, pinhole and fleck	Classroom 15,16,17 (Location 15)	Date stamped; 06/19/14	No

Ceiling tiles are presumed to be non-asbestos based on the date of manufacture determined from the date stamp applied to the top of the tiles. The tiles were manufactured after asbestos stopped being used in acoustic ceiling tiles.

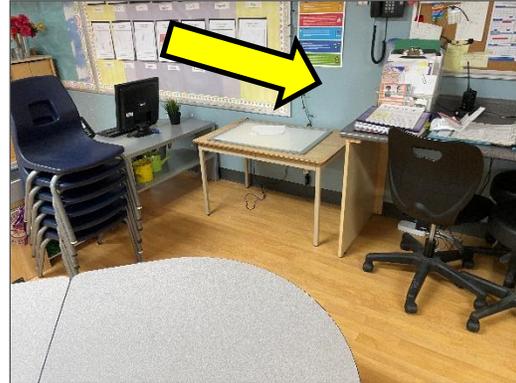
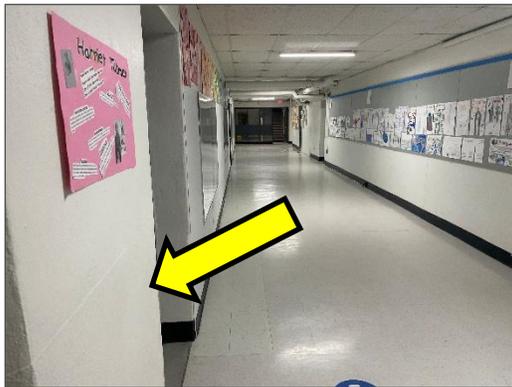
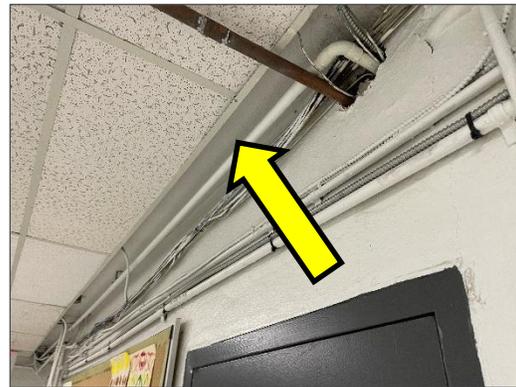
- On walls in Classroom 3 (Location 3, samples S0099, photo 2).
- On walls and ceilings in the Corridor (Location 20, samples S0114A-C, S0120A-C, S0121A-C, photos 3 and 4).
- On walls in Classrooms 3 and 4 (Locations 3 and 4, samples S0117A-C, photos 5 and 6).
- On walls and ceilings in the Boys Washroom (Location 12, samples S0118A-E, photo 7).
- On walls and ceilings in the Girls Washroom (Location 1, samples S0119A-D, photo 8).
- On ceilings in the Caretakers Storage (Location 8, samples S0053).
- On walls in the Storage / Crawlspace Entrance (Location 14, samples S0083).

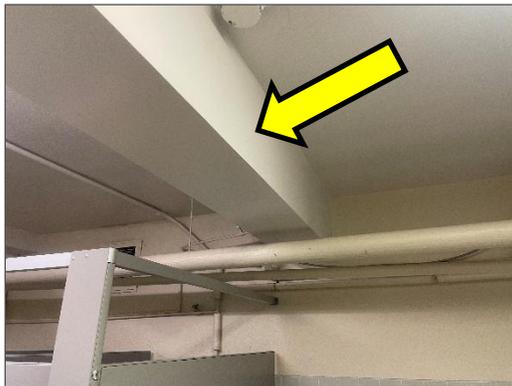
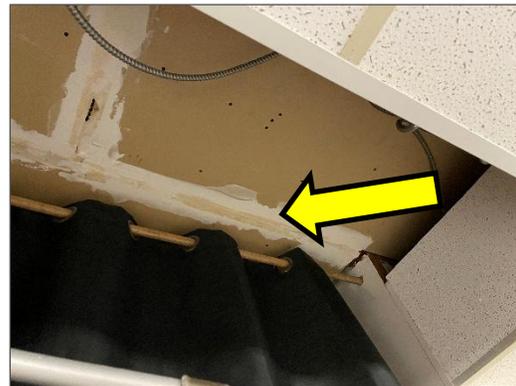
Drywall joint compound present on wall and ceiling finishes throughout the assessed area does not contain asbestos (samples S0024, S0086, S0111A-C, photos 1 and 2).

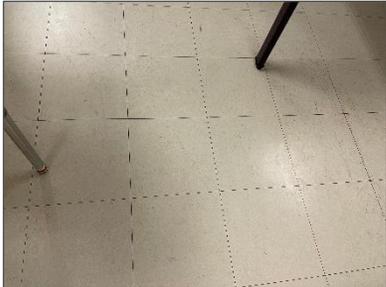
Description	Sample Location (Location #)	Sample Number	Asbestos (Tile / Adhesive)	Photo
12"x12", white with faint brown streaks	Classroom 4 (Location 4)	S0031 and S0104A-C	No/No

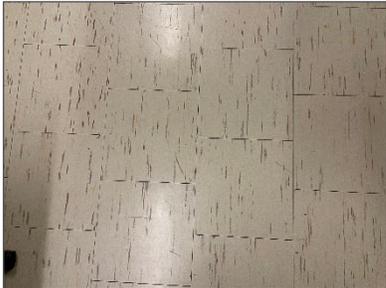
12"x12", beige with brown and orange streaks	Classroom 3 (Location 3) Classroom 4 (Location 4)	S0105A-C	No/No

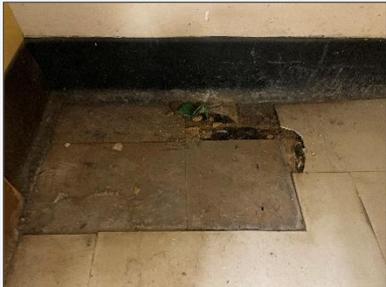
9"x9", under 12"x12" white with faint brown streaks	Classroom 4 (Location 4), presumed present below non-asbestos tiles throughout the Classroom	S0113A-C	Yes / No

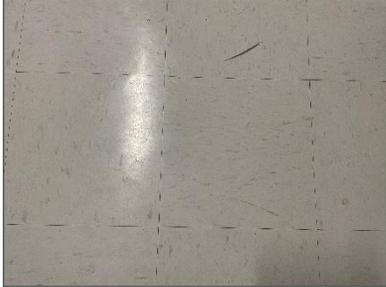
12"x12", white with grey fleck	Corridor (Location 20)	S0116A-C	No/No

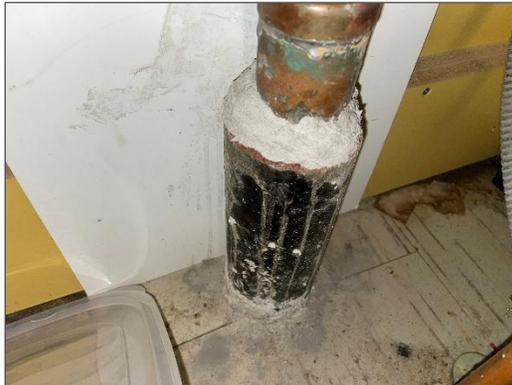
Photo 1

Firestopping (cementitious) present at pipe and conduit penetrations in Classroom 3 (Location 3) does not contain asbestos (samples S0103A-C, photo 1).

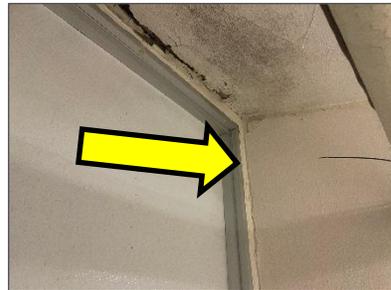
Material, Description and Application	Sample Location (Location #)	Sample Number	Asbestos	Photo
Caulking, grey at windows	Exterior, Classroom 3 and Classroom 4 (Location 1948)	S0013A-C	None detected	
Caulking, dark brown on metal cladding	Exterior, Entrance 6 (Location 1919)	S0014A-C	None detected	
Caulking, grey at windows	Boys Washroom (Location 12) Girls Washroom (Location 1)	S0100A-C	None detected

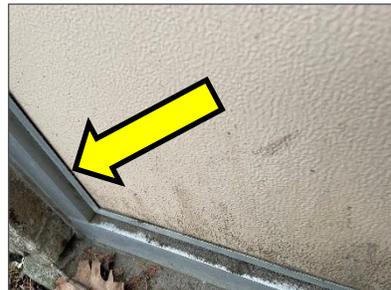
Putty, at window spandrel	Exterior, Boys Washroom (Location 1919)	S0108A-C	None detected

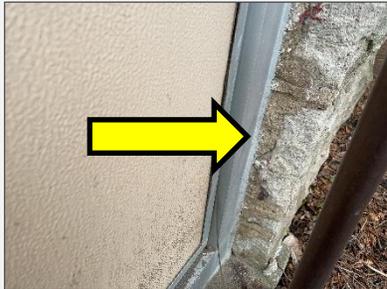
Material, Description and Application	Sample Location (Location #)	Sample Number	Asbestos	Photo
Caulking, grey at windows	Exterior, Boys Washroom and Girls Washroom (Location 1919)	S0109A-C	Yes

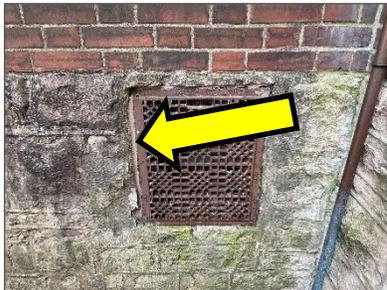
Caulking, brown at vent exhaust	Exterior (Location 1919)	S0110A-C	None detected

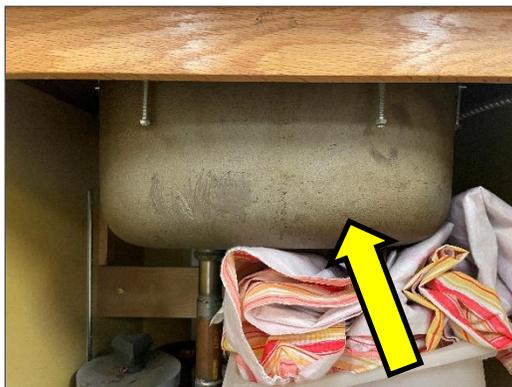
Photo 5

Gold mastic, containing asbestos, is present on the underside of the sink in Classroom 3 (samples S0101A-C, photo 5).

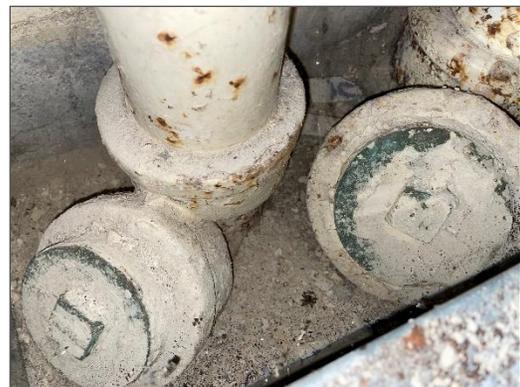
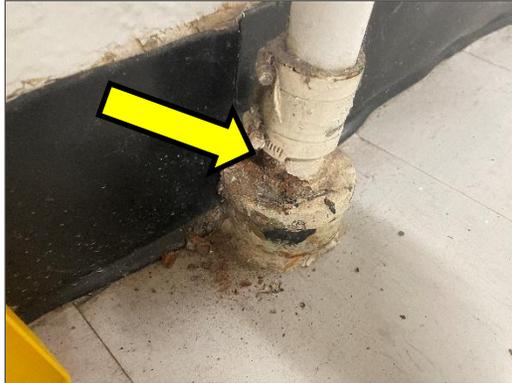
Beige paint present on cast iron pipes throughout the assessed area does not contain asbestos (samples S0112A-C, photos 6 and 7).

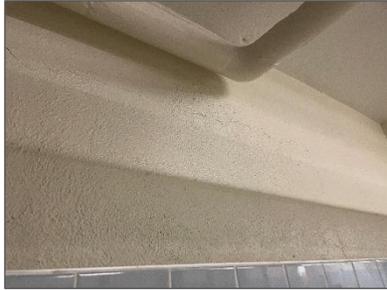
Sample Number	Colour, Substrate Description	Sample Location	Lead (%)	Photo
L0001	Cream on rough plaster	Boys Washroom (Location 12)	0.091

Results less than or equal to 0.1% (1,000 mg/kg), but equal to or greater than 0.009% (90 mg/kg), are considered low-level lead paints or surface coatings in accordance with the EACC guideline.

For paints identified as having low levels of lead (i.e., equal to or above 0.009% (90 mg/kg) but less than or equal to the EACC guideline of 0.1% (1,000 mg/kg) for lead-containing paints) special precautions are not recommended unless aggressive disturbance (grinding, blasting, torching) is planned. Exposure from construction disturbance of paints containing lead less than 0.009% (90 mg/kg) is assumed to be insignificant.

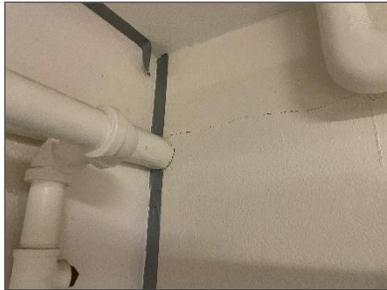
L0002	Cream on metal pipe	Boys Washroom (Location 12)	0.13

Results above 0.1% (1,000 mg/kg) are considered lead-containing, and over 0.5% (5,000 mg/kg) are considered lead-based.

Items painted with paints containing elevated levels of lead may be a hazardous waste. Test lead-painted materials for leachable lead and other metals prior to disposal. Metallic components coated with lead

paint do not require leachate testing and can be disposed of as non-hazardous construction and demolition (C&D) waste.

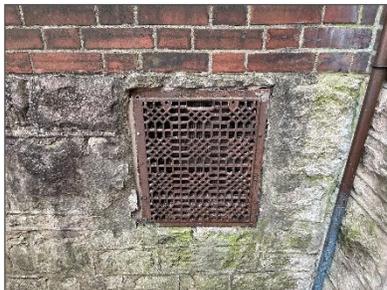
L0003	Brown on blue on metal	Exterior, Boys Washroom (Location 1919)	0.29

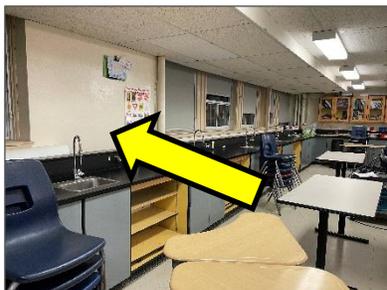
L0004	Beige on smooth plaster	Classroom 3 (Location 3)	0.46

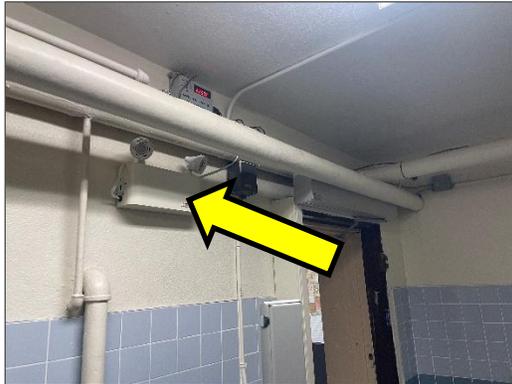
Photo 1

Lead-containing batteries are present in emergency lighting (photo 1).

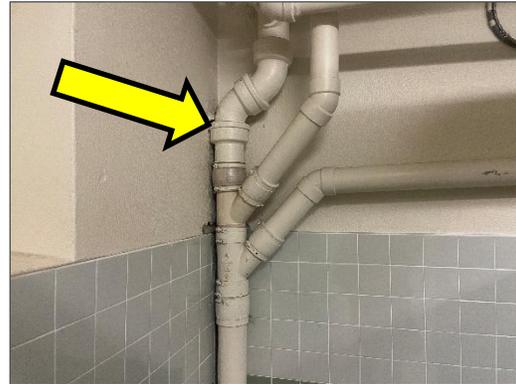
Photo 2

Lead caulking is present in bell and spigot fittings on cast iron pipes (photo 2).

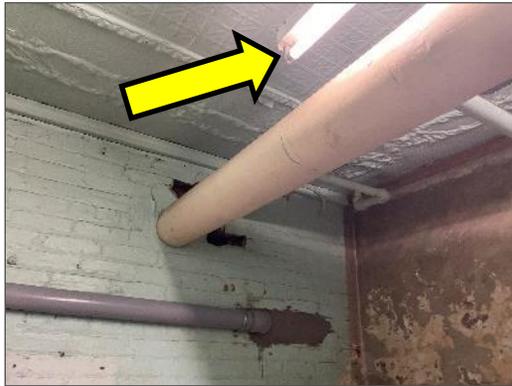
Photo 1

Mercury vapour is present in fluorescent lamp tubes (photo 1).

Do not break lamps. Recycle and reclaim mercury from fluorescent lamps when taken out of service. Mercury is classified as a hazardous waste and must be disposed of in accordance with applicable regulations.

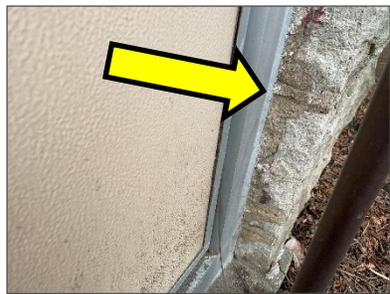
Material, Colour, Application	Sample Location (Location #)	Sample Number	PCB (mg/kg)	Photo
Caulking, grey on window frames	Boys Washroom Exterior (Location 1919)	P0001	0.2

Caulking is considered non-PCB solid based on the threshold (50 mg/kg).

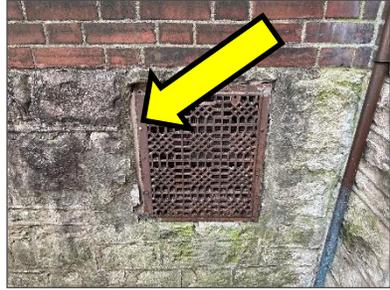
Material, Colour, Application	Sample Location (Location #)	Sample Number	PCB (mg/kg)	Photo
Caulking, brown at exhaust vent	Boys Washroom Exterior (Location 1919)	P0002	<0.1
