FINAL
Hazardous Building
Materials Assessment
(Pre-construction)

Kilbride Public School
6611 Panton Street, Burlington,
Ontario

April 14, 2025

Pinchin File: 352316.001

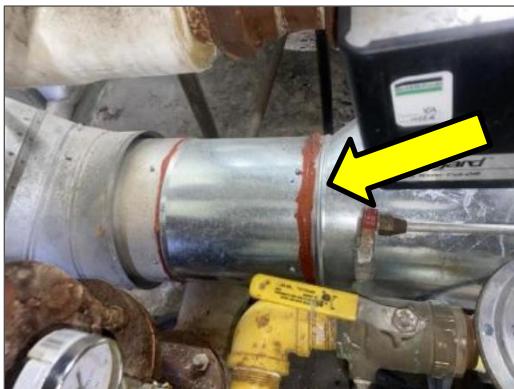
Photo 1

Red duct mastic present at seams / joints on the ducts in the Mechanical Room (Location 120) does not contain asbestos due to the material of manufacture (silicone, photo 1).

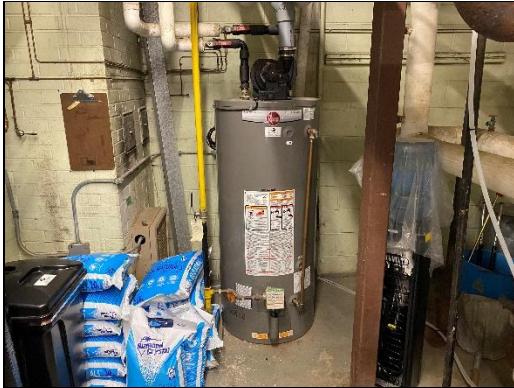
Photo 1

Exterior of mechanical equipment (hot water tanks and boilers) is uninsulated (photos 1 and 2).

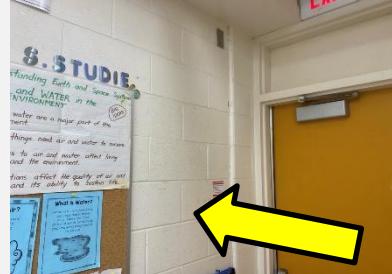
Description	Locations	Sample Number	Asbestos	Photo
Vermiculite in exterior concrete block walls	1967 era	S0022	Yes

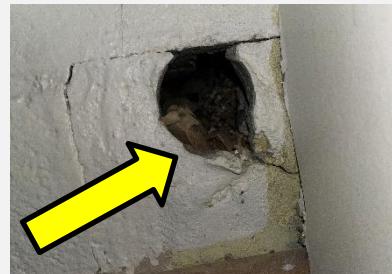
Vermiculite observed in inaccessible cavities and cracks	1959 era	S0078	Yes

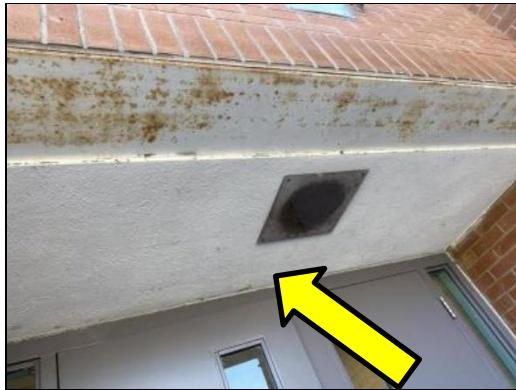
Photo 1

Textured plaster, containing chrysotile asbestos is present as an exterior soffit above Door #3 outside Corridor 141 (Exterior location 150, samples S0037, photo 1). Overspray from the asbestos-containing plaster is present above the ceiling at light fixture openings, on the deck, ducts and within junction boxes.

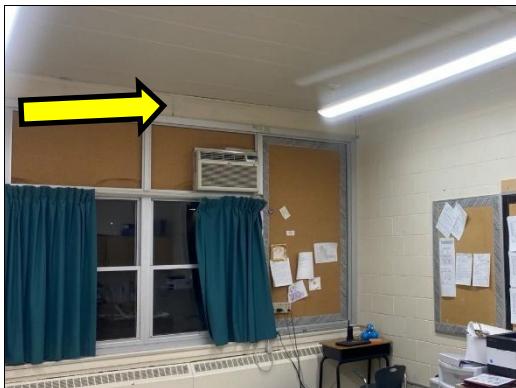
Photo 1

Transite board, containing chrysotile asbestos, is present above windows in Room 115 (sample S0025, photo 1).

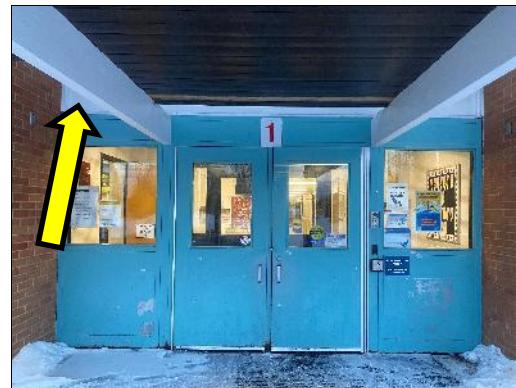
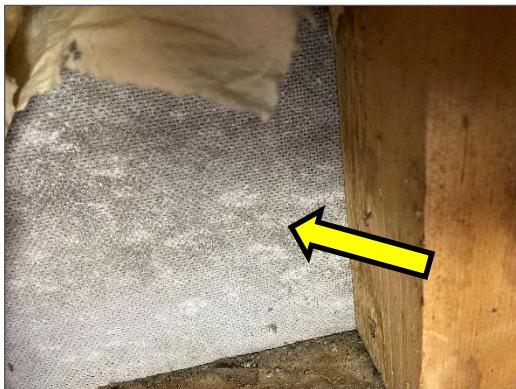
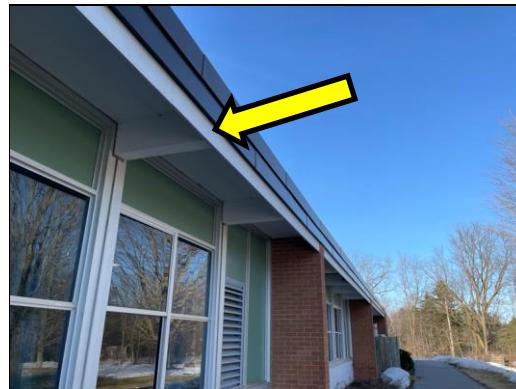
Transite board, confirmed to contain asbestos based on visual observation, is present as exterior fascia over Door #1 Exterior (Location 151) and exterior of the 1959 era of construction (photos 2-4).

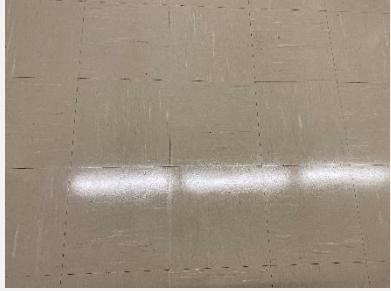
Description	Sample Number	Asbestos (Tile / Mastic)	Locations	Photo
9"x9", beige with white and brown streaks	S0001 (Tile) S0002 (Mastic)	Chrysotile / None detected	Classroom 108 Classroom 109 (1959 era)

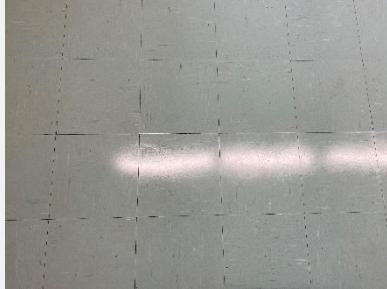
Description	Sample Number	Asbestos (Tile / Mastic)	Locations	Photo
9"x9", green	S0031 (Tile) S0003 (Mastic)	Chrysotile / None detected	Classroom 102 Classroom 103 (1959 era)

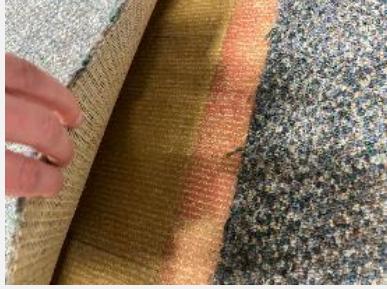
9"x9", red and beige (concealed below carpet)	N/A	Presumed / Presumed	Library 116 (1959 era)

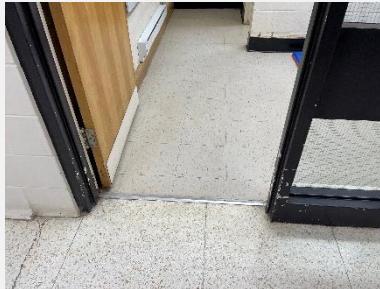
12"x12", beige with grey and brown streaks	S0060 (Tile and Mastic)	None detected / Chrysotile	Office 126 (1967 era)

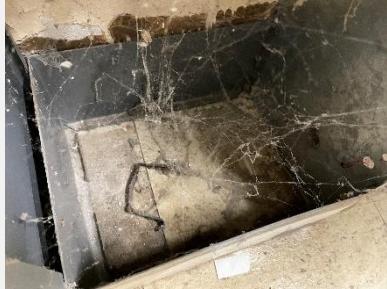
Description	Sample Number	Asbestos (Tile / Mastic)	Locations	Photo
12"x12", white with black streaks (residual inside/under radiators and or edges/ perimeter of rooms)	S0061C (Tile and Mastic)	Chrysotile / None detected	Staff Room 125 and 125A (1967 era)

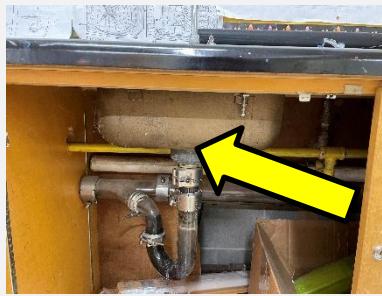
Gold sink undercoating	Classroom 105 Classroom 128	S0049A-C	Chrysotile

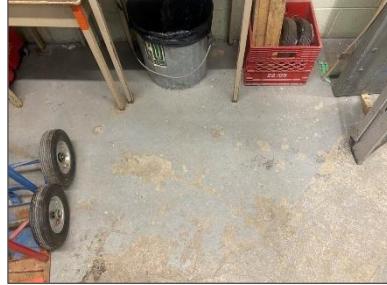
Sample Number	Colour, Substrate Description	Sample Location	Lead (%)	Photo
L0001	Grey on concrete floor	Mechanical Room (Location 120)	0.40

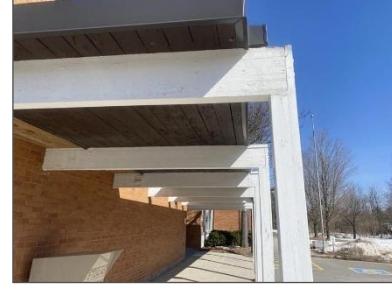
L0011	White on wood canopy beam	Exterior (Location 151)	0.97

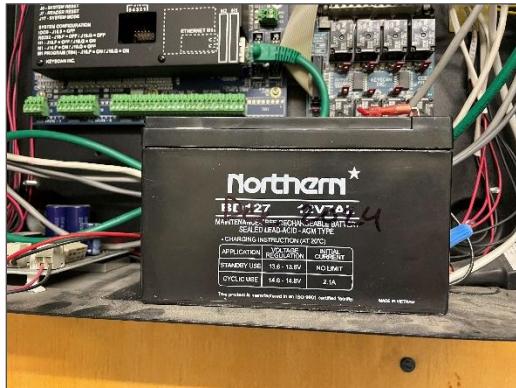
Photo 1

Lead-containing batteries are present in emergency lighting and fire control panels (photo 1).

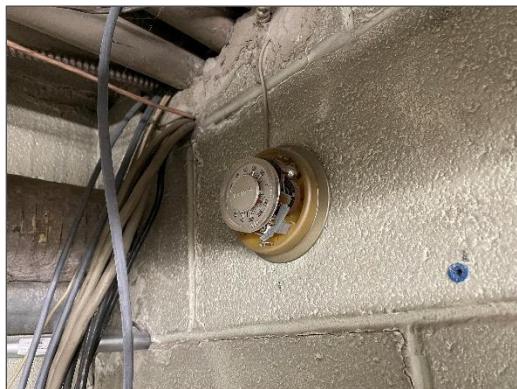
Photo 1

Liquid mercury is present in thermostats (photo 1) and is assumed present in laboratory drainpipes in Classroom 105 (photo 1).

All light fixtures were observed to be LED and will not contain mercury vapor in the tubes. Recycle mercury thermostats if removed from service.

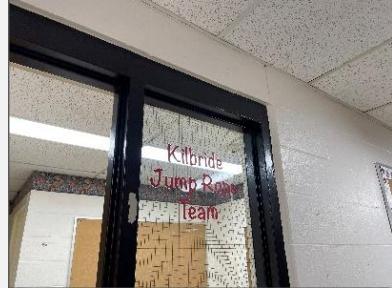
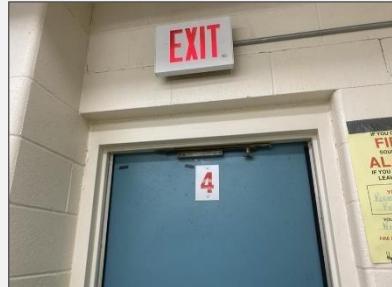
Material, Colour, Application	Sample Location (Location #)	Sample Number	PCB (mg/kg)	Photo
Caulking, composite, interior door frames	1967 Era of construction	P0001	157

Caulking highlighted in the table above is considered a PCB solid based on the threshold (50 mg/kg).

Remove PCB caulking if affected by the renovation work. PCB caulking is a hazardous waste, package, and ship for destruction at a federally permitted facility.
