RFT 26-047 - Window Replacement at Bruce T . Lindley Public School

Hazardous Building Materials Assessment (Pre-construction)

Window Replacement Project
Bruce T. Lindley Public School
2510 Cavendish Drive,
Burlington, Ontario

Pinchin File: 368273.002

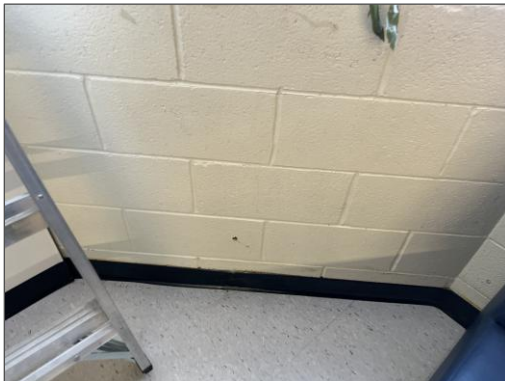
Photo 1

Destructive testing was conducted of a representative selection of masonry block walls, including creating penetrations at various locations (photos 1 and 2). The locations of destructive testing have been indicated on the drawings in Appendix I.

Loose fill vermiculite was not observed within the cavities.

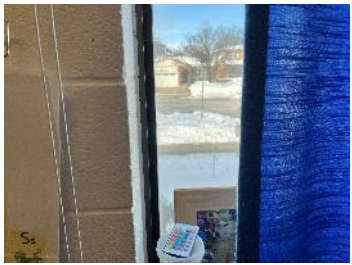
Material, Description and Application	Sample Location (Location #)	Sample Number	Asbestos	Photo
Caulking, grey around the interior window frames	Windows (Location 1)	S0002A-C	No

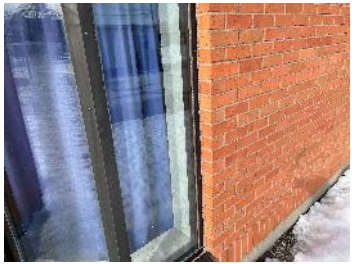
Caulking, brown around the exterior window frames	Windows (Location 1)	S0004A-C	No

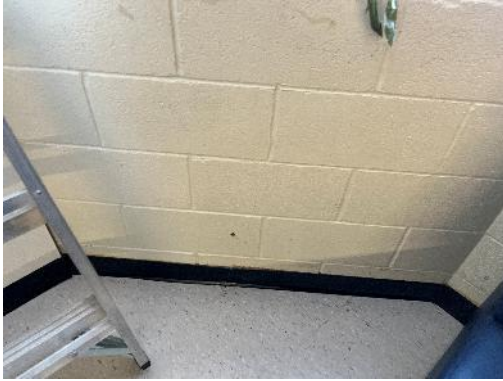
Photo 1

White paint present on concrete block in the assessed area does not contain asbestos (samples S0001A-G, photo 1).

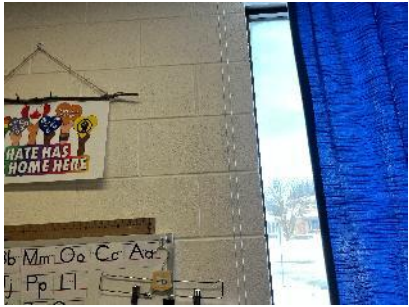
Sample Number	Colour, Substrate Description	Sample Location	Lead (%)	Photo
L0001	White on concrete wall	Windows (Location 1)	0.00041

Paints containing lead equal to or less than 0.009% (90 mg/kg) are assumed to be insignificant relating to potential exposure from construction disturbance in accordance with the EACC guideline.

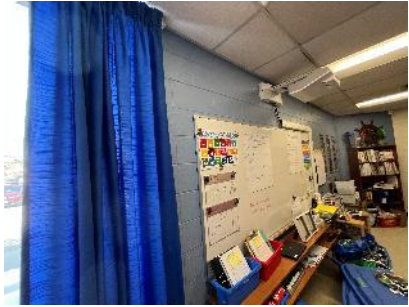
L0002	Blue on concrete wall	Windows (Location 1)	0.00096

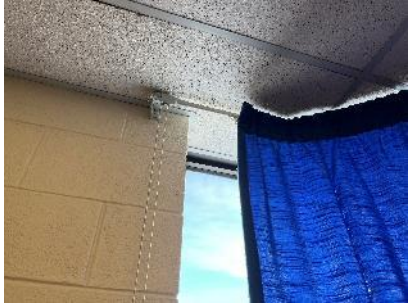
L0003	Yellow on concrete wall	Windows (Location 1)	<0.00067

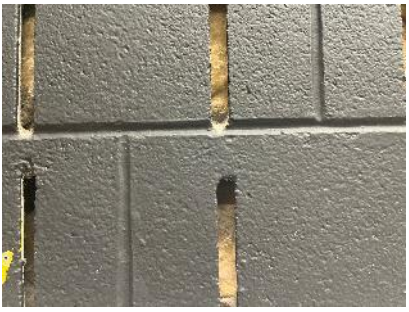
Sample Number	Colour, Substrate Description	Sample Location	Lead (%)	Photo
L0004	Black on concrete wall	Windows (Location 1)	0.00034

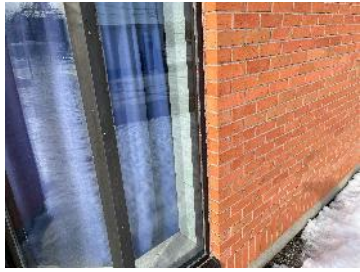
Material, Colour, Application	Sample Location (Location #)	Sample Number	PCB (mg/kg)	Photo
Caulking, brown on exterior window frames	Windows (Location 1)	P0001	<0.2

Results less than 50 mg/kg is considered a non-PCB-containing solid.

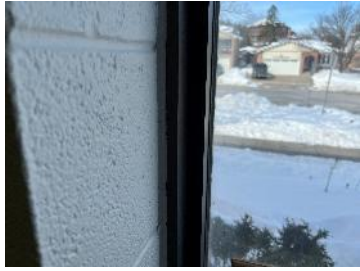
Caulking, grey on interior window frames	Windows (Location 1)	P0002	<0.2
