RFT 26-065 Lighting Renewal Project - Lakeshore Public School

Hazardous Building Materials Assessment (Pre-construction)

Lighting Retrofit Project
Lakeshore Public School
2243 Lakeshore Road,
Burlington, Ontario

Halton District School Board (Client) retained Pinchin Ltd. (Pinchin) to conduct a hazardous building materials assessment at Lakeshore Public School located at 2243 Lakeshore Road, Burlington, Ontario. Pinchin performed the assessment on April 9, 2026.

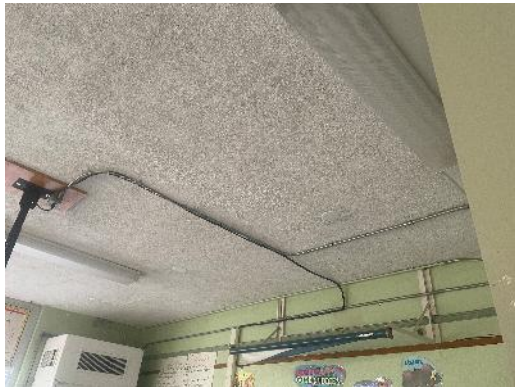
Photo 1

Texture coat, containing asbestos, is present on ceilings in the 1951 era of the building (samples S0034, photo 1). The substrate is presumed to contain asbestos. Overspray from the asbestos-containing texture coat is present above the ceiling at light fixture openings, on the deck, ducts and within junction boxes.

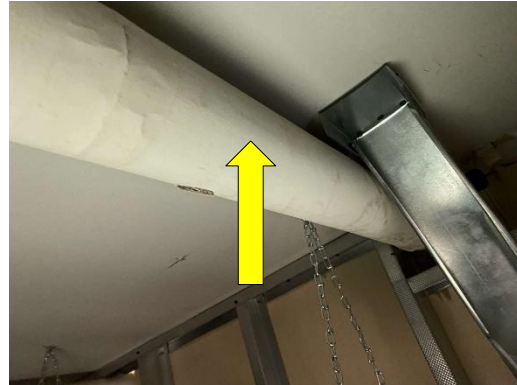
Photo 2

A white corrugated paper insulation (trade name Aircell), containing asbestos, is present on straight sections of hot water heating system pipes (samples S0037 and S0046, photo 2).

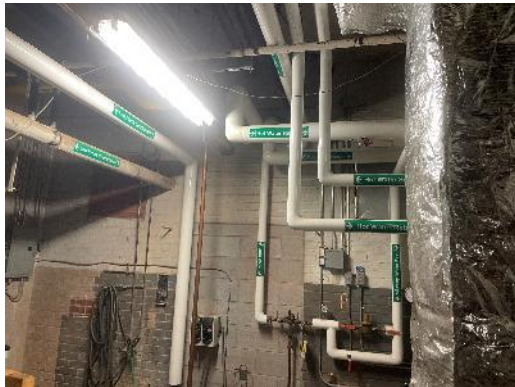
Photo 3

Remaining pipes are either insulated with fibreglass, or other non-asbestos insulation such as mineral fibre or elastomeric foam insulation (photo 3).

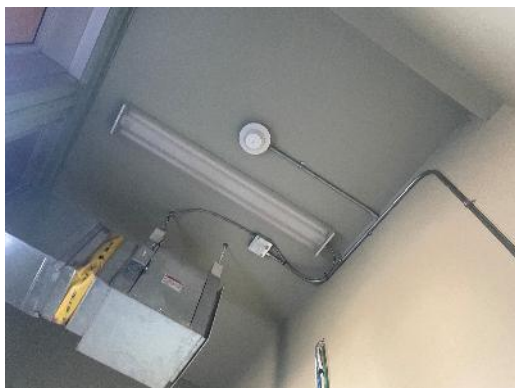
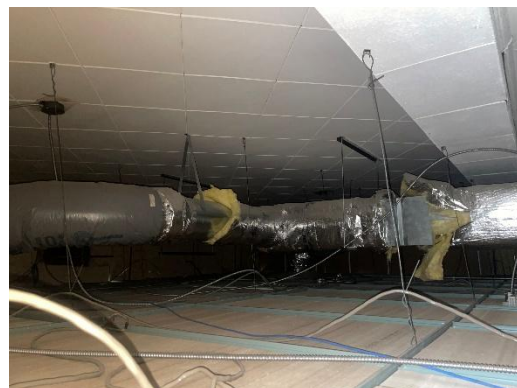
Ducts are either uninsulated or insulated with non-asbestos fibreglass (foil-faced or canvas, photos 1 and 2).

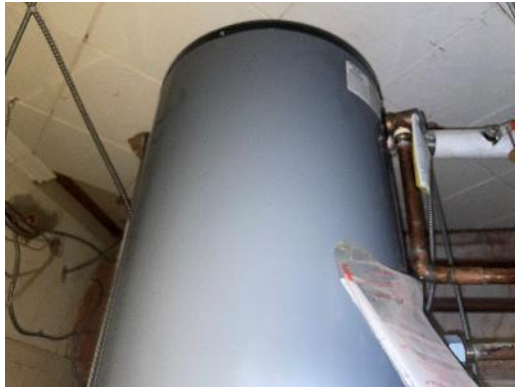
Photo 1

Mechanical equipment (e.g. furnace, hot water tanks, boilers) is either uninsulated or insulated with non-asbestos fibreglass (photo 1).

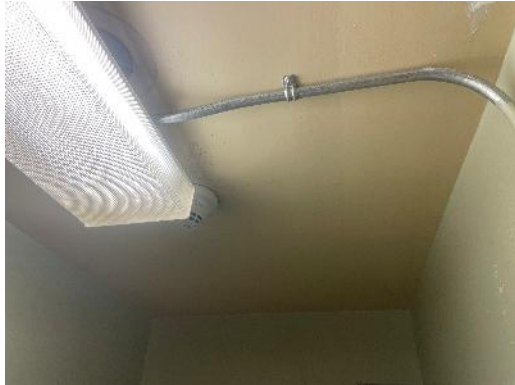
Photo 1

Plaster present on walls and ceilings in the assessed area does not contain asbestos (samples S0019, S0020, S0021, S0022, S0023 and S0024, photo 1).

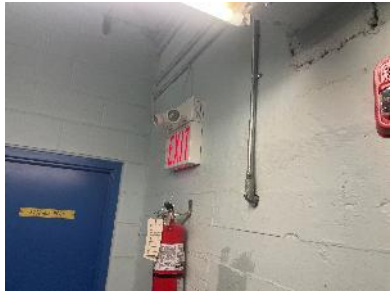
L0015	Grey paint on poured concrete wall	Classroom, (Location 2)	0.39

Results above 0.1% (1,000 mg/kg) are considered lead-containing, and over 0.5% (5,000 mg/kg) are considered lead-based in accordance with the EACC guideline.

Items painted with paints containing elevated levels of lead may be a hazardous waste. Test lead-painted materials for leachable lead and other metals prior to disposal. Metallic components coated with lead

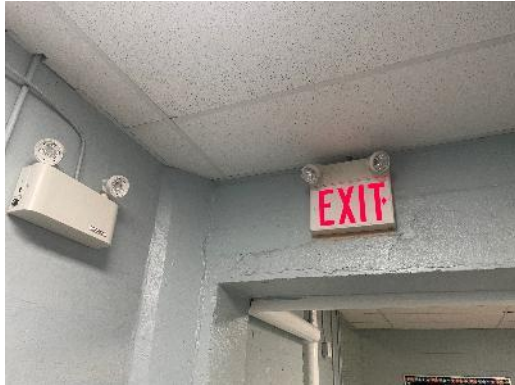
Photo 1

Lead-containing batteries are present in emergency lighting (photo 1).

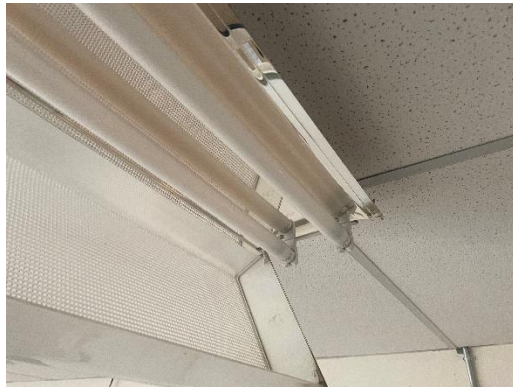
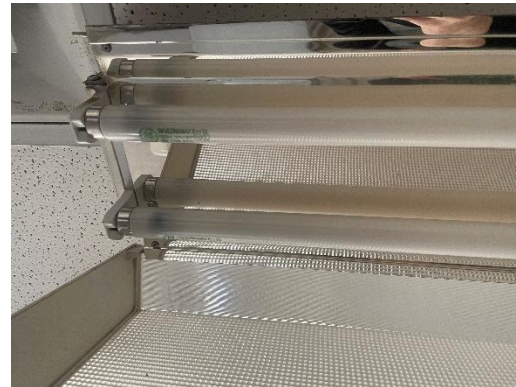
Mercury vapour is present in fluorescent lamp tubes and other lighting that is known to contain mercury such as mercury vapour lamps (photos 1 and 2).

Do not break lamps or separate liquid mercury from components. Recycle and reclaim mercury from fluorescent lamps when taken out of service. Mercury is classified as a hazardous waste and must be disposed of in accordance with applicable regulations.
