Asbestos Survey

for Victoria Park Community Homes
at Various Sites Throughout Hamilton, Waterdown, Burlington,
Milton, Brantford and Kitchener/Waterloo, Ontario

Prepared March 20, 2008

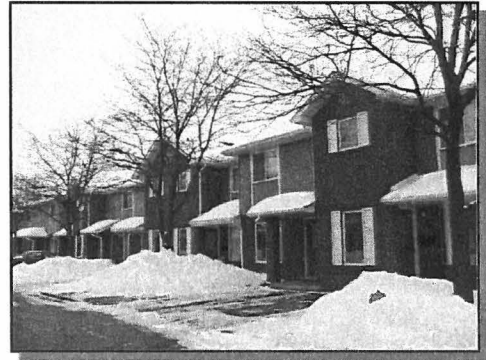
Photo 1: Exterior view of 588 Greenfield

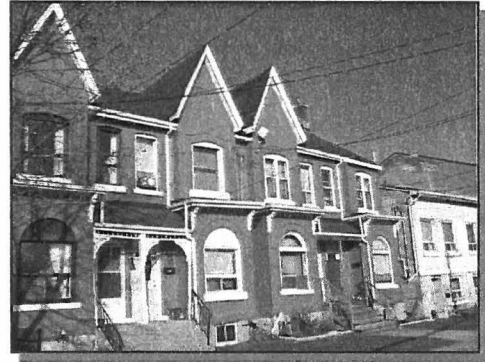
Photo 2: Exterior view of 349 - 353 MacNab

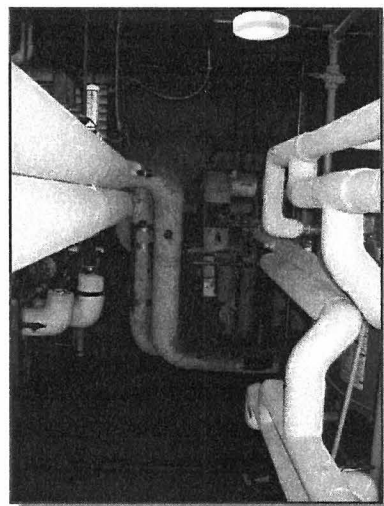
One out of the four (4) apartment buildings inspected contained pipe insulation where previous abatement had been conducted in the past. All boiler rooms inspected contained newer fiberglass pipe wrap and/or PVC coverings. Based on the conditions of present materials and equipment, ACM removals have been conducted in the past.

Photo 3: ACM pipe insulation present at PH Mechanical Room - 1 Hamilton Street South

- remove insulation on pipe lengths or fittings where they still exist and are in good condition;
- remove heat shields at furnace ductwork at single family houses/row houses;
