# Arborist Report and Tree Preservation Plan

Regarding:  
Glenview Public School  
143 Townsend Avenue

**GEOTECHNICAL INVESTIGATION  
GLENVIEW PUBLIC SCHOOL GYM REPLACEMENT  
143 TOWNSEND AVENUE EAST  
BURLINGTON, ONTARIO**

**Geotechnical Investigation**  
**Glenview Public School Gym Replacement**  
**143 Townsend Avenue East**  
**Burlington, Ontario**

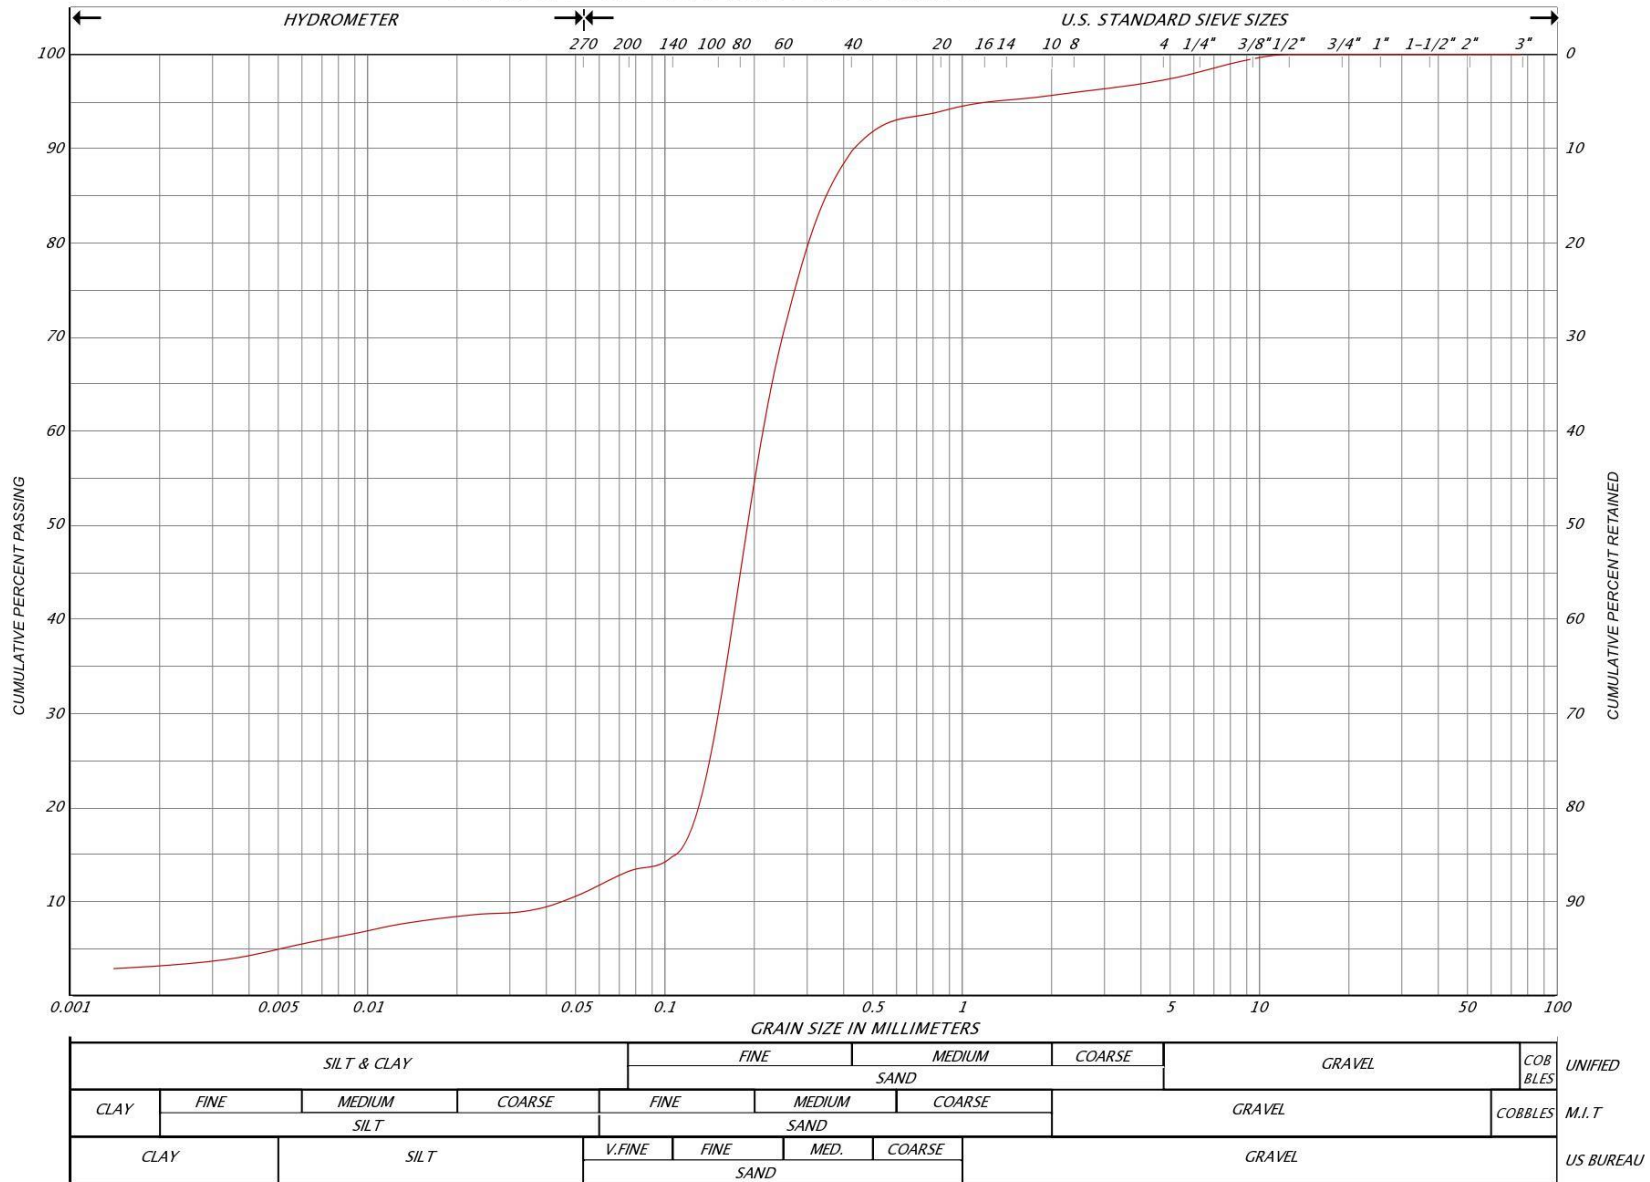
PROJECT NO.23HF019  
FIGURE NO. 1

PARTICLE SIZE DISTRIBUTION CHART

BH2 SS2 – 0.76 m to 1.4 m

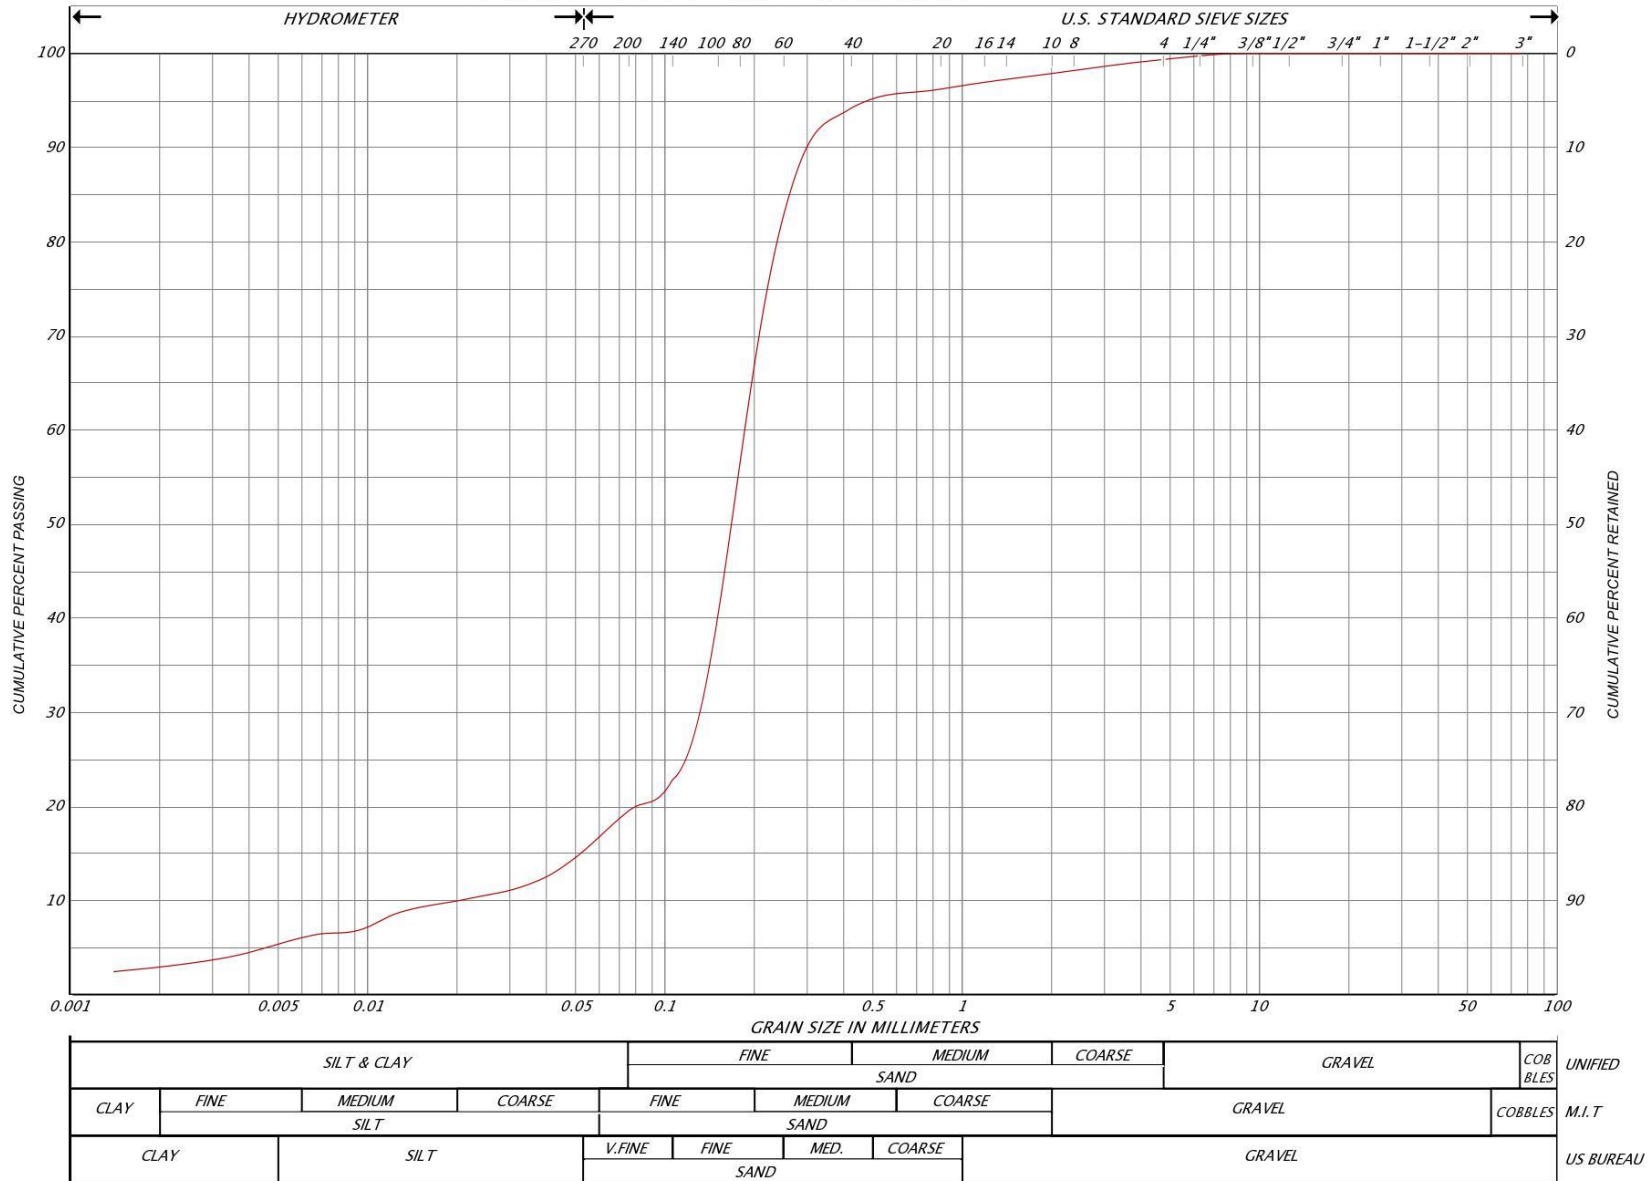
PROJECT NO.23HF019  
FIGURE NO. 2

PARTICLE SIZE DISTRIBUTION CHART

BH3 SS3 – 1.5 m to 2.1 m

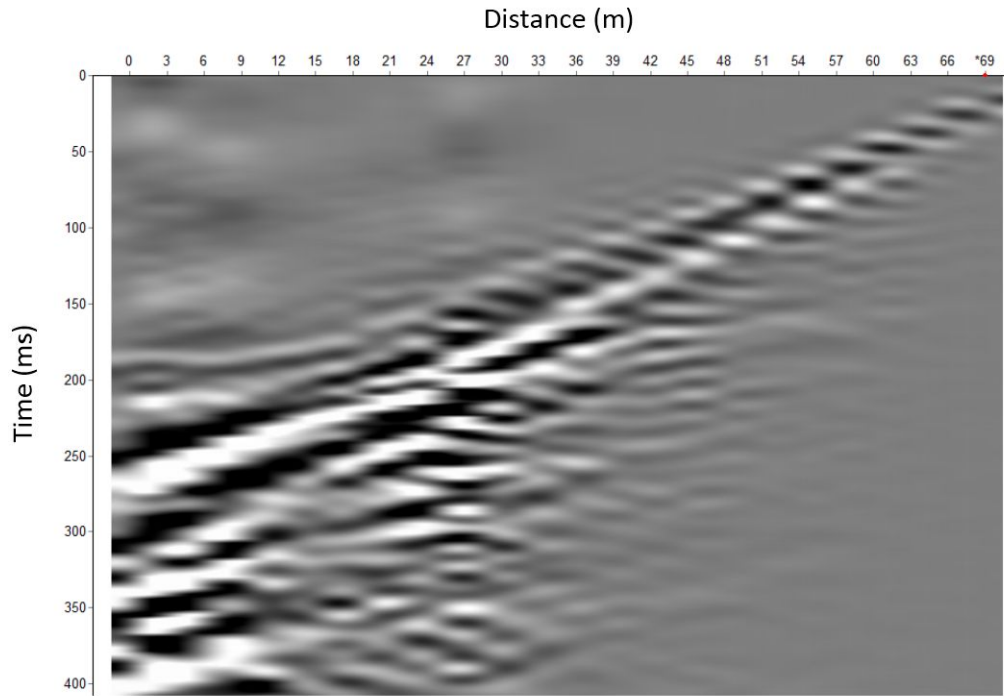
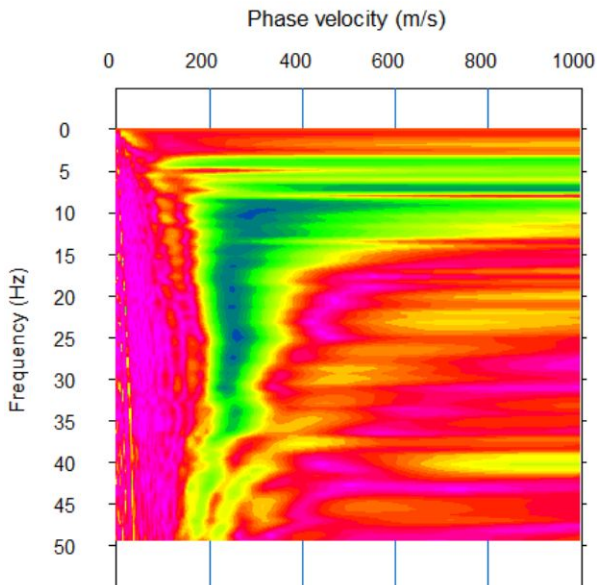
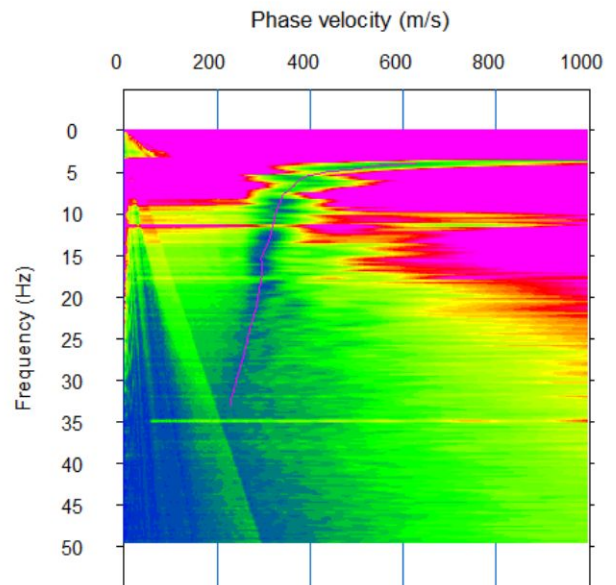
**Figure 4** Data examples displaying a stacked S-wave refraction shot record (top) and MASW dispersion images (bottom).

**Active acquisition (spread length 23 m)**

**Passive acquisition**

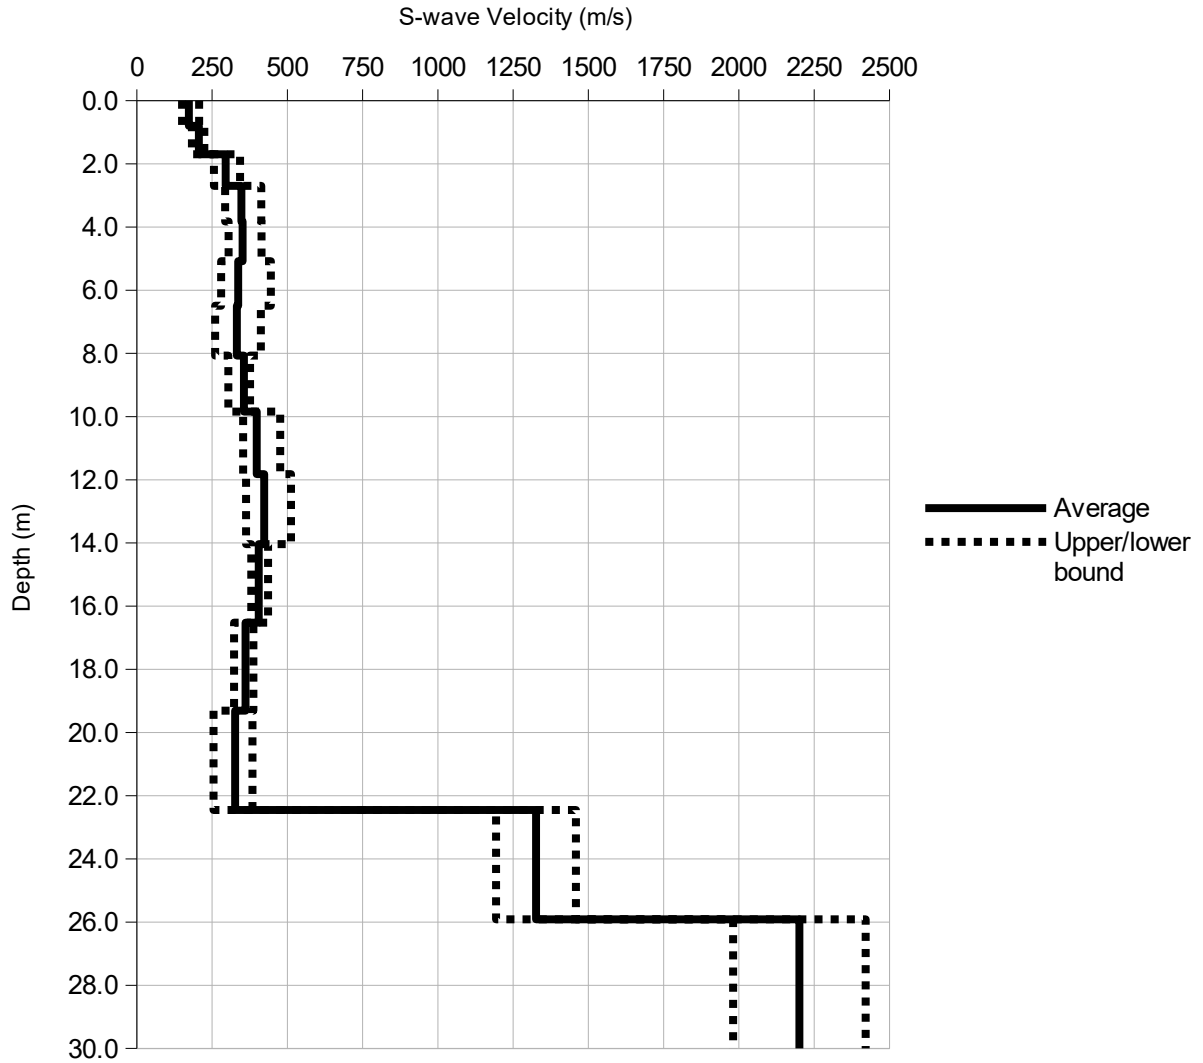
**Figure 5** Shear wave velocity profile from MASW sounding and S-wave refraction.

MASW Sounding & S-wave Refraction  
143 Townsend Ave, Burlington, ON

**Table 1** *Shear wave velocities from MASW sounding and S-wave refraction.*

Depth Interval (m)		S-wave Velocity (m/s)
From	To	
0.0	0.8	173
0.8	1.7	206
1.7	2.7	295
2.7	3.8	347
3.8	5.1	351
5.1	6.5	337
6.5	8.1	332
8.1	9.8	356
9.8	11.8	398
11.8	14.0	423
14.0	16.5	405
16.5	19.3	361
19.3	22.5	327
22.5	25.9	1326
25.9	30.0	2201
