END OF ADDENDUM NO. 2

NEW CULTURAL CLUB 'CROATIAN NATIONAL HOME'
 615 BARTON STREET, STONEY CREEK, ON.

SITE PLAN (DA-23-001)

**SCOPED ENVIRONMENTAL IMPACT STATEMENT
615 BARTON STREET - CITY OF HAMILTON**

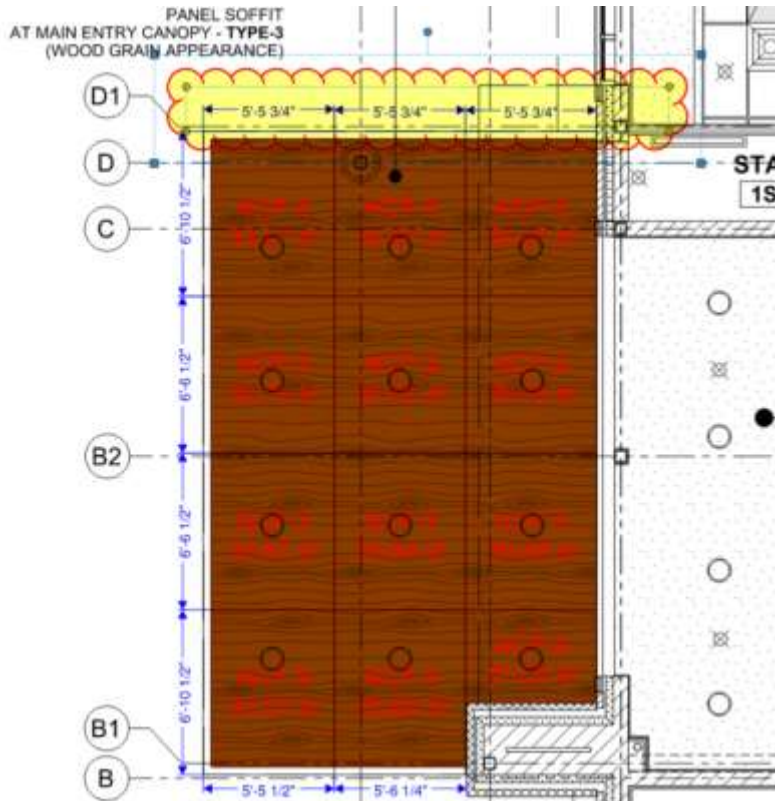
As you see from below snip (Extracted from dwg A2.40), the width of ACP at the Soffit exceeds 60". Please provide revised layout.

The ACP will not exceed the manufacturer standard lengths.

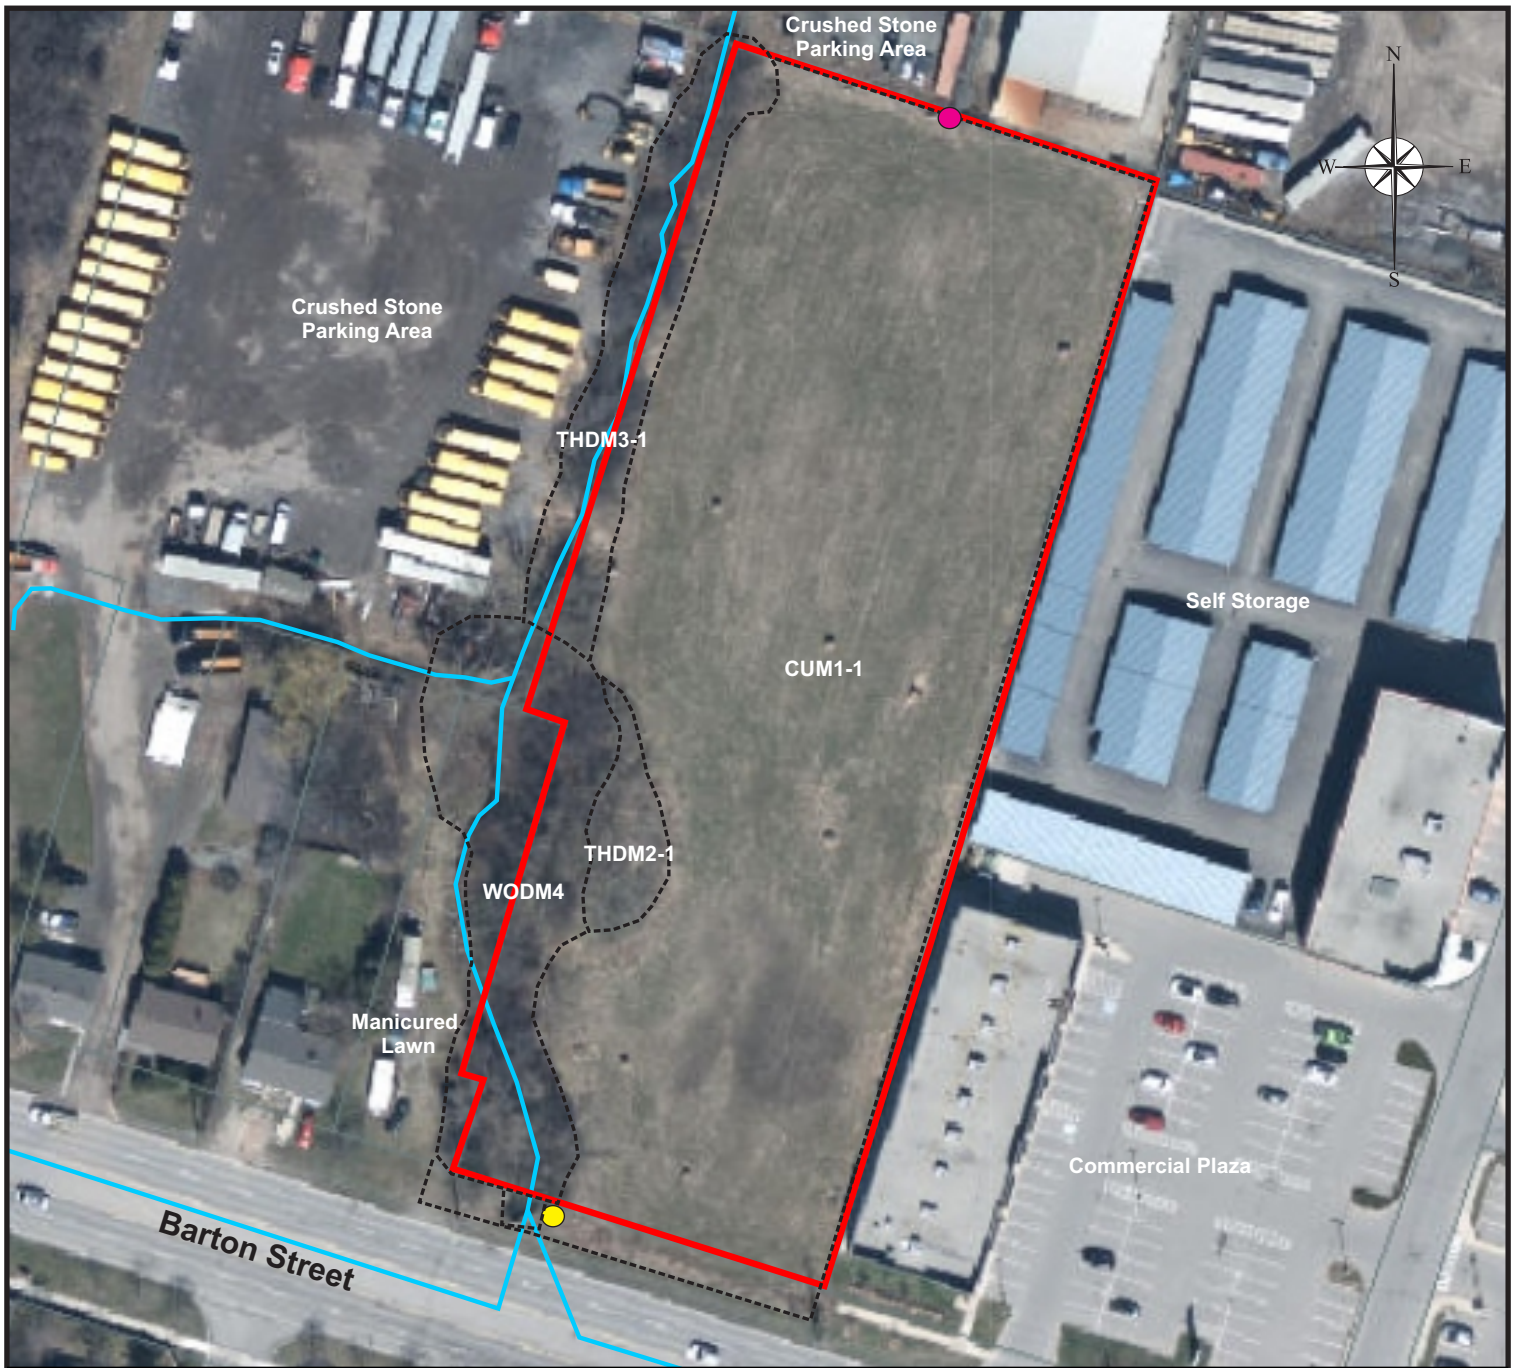
Figure 2
Extent of Vegetation Communities
on the Subject Property

A total of four vegetation communities were identified on and adjacent to the Subject Property. These vegetation communities were classified and mapped according to the Ecological Land Classification (ELC) System for Southern Ontario. Vegetation communities on the Subject Property consist primarily of an old field meadow, along with a deciduous woodland and Sumac and Buckthorn thickets associated with Stoney Creek Watercourse 4. These vegetation communities are mapped on Figure 2 and descriptions of each discussed below. Information on ELC communities where tree removal is proposed is provided in the tree inventory table in Appendix C.

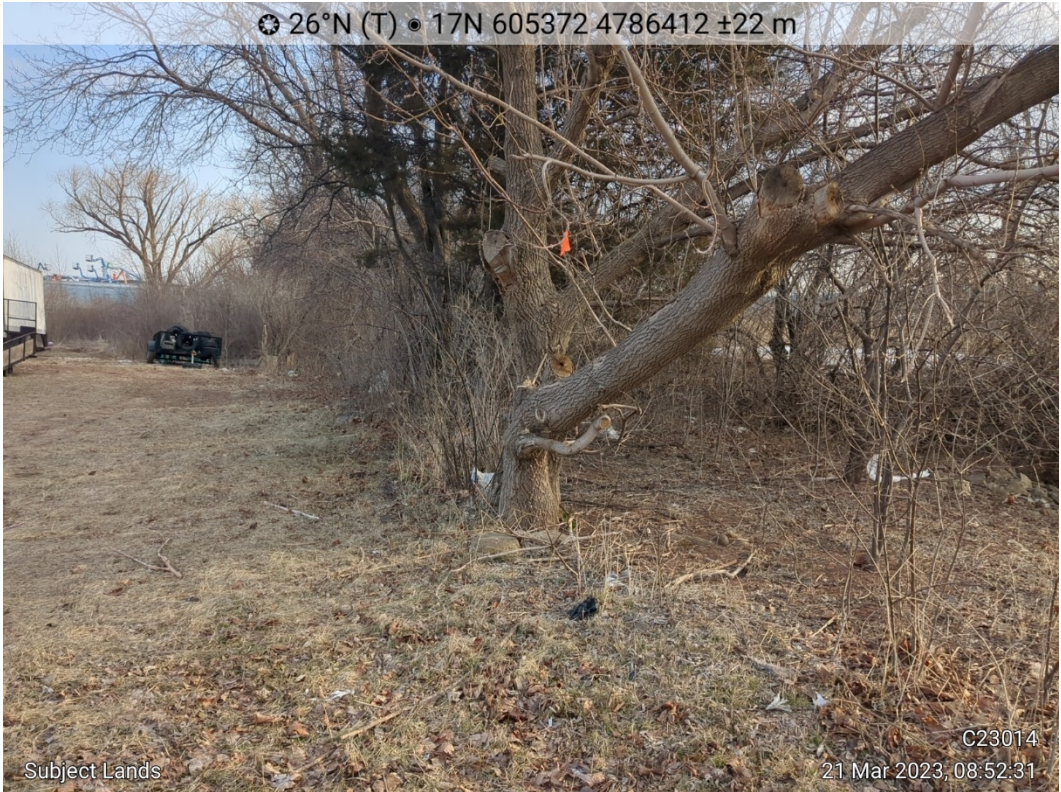
Photo 3: View of Tree 1269 along Barton Street.

One Tree was identified on Municipal property during the tree inventory. Tree #1269 is a Manitoba Maple on southwestern portion of the Subject Property along Barton Street. This tree was observed to have low branching and a sprawling growth form typical of Manitoba Maples that extends into the proposed sidewalk location. This tree is recommended to be removed due to impacts associated with the proposed sidewalk construction along the north side of Barton Street. City of Hamilton Forestry staff have issued a public tree permit for the removal of this tree (See Appendix E)

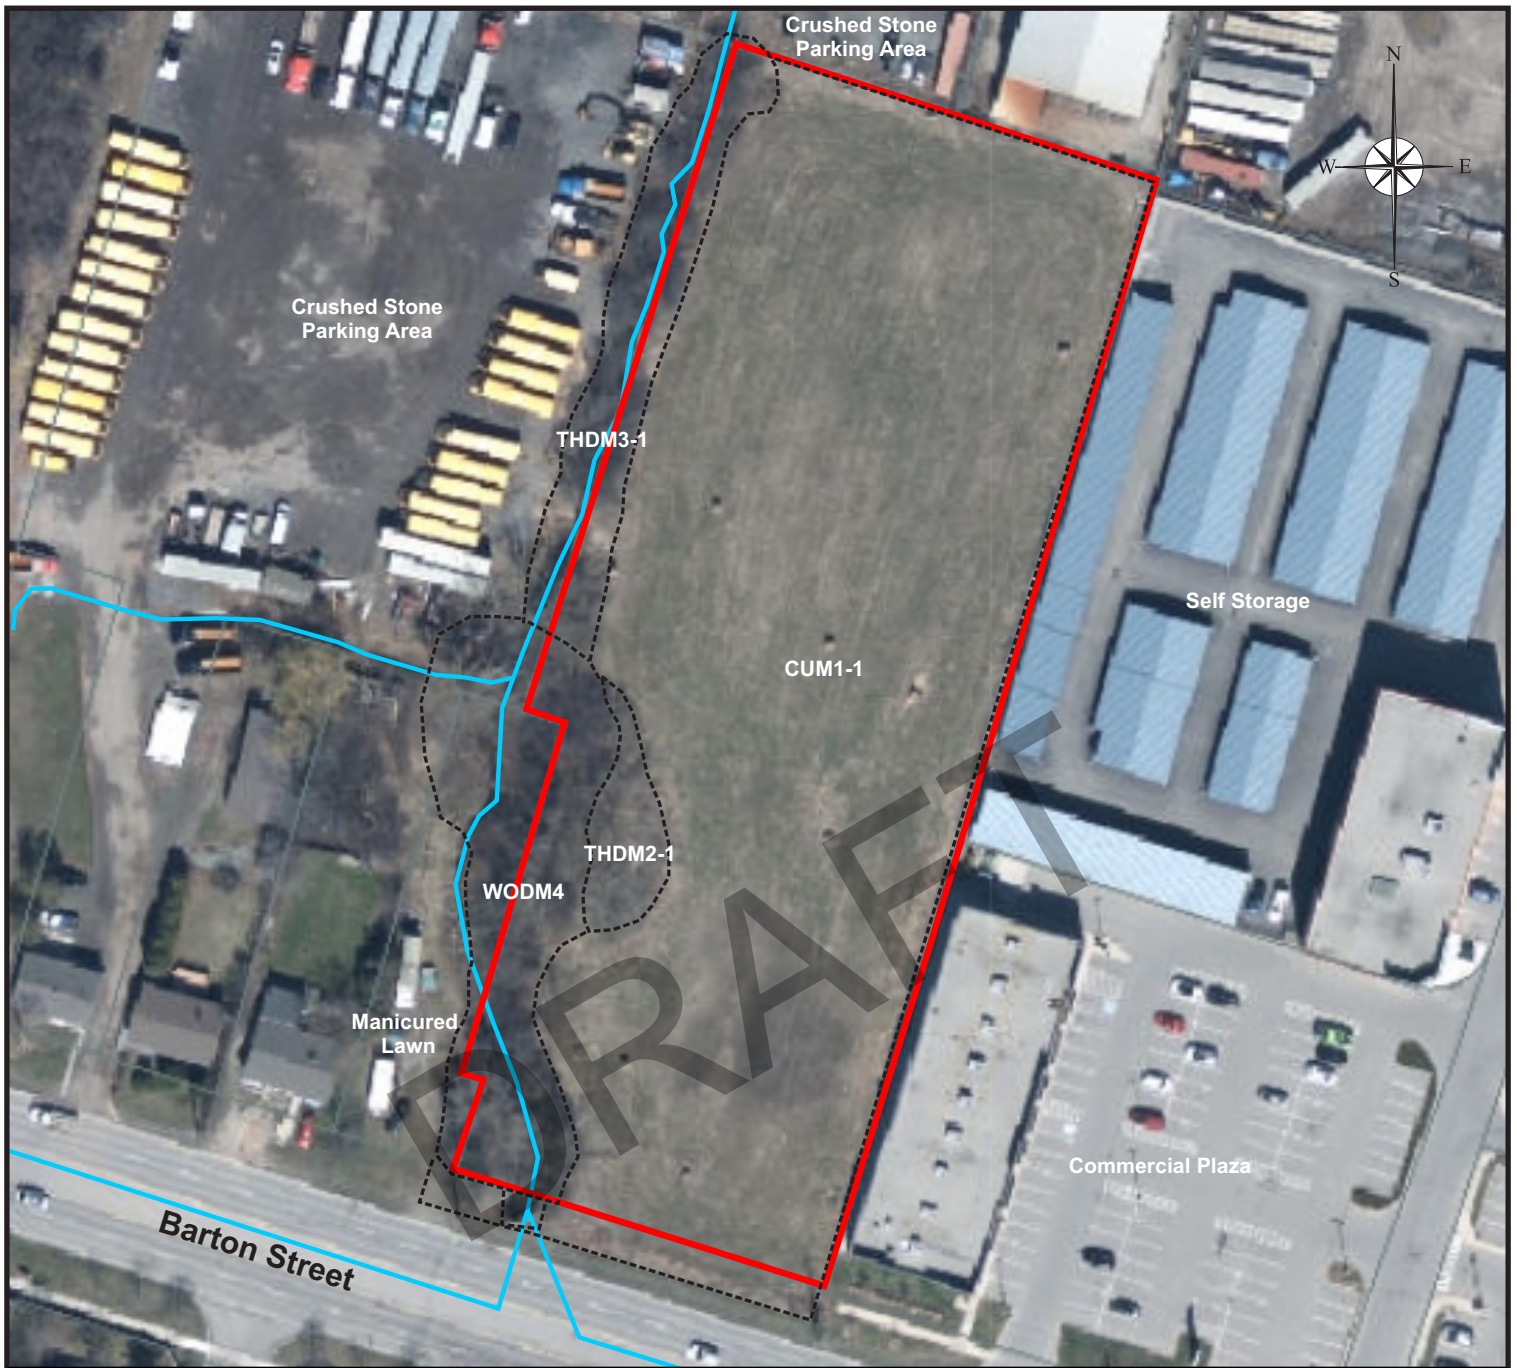
Figure 2
Extent of Vegetation Communities
on the Subject Property

A total of four vegetation communities were identified on and adjacent to the Subject Property. These vegetation communities were classified and mapped according to the Ecological Land Classification (ELC) System for Southern Ontario. Vegetation communities on the Subject Property consist primarily of an old field meadow, along with a deciduous woodland and Sumac and Buckthorn thickets associated with Stoney Creek Watercourse 4. Site Photos of these vegetation communities are shown in Appendix B. These vegetation communities are mapped on Figure 2 and descriptions of each discussed below.

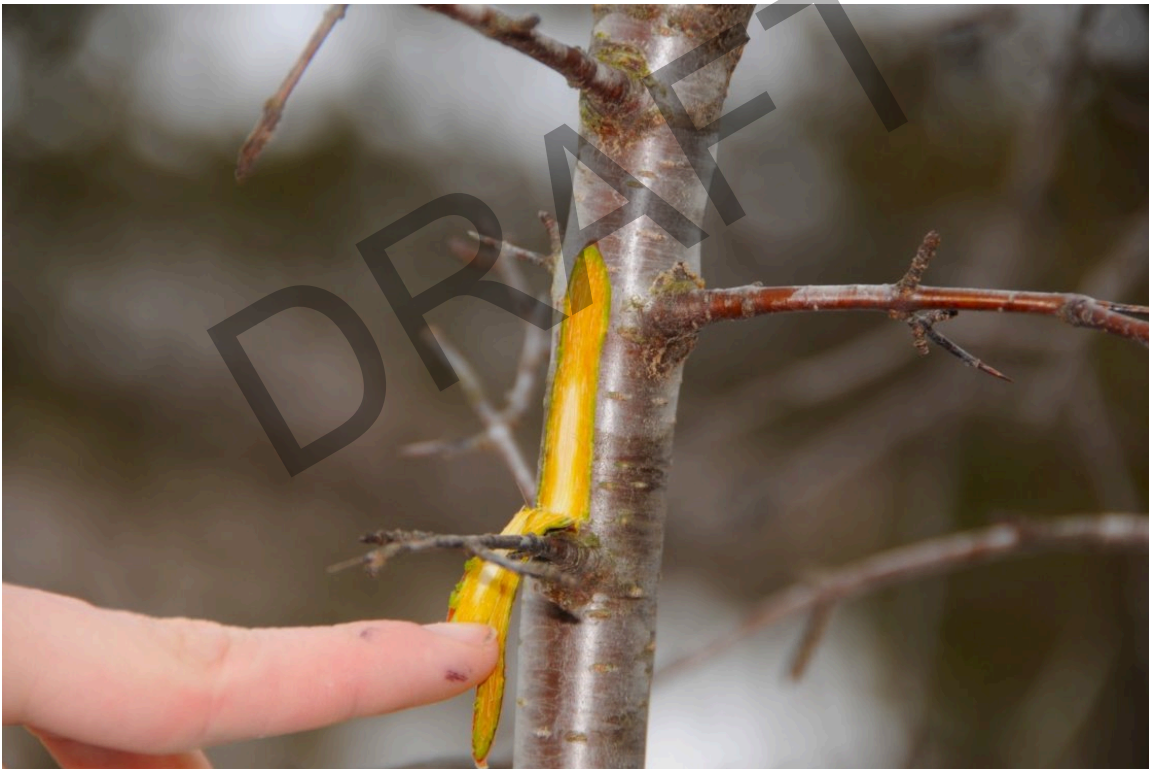
Buckthorn bark is greyish brown, with a yellow-green underlayer & orange heartwood. Photo Credit: Invasive Species Centre

Common Buckthorn grows in the form of a shrub or small to medium sized tree. It has smooth dark green leaves that are finely toothed. Leaves have three to five strongly curvy veins per side on the underside, arching towards the top of the leaf. Buckthorn leaves are opposite to sub-opposite along the stem of the plant, with older branches ending in a short, sharp thorn. Flowers have two to six small yellowish green petals. Buckthorn typically is one of the first shrub to leaf out in the spring, and one of the last to drop its leaves in the fall. The fruiting component of Common Buckthorn consists of multiple clusters of small berry-like fruit that come out in late summer/early fall. The fruit is black when mature and green when immature. Buckthorn buds are scaly and lie close to the twig. The bark of Buckthorn is greyish brown with prominent small lenticels. The bark begins smooth and shiny when young and becomes rough and textured as it reaches maturity.

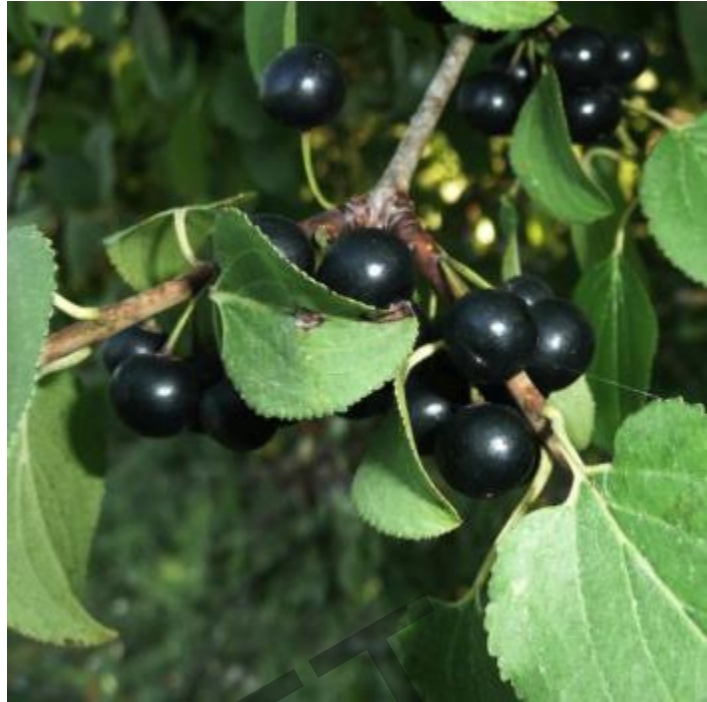
The fruiting body of Common Buckthorn is a black when mature, green when immature, and comes in dense clusters as pictured. Photo Credit: Invasive Species Centre

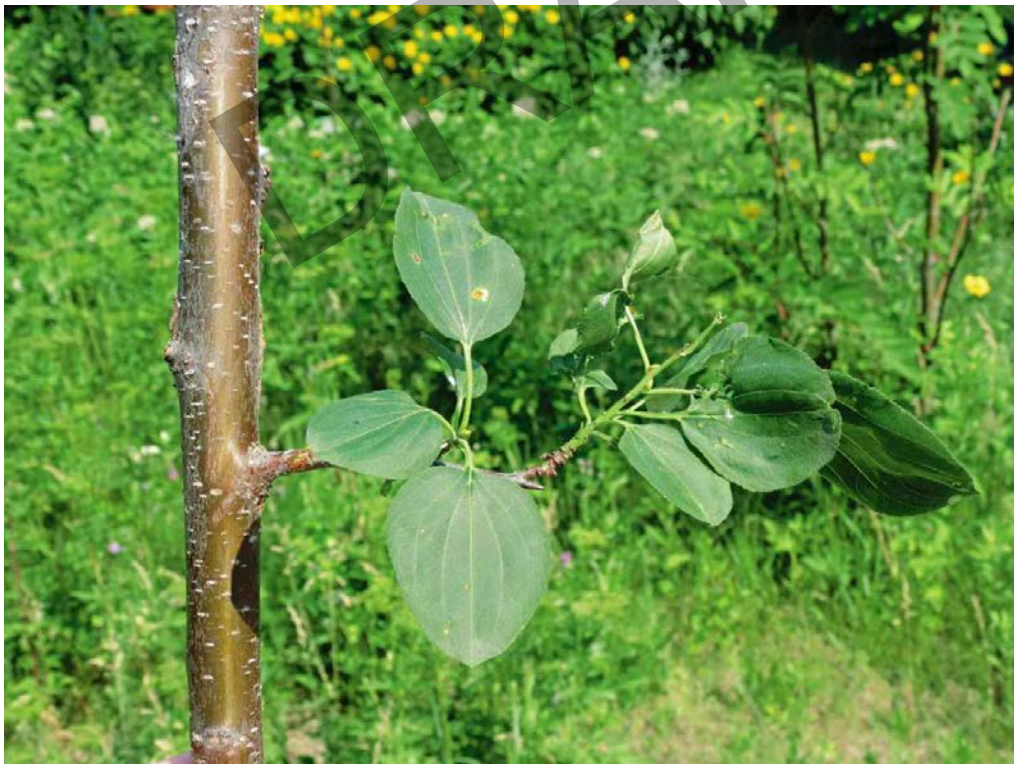
Common Buckthorn leaves are sharp, pointed but curved, and have rounded serrated teeth. Photo Credit: Invasive Species Centre

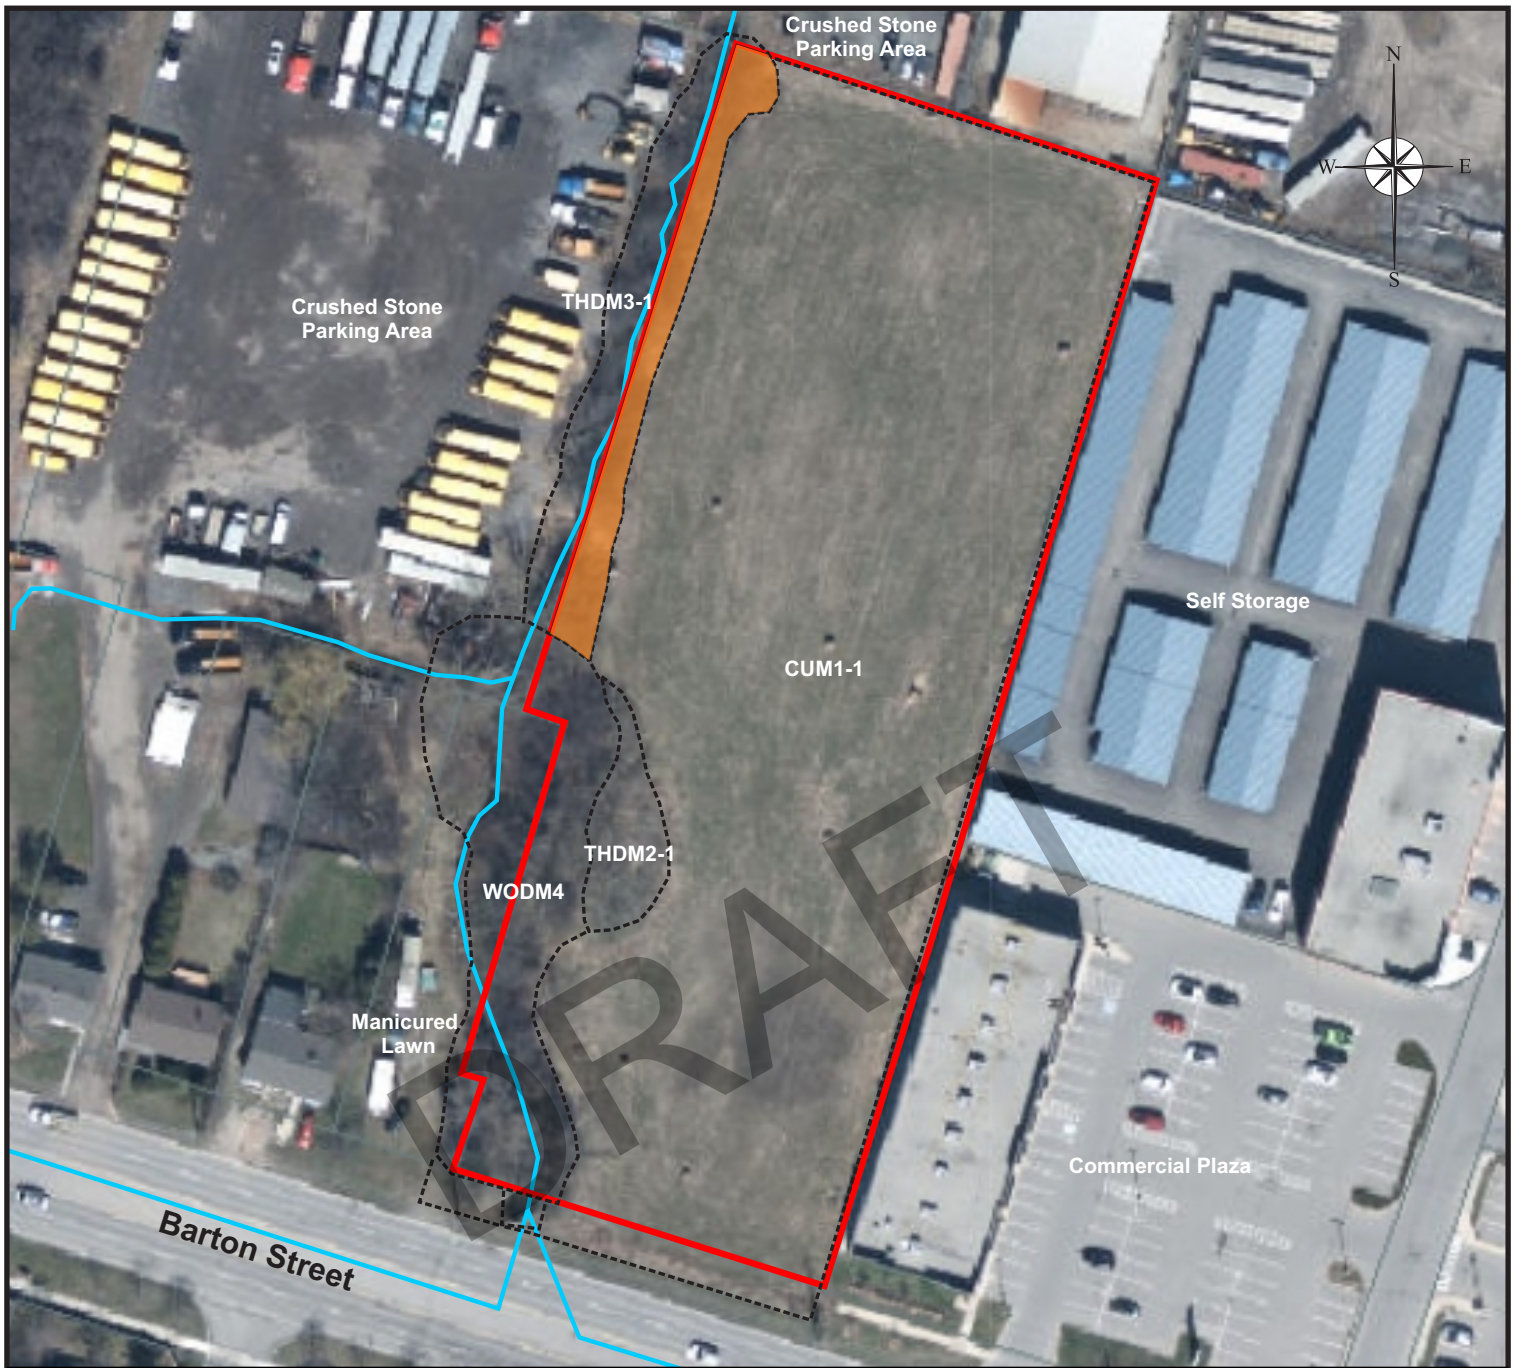
It is important to note that there is a dense population of Buckthorn currently off property, directly adjacent to the intended removal area. Early in the creation of this report, it was recommended that the adjacent landowner be contacted to see if they would be interested in Buckthorn removal on their property as well. This would help limit the potential of Buckthorn re-establishment on the Subject Property. Unfortunately, it is our understanding that the adjacent landowner has stated that they do not want to conduct any invasive species removal on their property. Furthermore, they have stated that they do not want anyone else going on their property to conduct Buckthorn removals and thus, the population of Common Buckthorn will remain indefinitely.

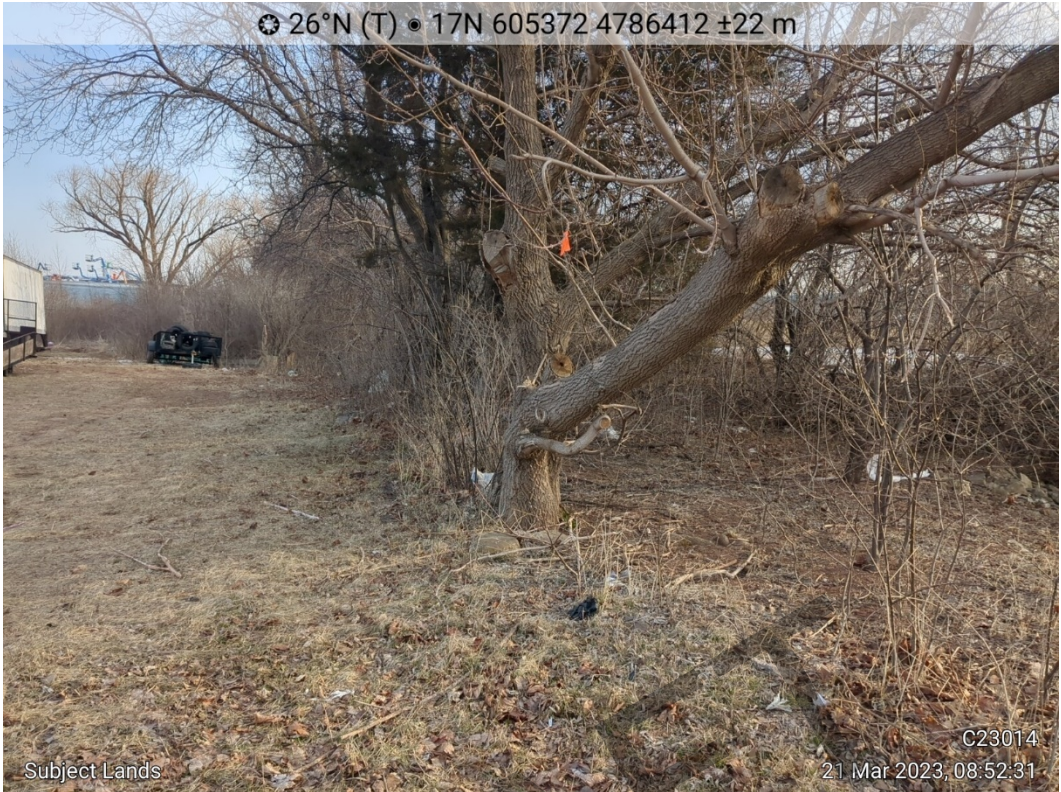
Photo 3: View of Tree 1269 along Barton Street.
