Hazardous Building Materials Assessment

Window and Door Replacement
Lake Avenue Elementary
School

157 Lake Avenue North,
Hamilton, Ontario

February 10, 2021

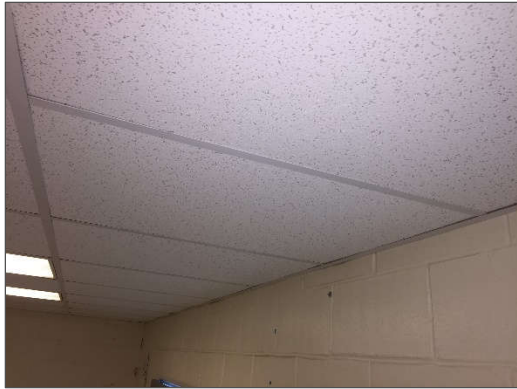
Size, Type, Pattern, Photo #	Locations (Location #)	Sample Number or Date Code	Asbestos Type
24" x 48", lay-in, pinhole and fleck, Photo 1	1971 (Location 1)	08/16/12	None

All ceiling tiles are presumed to be non-asbestos based on the date of manufacture determined from the date stamp applied to the top of the tiles. The tiles were manufactured after asbestos was stopped being used in acoustic ceiling tiles.

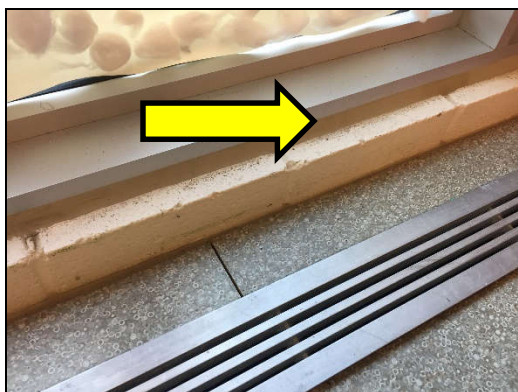
Photo 1

Material and Colour	Location (Location #)	Sample Number	Asbestos Type
Caulking, grey, photo 1	Around interior windows, 1971 (Location 1)	S0001A-C	None Detected
Caulking, grey, photo 2	Around exterior doors, 1971 (Location 1)	S0003A-C	None Detected
Caulking, white, photo 3	Around exterior doors, 2011 (Location 2)	S0005A-C	None Detected
Caulking, grey, photo 4	Around windows, 2011 (Location 2)	S0006A-C	None Detected
Caulking, grey, photo 5	Around exterior windows, 1951 (Location 3)	S0007A-C	None Detected
Butyl tape, black, photo 6	On doors, 1951 (Location 3)	S0008A-C	None Detected
Caulking, grey, photo 7	At exterior doors, 1951 (Location 3)	S0009A-C	Chrysotile
Butyl tape, grey, photo 8	At exterior windows 1951 (Location 3)	S0010A-C	Chrysotile
Butyl tape, black, photo 9	At exterior windows, 1951 (Location 3)	S0011A-C	Chrysotile
Caulking, brown, photo 10	Around exterior doors, 1974 (Location 4)	S0013A-C	None Detected

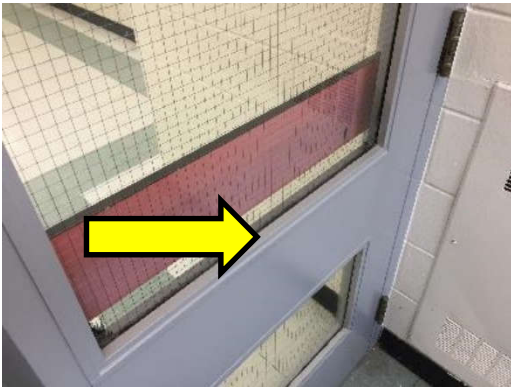
Photo 11

Butyl tape, black, photo 11	On exterior doors, 1974 (Location 4)	S0014A-C	None Detected

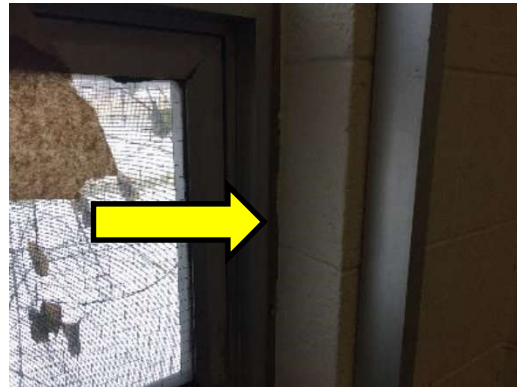
Photo 12

Material and Colour	Location (Location #)	Sample Number	Asbestos Type
Caulking, grey, photo 12	At exterior windows, 1974 (Location 4)	S0015A-C	Chrysotile
Butyl tape, grey, photo 13	At exterior doors, including second set of doors, 1974 (Location 4)	S0018A-C	Chrysotile
Butyl tape, grey, photo 14	On exterior windows, 1974 (Location 4)	S0019A-C	None Detected
Butyl tape, black, photo 15	On exterior windows, 1974 (Location 4)	S0020A-C	None Detected
Caulking, grey, photo 16	Around exterior doors, 1982 (Location 5)	S0022A-C	None Detected
Caulking, grey, photo 17	On exterior doors, 1982 (Location 5)	S0023A-C	None Detected
Caulking, grey, photo 18	On exterior windows, 1971 (Location 1)	S0025A-C	None Detected
Butyl tape, black, photo 19	On windows 1971 (Location 1)	S0026A-C	None Detected
Caulking, grey, photo 20	Around exterior windows, 1974 (Location 4)	S0027A-C	None Detected
Caulking, grey, photo 21	Around exterior doors, 1974 (Location 4)	S0028A-C	None Detected

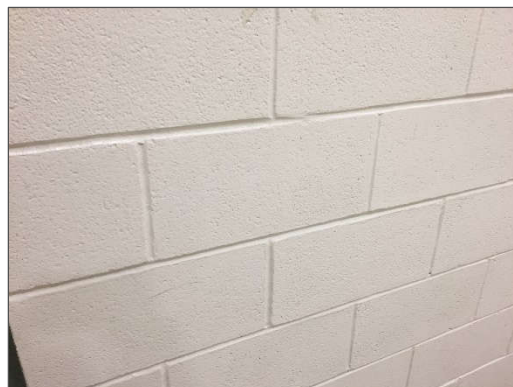
Photo 2

Mortar present in the concrete block masonry brick does not contain asbestos (samples S0032A-G, photo 2).

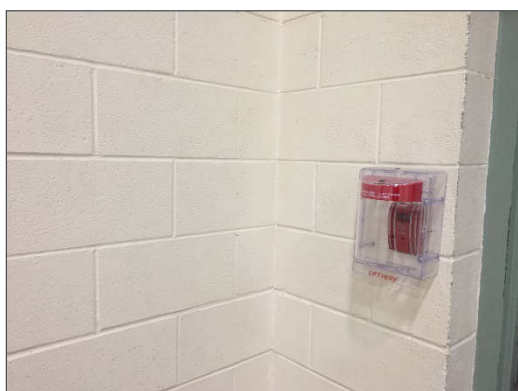
Photo 3

Cream paint present on the masonry block walls does not contain asbestos (Location 5, samples S0031A-C, photo 3).

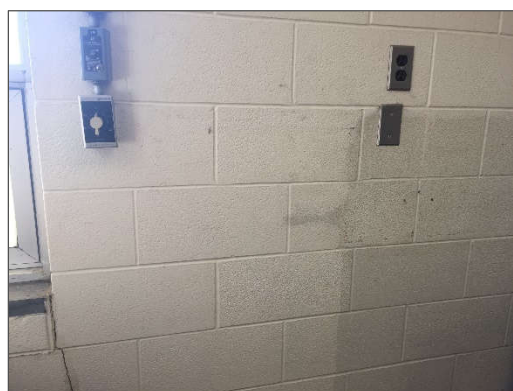
Photo 4

Cream paint present on the masonry block walls does not contain asbestos (Location 4, samples S0033A-C, photo 4).

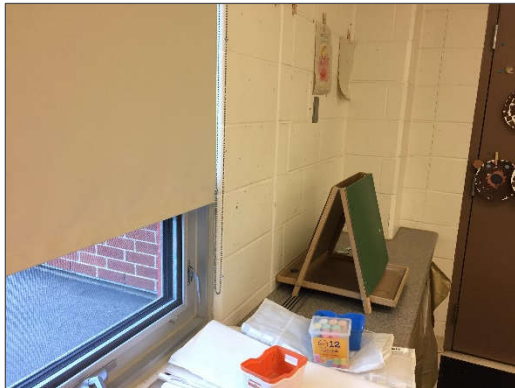
Photo 1

Sample Number and Photo #	Colour, Substrate Description	Location (Location #)	Lead (%)
L0001, photo 1	White on masonry walls	1971 (Location 1)	<0.0063
L0002, photo 2	White on masonry walls	2011 (Location 2)	<0.0070
L0003, photo 3	White on masonry walls	1951 (Location 3)	<0.0063
L0004, photo 4	Grey on plaster walls	1951 (Location 3)	0.17
L0005, photo 5	White on masonry walls	1974 (Location 4)	0.029
L0006, photo 6	White on masonry walls	1982 (Location 5)	0.0064
NA	All Paint not sampled	Throughout	Presumed >0.1

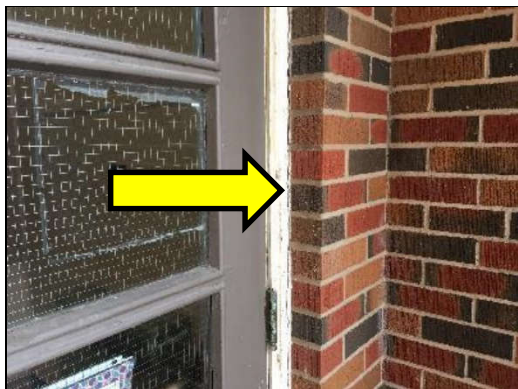
Photo 1

Material, Colour and Photo #	Location	Sample Number	PCB concentration (ppm)
Caulking, grey, photo 1	Around exterior doors (Location 3)	P001	<0.2
Caulking, grey, photo 2	Around exterior doors (Location 5)	P002	<0.2
Caulking, grey, photo 3	Around exterior windows (Location 1)	P003	<0.2
Caulking, grey, photo 4	Around exterior windows (Location 4)	P004	6
Caulking, grey, photo 5	Around exterior doors (Location 1)	P005	<0.2
Caulking, white, photo 6	Around exterior door	P006	<0.2
Caulking, white, photo 7	Around exterior windows	P007	<0.2
