RFT 25-055 - Washroom Renovation - Central Public School

Hazardous Building Materials Assessment (Pre-construction)

Washroom Renovation Project
Central Public School
638 Brant Street, Burlington,
Ontario

May 7, 2025

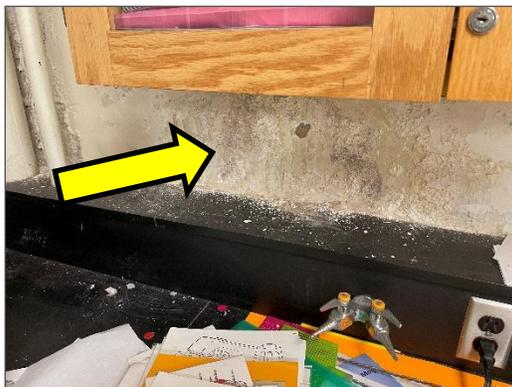
Photo 5

- On walls in Classroom 3 (Location 3, samples S0099, photo 2).
- On walls and ceilings in the Corridor (Location 20, samples S0114A-C, S0120A-C, S0121A-C, photos 3 and 4).
- On walls in Classrooms 3 and 4 (Locations 3 and 4, samples S0117A-C, photos 5 and 6).
- On walls and ceilings in the Boys Washroom (Location 12, samples S0118A-E, photo 7).
- On walls and ceilings in the Girls Washroom (Location 1, samples S0119A-D, photo 8).
- On ceilings in the Caretakers Storage (Location 8, samples S0053).
- On walls in the Storage / Crawlspace Entrance (Location 14, samples S0083).

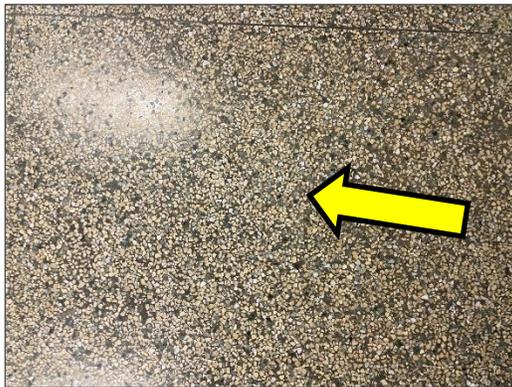
Photo 3

Terrazzo flooring in the Boys Washroom and Girls Washroom (Locations 12 and 1) does not contain asbestos (samples S0102A-C, photos 3 and 4)
