**GLENGROVE PUBLIC SCHOOL CHILDCARE RENOVATION  
1934 Glengrove Road, Pickering, Ontario**

**Tender No. T20-62  
Durham District School Board**

# LIMITED DESIGNATED SUBSTANCE SURVEY REPORT (RENOVATION AREAS)

## **Glengrove Public School 1934 Glengrove Road Pickering, Ontario**

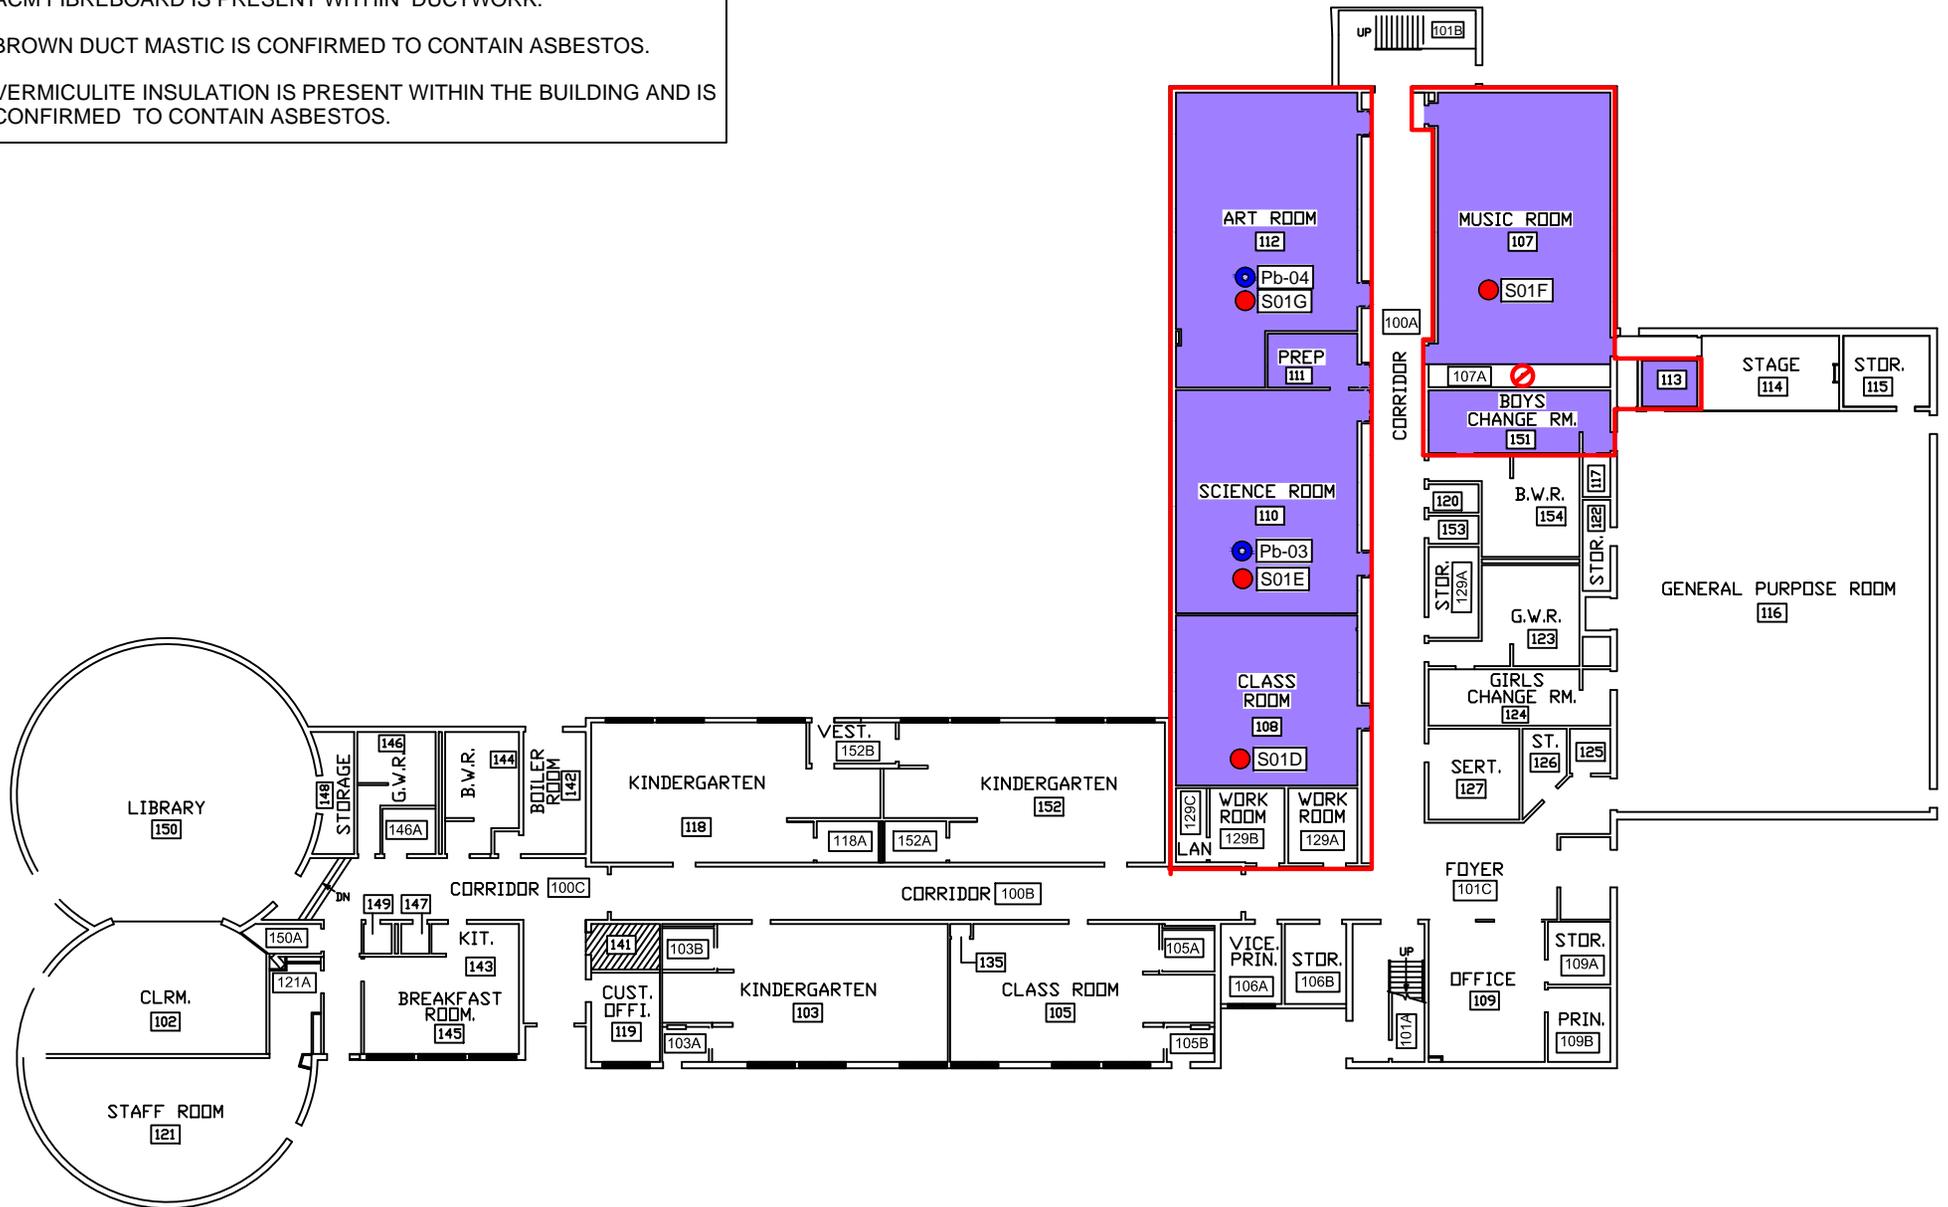
BROWN DUCT MASTIC IS CONFIRMED TO CONTAIN ASBESTOS.

VERMICULITE INSULATION IS PRESENT WITHIN THE BUILDING AND IS CONFIRMED TO CONTAIN ASBESTOS.

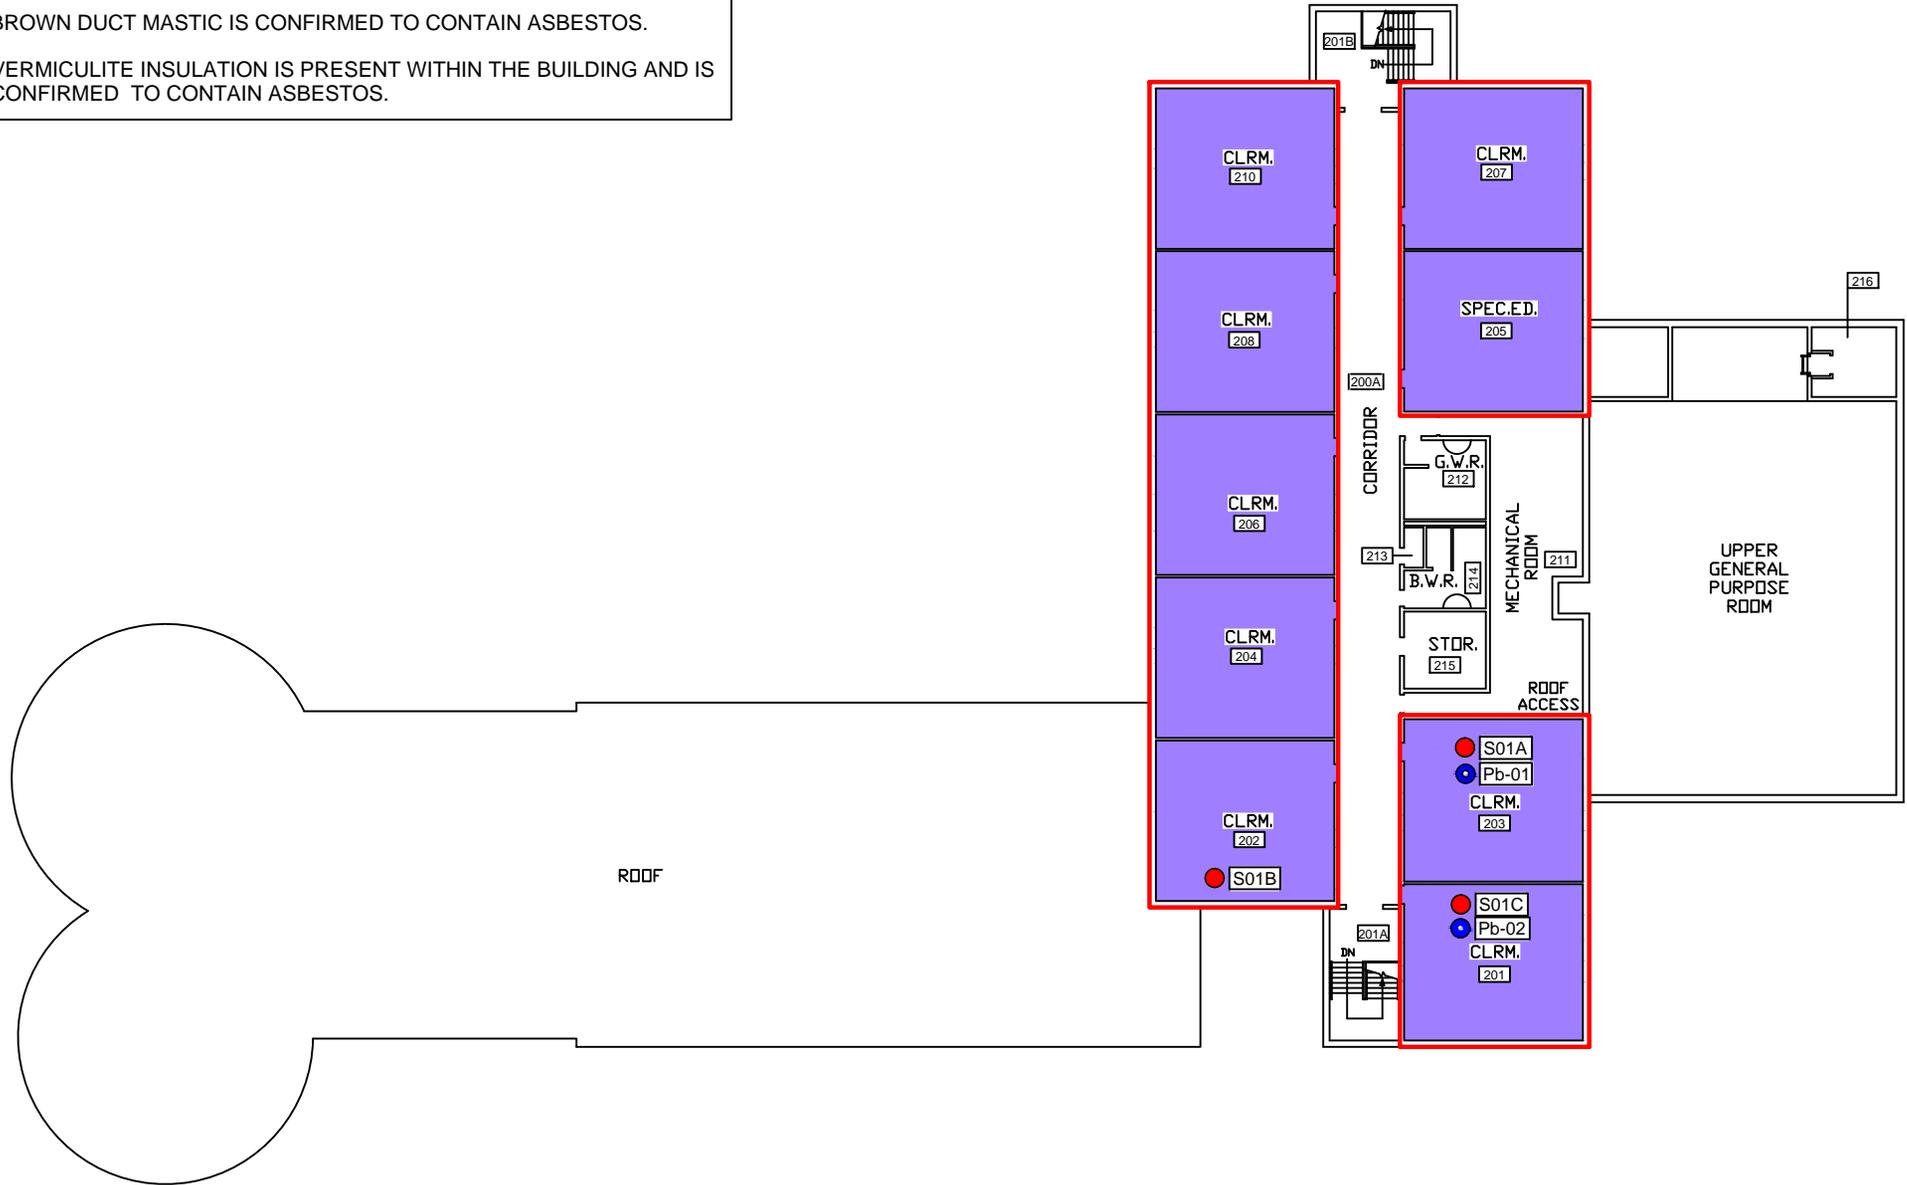
BROWN DUCT MASTIC IS CONFIRMED TO CONTAIN ASBESTOS.

VERMICULITE INSULATION IS PRESENT WITHIN THE BUILDING AND IS CONFIRMED TO CONTAIN ASBESTOS.
