Addendum No. 1

RFT 21-116 School Renovations – John T. Tuck Public School

PRE-RENOVATION DESIGNATED SUBSTANCES AND HAZARDOUS MATERIALS SURVEY

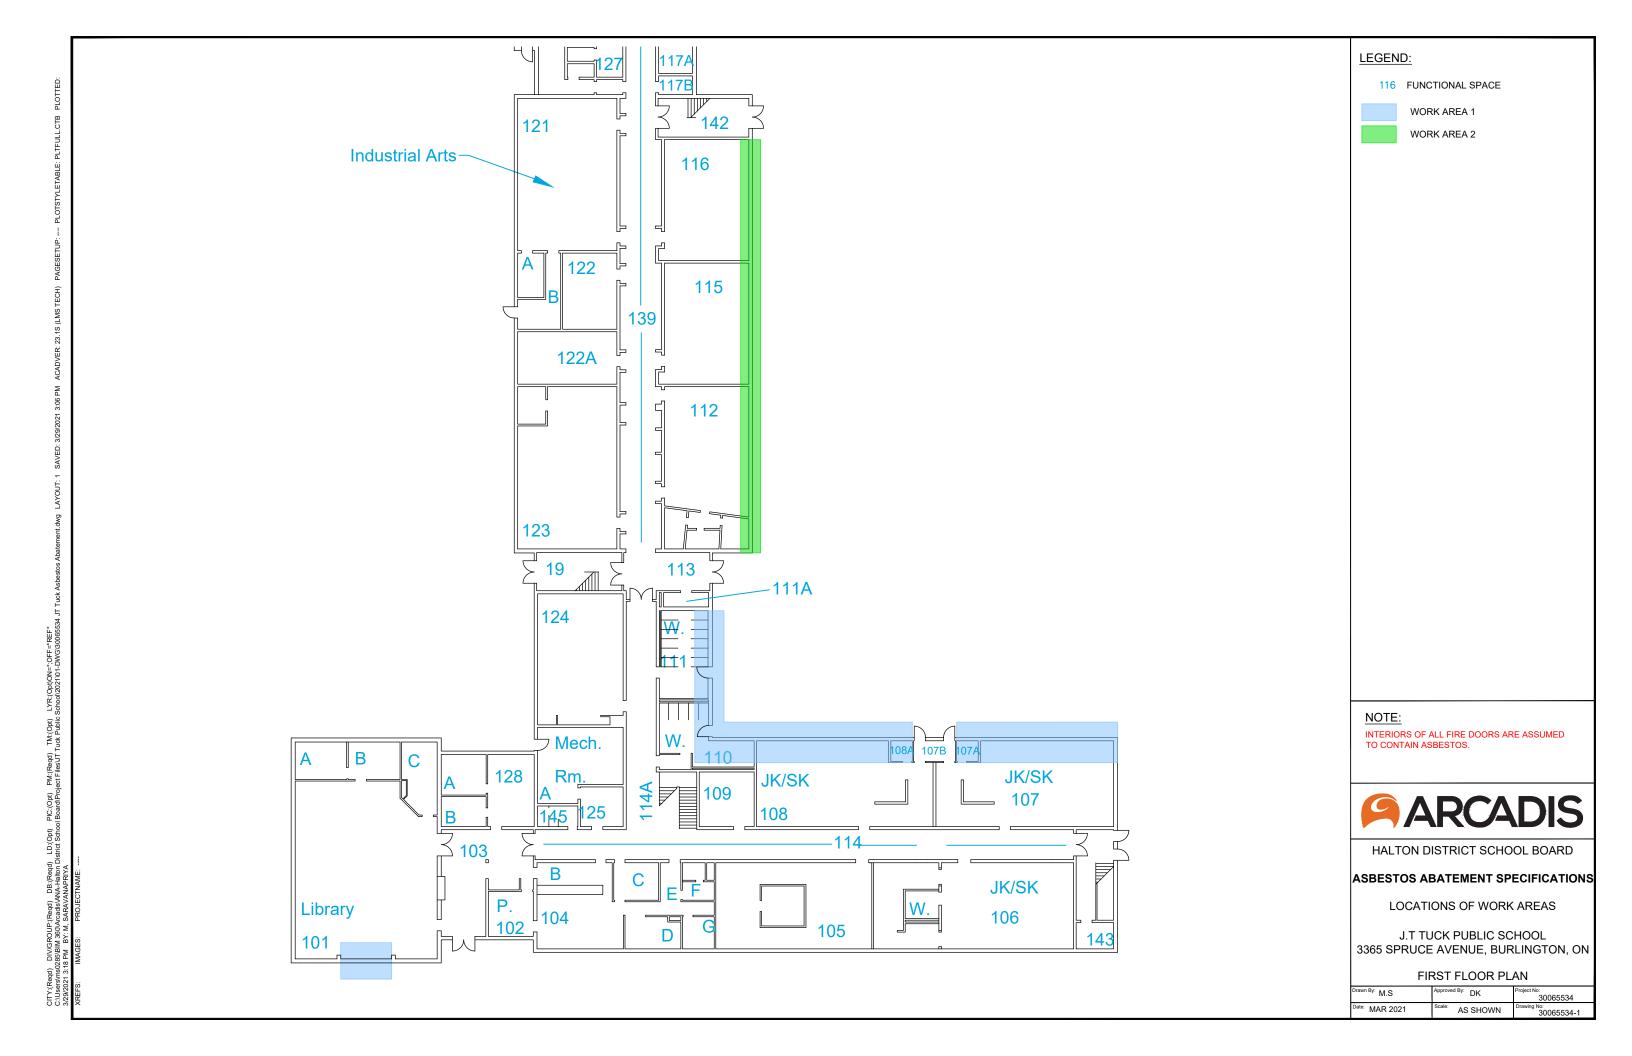
The designated study areas, roof replacement areas and eras of construction are shown on floor plans provided in Appendix A.

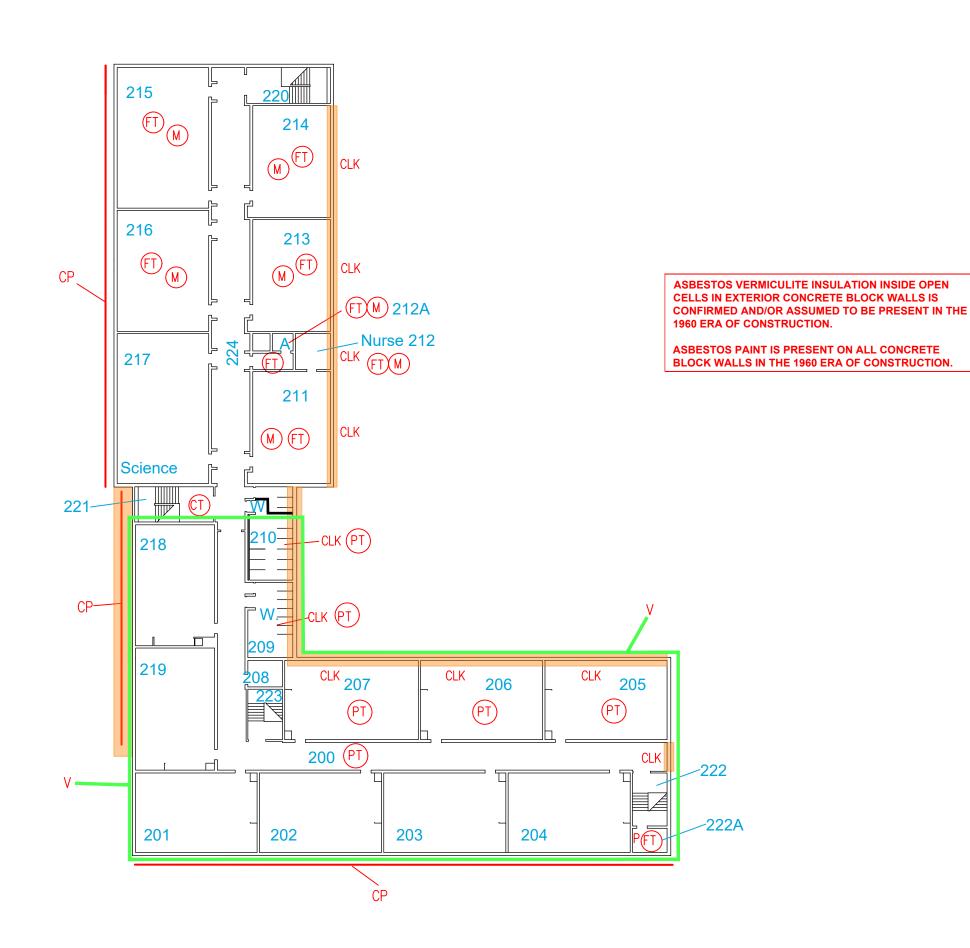
| Approved By: DK | Project No: 30065534 | | Date: MAR 2021 | Scale: AS SHOWN | Drawing No: 30065534-1

FIRST FLOOR

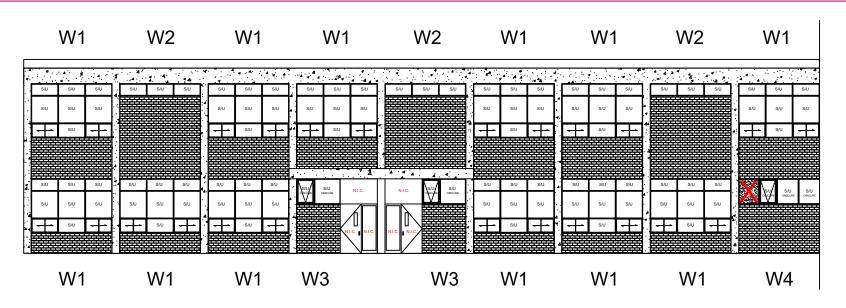
REVISION NOTE:

Locations indicated with a red 'X' require the removal and re-installation of the existing electrical conduit as noted in Addendum #1

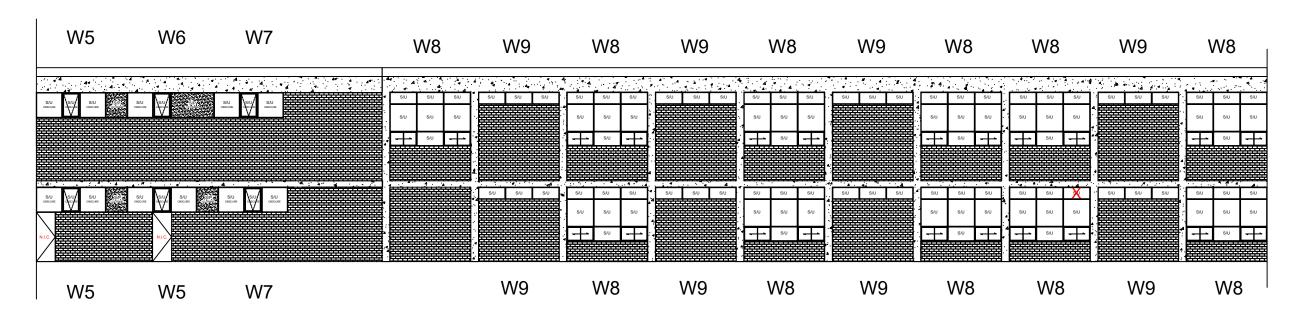
EAST ELEVATION - Photo #'s 4, 5 & 6
