Addendum # 1
Bid Opportunity: 26-7851-RFT
Crestview Public School
RAAC Roof Deck Replacement/ Interior Alterations
Closing Date: Wednesday, April 1, 2026, 2:00 PM

PROJECT-SPECIFIC DESIGNATED SUBSTANCE & HAZARDOUS MATERIALS ASSESSMENT

Crestview Public School
153 Montcalm Drive,
Kitchener, Ontario

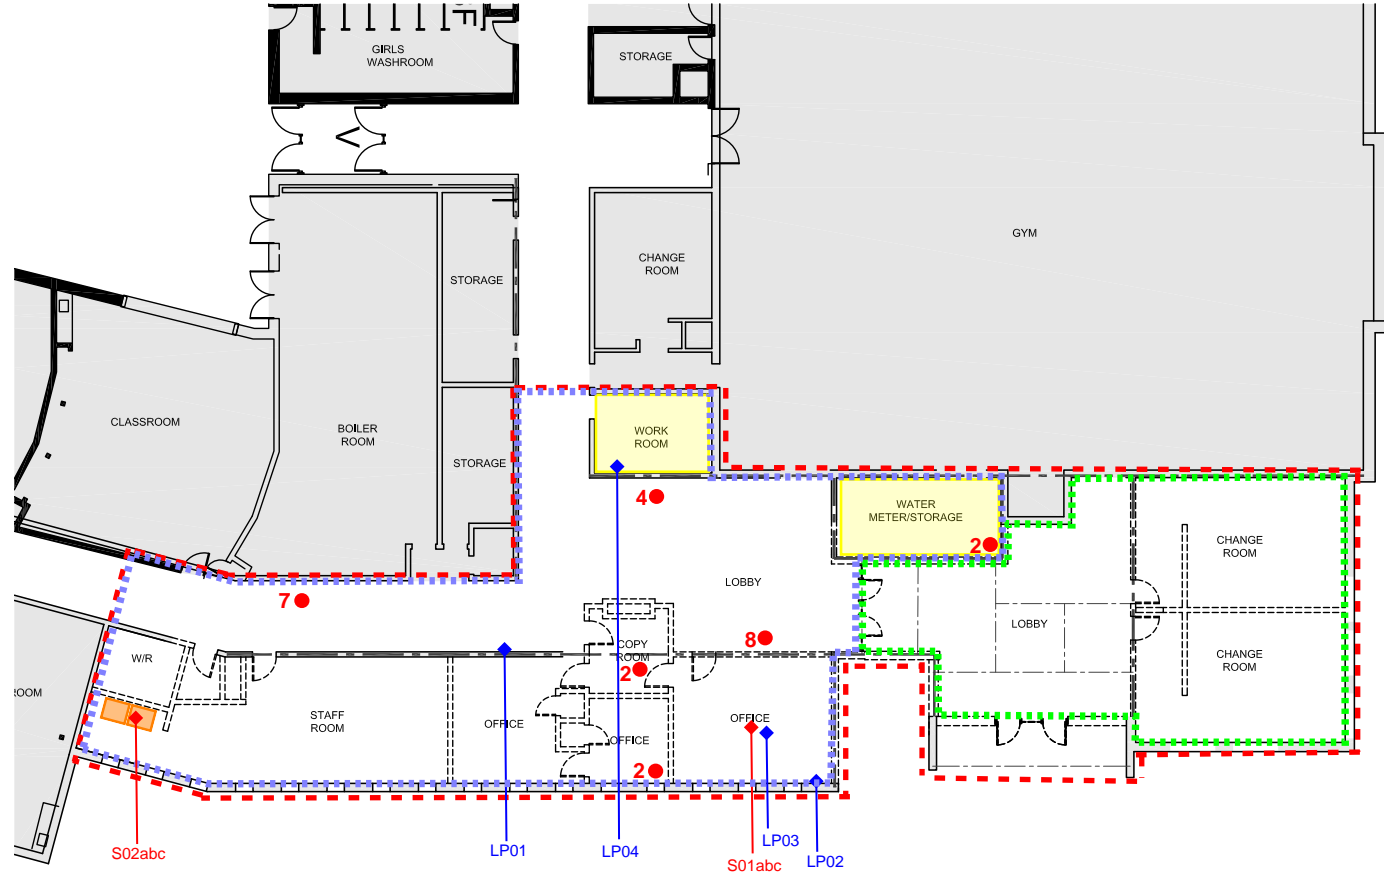
1. Parping cement on mechanical pipe fittings above lay-in ceilings in corridor 802 (lobby), room 102 (copy room), room 103 (office), and room 138 (storage);
2. 9"x9" beige with brown streak vinyl floor tiles within rooms 137 (work room) and 138 (storage);
3. Black mastic associated with floor tiles throughout the original building;
4. White exterior window caulking at windows of the original building; and,
7. Gold acoustic sink coat on the underside of two (2) sinks within room 106 (staff room).

Appendix A	Condition Assessment Criteria for Asbestos-Containing Materials
Appendix B	Figure AS01: Extent of Assessment Area and Sample Locations
Appendix C	Laboratory Certificates of Analysis – Asbestos and Lead
Appendix D	Site Photographs – February 28, 2025
Appendix E	Background Information on Designated Substances and Other Hazardous Materials

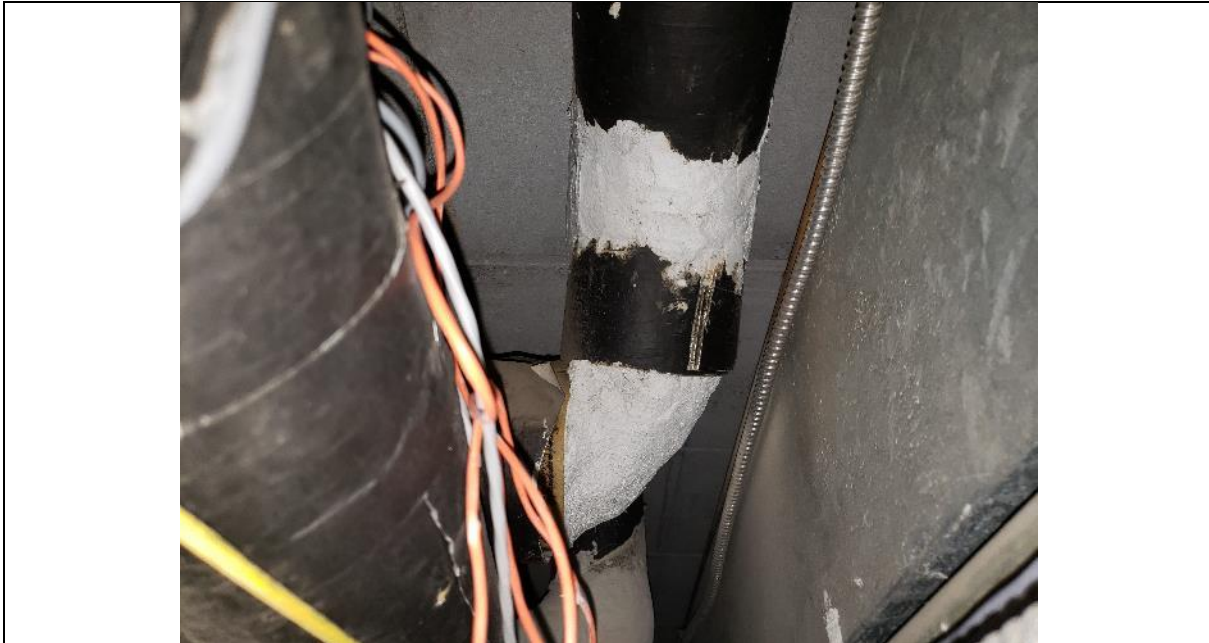
P1 – Asbestos-Containing Mechanical Pipe Fittings

Photograph of asbestos-containing parging cement on mechanical pipe fittings observed to be in fair condition within the lobby. The parging cement is undamaged butunjacketed.

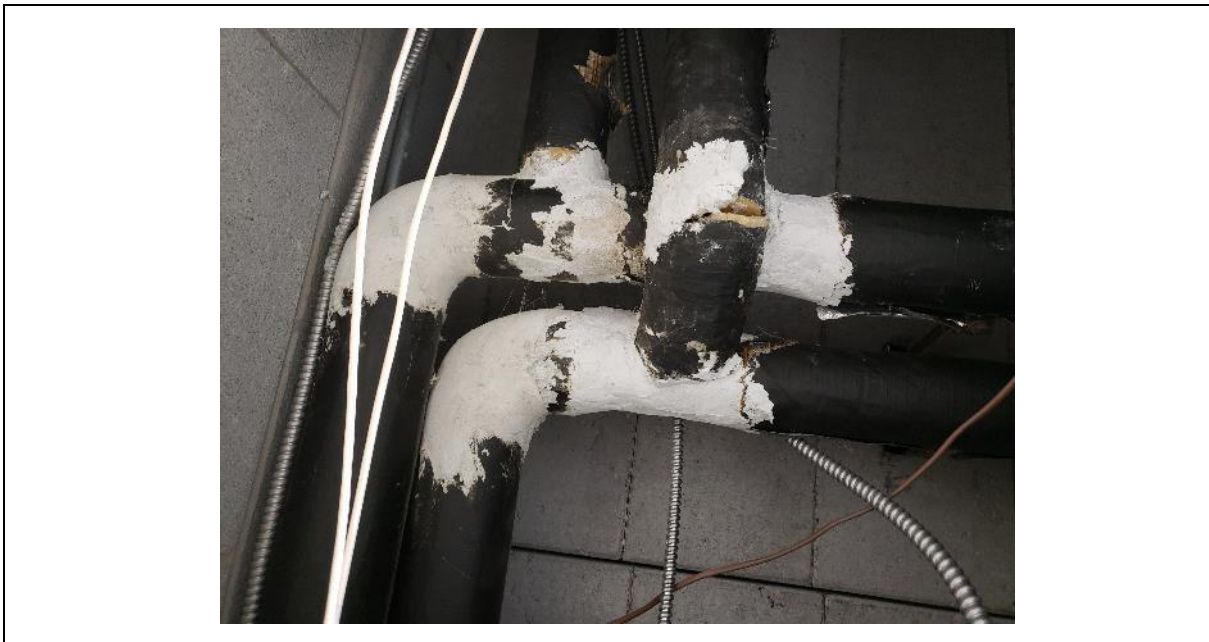
P2 – Asbestos-Containing Mechanical Pipe Fittings

Photograph of asbestos-containing parging cement on mechanical pipe fittings observed to be in poor condition within the lobby. The parging cement is unjacketed and damaged.

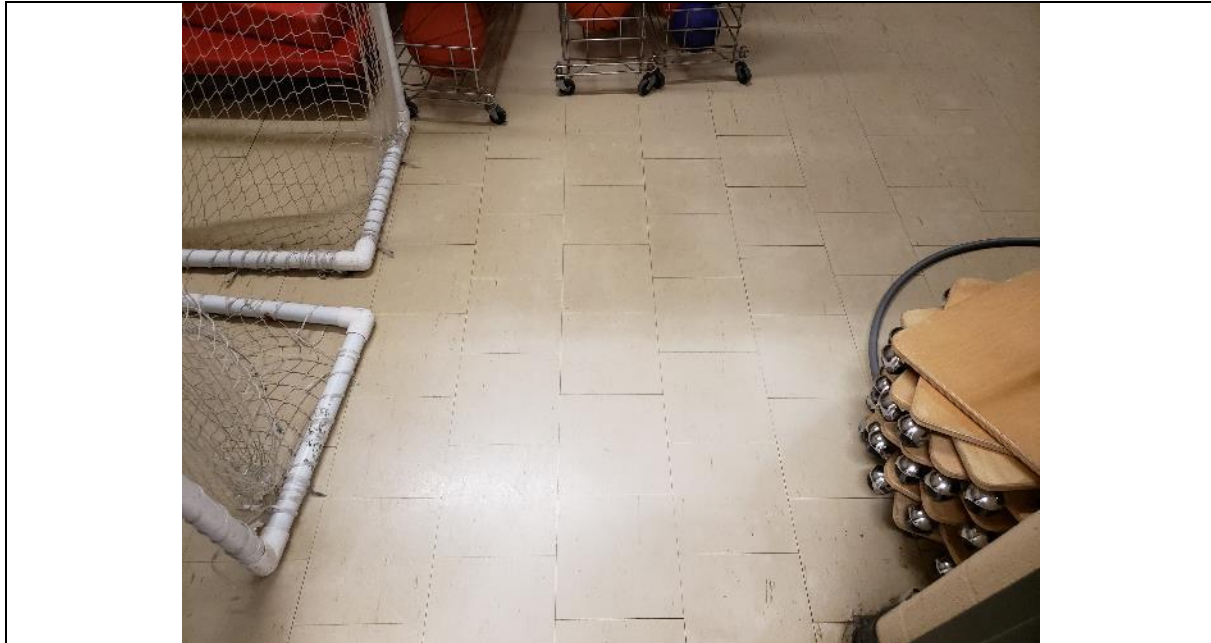
P3 – Asbestos-Containing 9”x9” Vinyl Floor Tiles

Photograph of asbestos-containing 9”x9” beige with brown streak vinyl floor tiles identified within the work room and storage room. The floor tiles are in good condition.

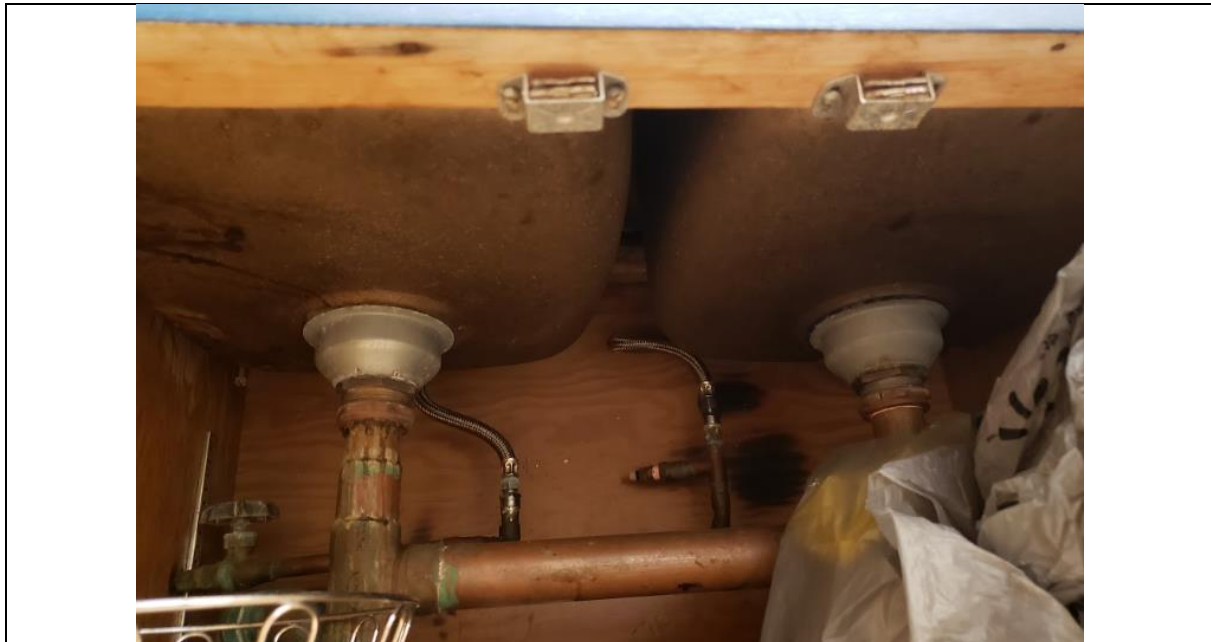
P4 – Asbestos-Containing Gold Acoustic Sink Coat

Photograph of asbestos-containing gold sink coat identified on the underside of two (2) sinks within the staff room. The sink coating is in good condition.
