FINAL
Hazardous Building
Materials Assessment
(Pre-construction)

Kilbride Public School
6611 Panton Street, Burlington,
Ontario

April 14, 2025

Pinchin File: 352316.001

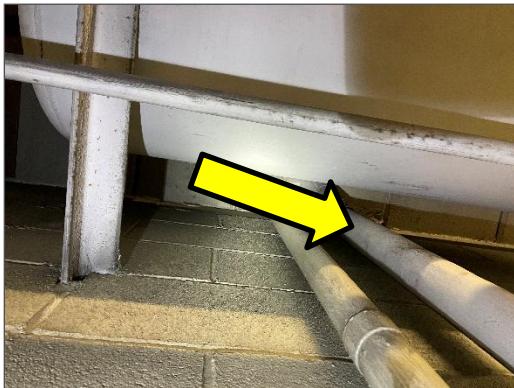
Photo 3

Sweatwrap insulation, (brown layered paper) containing chrysotile asbestos, is present on straight sections of cold system pipes in the 1959 section (samples S0023, photo 3).

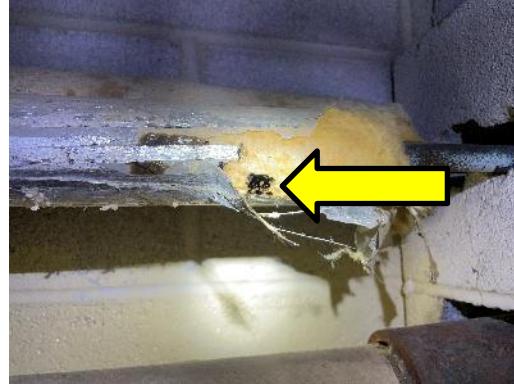
Photo 4

Tar present below silver pipe wrapping on fibreglass insulation does not contain asbestos (sample S0065A-C, photo 4).

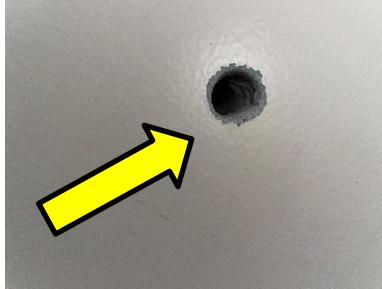
Description	Locations	Sample Number	Asbestos	Photo
No vermiculite observed in wall cavities	Library 116	N/A	N/A

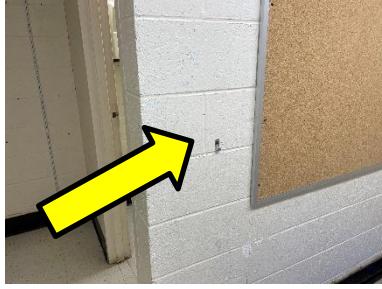
No vermiculite observed in interior wall cavities	Office / Washroom 126	N/A	N/A

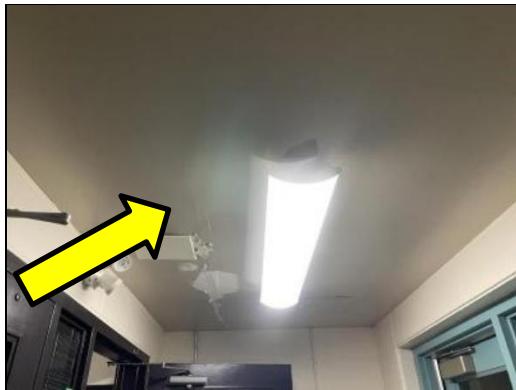
Photo 1

Drywall joint compound present on wall and ceiling finishes throughout the assessed area does not contain asbestos (samples S0038, S0039, and S0040, photos 1 and 2).

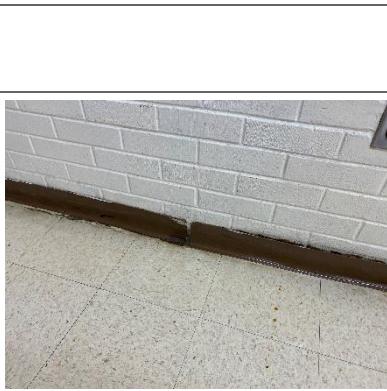
Black baseboards	S0012 and S0041	No / None detected	Throughout

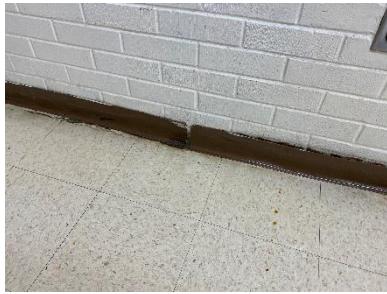
Brown baseboards	S0028 / S0013	None detected / None detected	Classroom 105 Classroom 106 (1959 era)

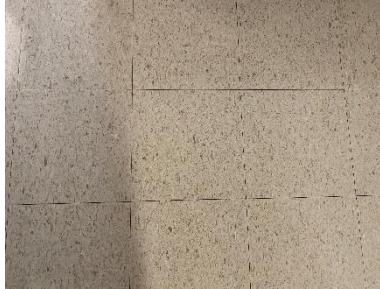
Description	Sample Number	Asbestos (Tile / Mastic)	Locations	Photo
12"x12", light beige with beige flecks	S0029 (Tile) S0010 & S0059 (Mastic)	None detected / None detected	Classroom 110 Classroom 111 Classroom 112 Classroom 114 Classroom 115 Storage 127 (1967 era, 1959 era)

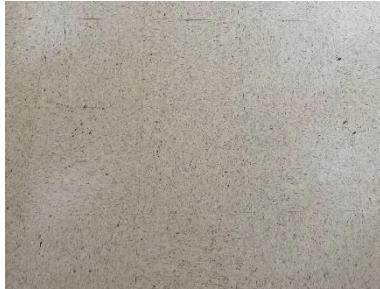
12"x12", dark beige with dark beige flecks	S0030 (Tile) S0062 (Mastic)	None detected / None detected	Kitchen 128 Washroom 126A (1967 era, 1984 era)

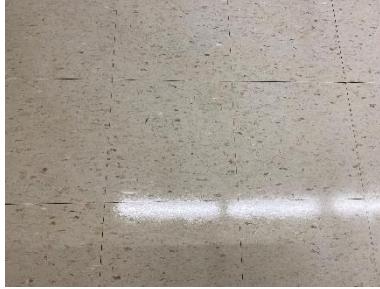
12"x12", white/beige with beige flecks	S0033 (Tile) S0056 (Mastic)	None detected / None detected	Classroom 107 Office 121 (1959 era)

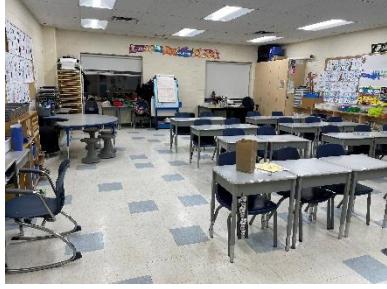
12"x12", blue with blue flecks	N/A	None (2009)	Classroom 149 (2009 era)

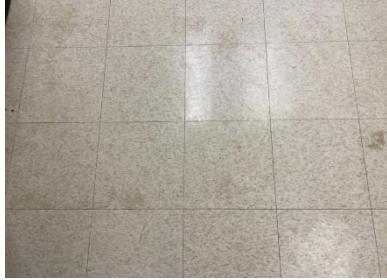
12"x12", grey with beige flecks	S0077 (Tile and Mastic)	None detected / None detected	Corridor 127 (1967 era)

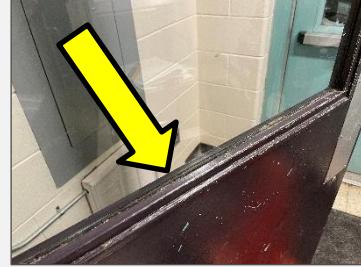
Material, Description and Application	Sample Location	Sample Number	Asbestos	Photo
Window putty in doors and panels, associated with double doors at Door #1	Corridor 143 (1959 era)	S0055	Yes

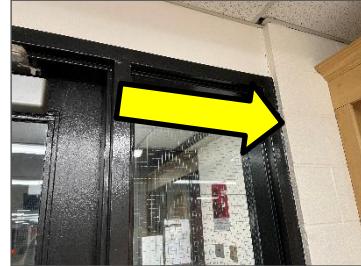
Interior caulking around door frames, associated with Door #1 and #12 (1959 era)	Corridor 143 (1959 era)	S0057	No

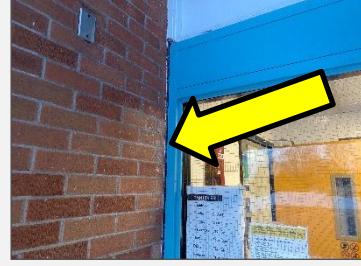
Exterior caulking around door frames and window panels, associated with Door #1, #12, and the library (1959 era)	Exterior 151 (1959 era)	S0058	Yes

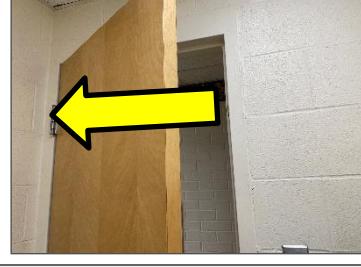
Interior caulking around door frames, associated with doors in the 1967 era	Office 126 Classroom 111 Corridor 141 (1959 era)	S0063	No

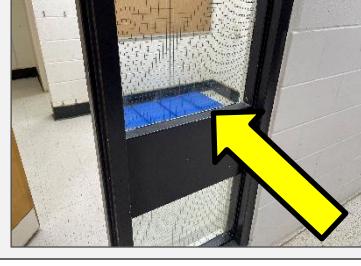
Window putty in doors and panels, associated with doors in the 1967 era	Corridor 141 Office 126 (1959 era)	S0064	Yes

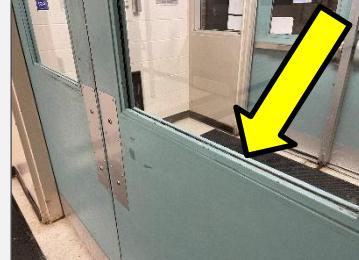
Material, Description and Application	Sample Location	Sample Number	Asbestos	Photo
Window putty in doors and panels, associated with Door #2 and #11	Corridor 145 Corridor 140 (1984 era)	S0066	Yes

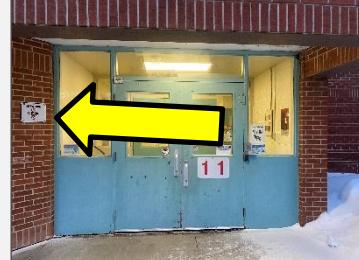
Exterior caulking around door frames, associated with Door #2, #8, #9, and #11	Exterior 152 (1984 era)	S0067	Yes

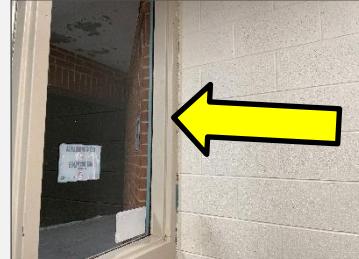
Interior caulking around door frames, associated with Door #2, #8, #9, and #11	Corridor 140 Gymnasium 132 Corridor 145 (1984 era)	S0068	Yes

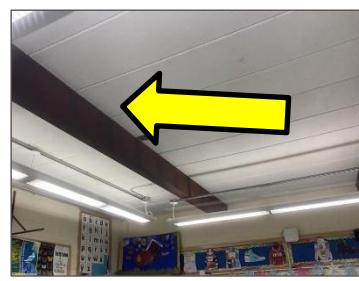
Caulking, grey, in between pre-cast concrete decking (Siporex)	Throughout assessed area	S0024	None detected

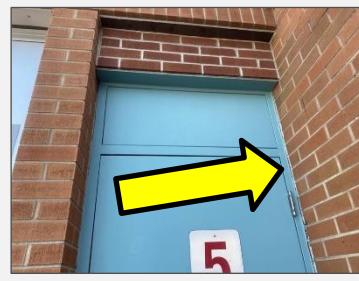
Exterior caulking around door frames, associated with Door #3, #4, and #5	Exterior 150 (1967 era)	S0074	Yes

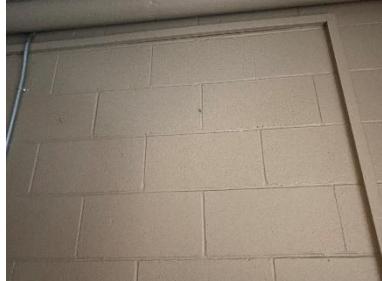
Description	Sample Location (Location #)	Sample Number	Asbestos	Photo
Paint on concrete block	Throughout assessed area	S0016D-G S0017G-G S0018D-G	None detected

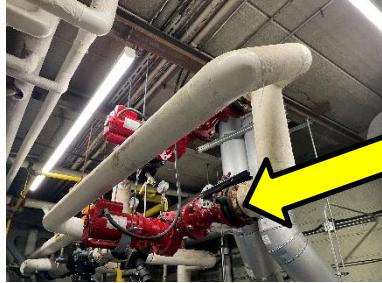
Gaskets between flanges of boiler connections	Mechanical Room 120	S0072A-C	None detected

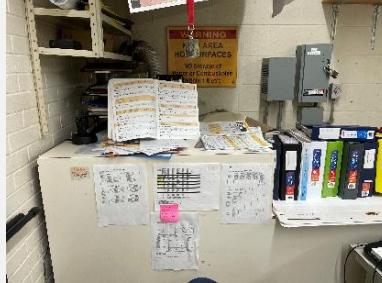
Refractory brick in kiln (assumed present, inaccessible)	Classroom 106	N/A	Presumed

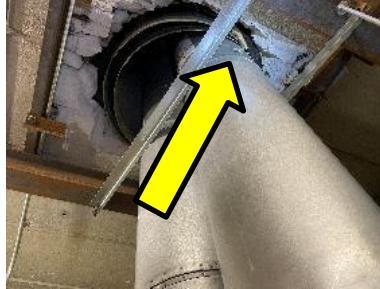
Description	Sample Location (Location #)	Sample Number	Asbestos	Photo
Roofing asphalt and tar applied as a firestop material	Mechanical Room 120, around duct vent through roof	S0073	None detected

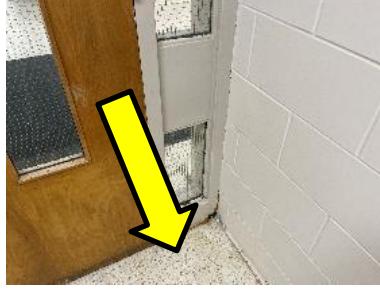
Terrazzo floors	Corridor 141 Corridor 145	S0070	None detected

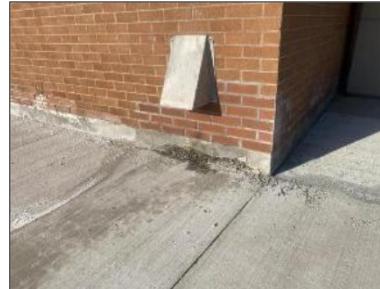
Parging on foundation	Exterior 151 (1959 era)	S0071	None detected

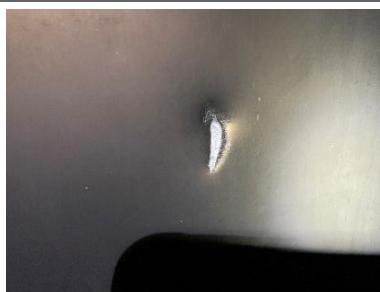
Styrofoam in spandrel panels	Library Exterior 151 (1959 era)	N/A	None

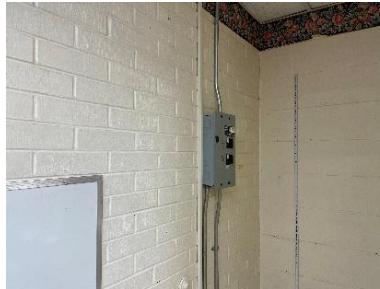
Mortar at masonry	All eras of construction	S0019, S0020, S0021, S0052, S0053, S0054	None

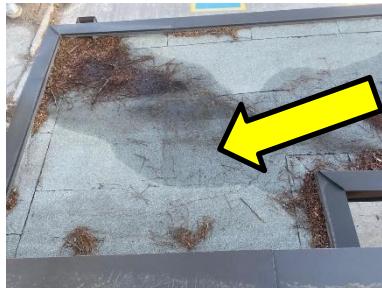
Tar/roofing on canopy roof	Exterior 151 (1959 era)	S0075	None

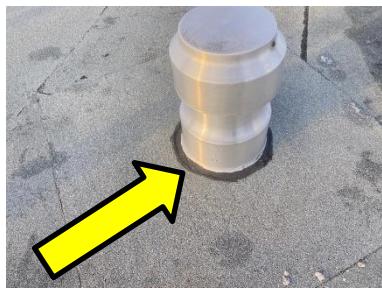
Tar on roof penetration above mechanical room	Exterior 151 (1959 era)	S0076	None

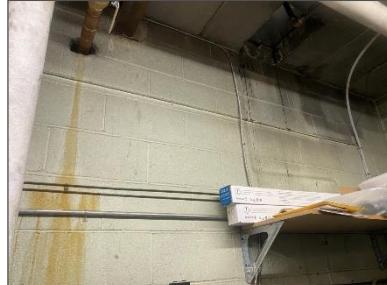
L0002	Light green on concrete block	Mechanical Room (Location 120)	0.29

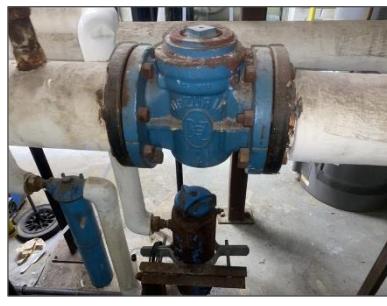
L0003	Blue on metal pipe	Mechanical Room (Location 120)	0.23

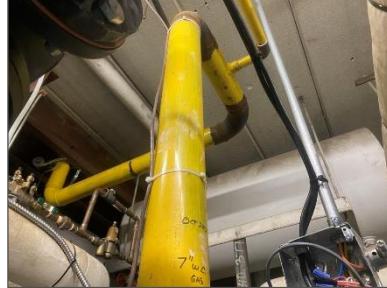
Sample Number	Colour, Substrate Description	Sample Location	Lead (%)	Photo
L0004	Yellow on metal pipe	Mechanical Room (Location 120)	0.011

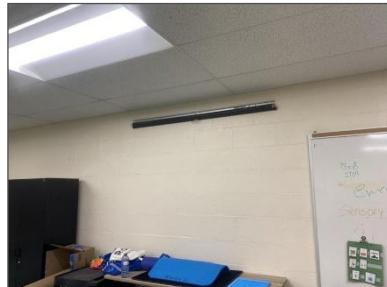
L0005	Light beige on concrete block	Classroom / Storage (Location 105)	0.0043

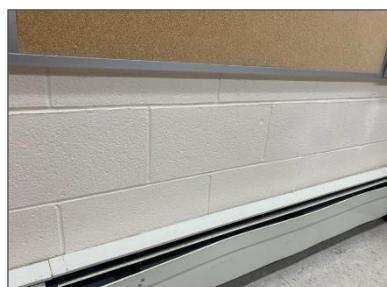
L0006	Light pink on concrete block	Classroom (Location 114)	0.14

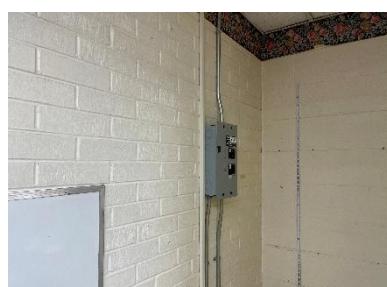
L0007	Cream on concrete block	Office / Washroom (Location 126)	0.13

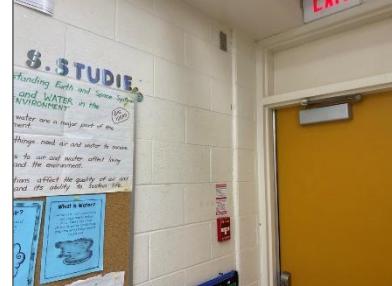
Sample Number	Colour, Substrate Description	Sample Location	Lead (%)	Photo
L0008	Light cream on concrete block	Classroom (Location 112)	0.15

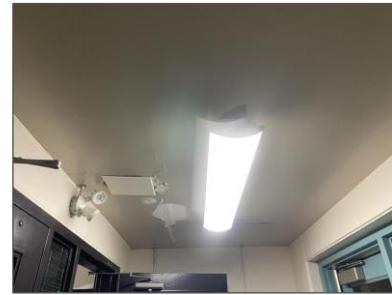
L0009	Beige on drywall ceiling	Corridor (Location 145)	0.0024

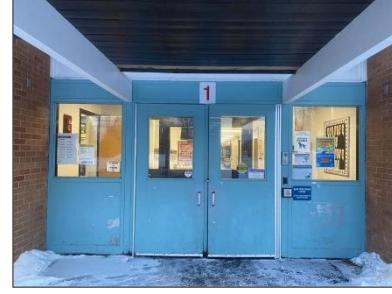
L0010	Blue on metal door	Exterior (Location 151)	0.0018

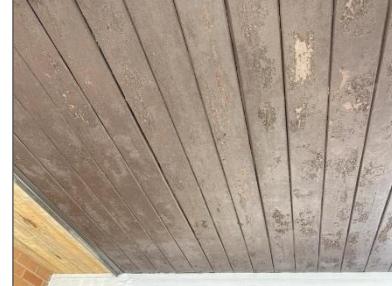
Sample Number	Colour, Substrate Description	Sample Location	Lead (%)	Photo
L0012	Brown on wood canopy deck	Exterior (Location 151)	0.26

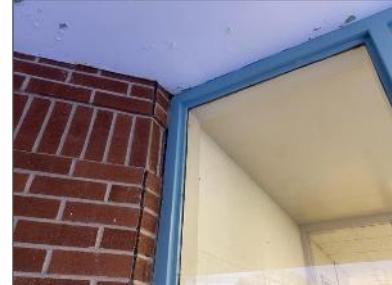
L0013	White on drywall soffit	Exterior (Location 150)	0.0021

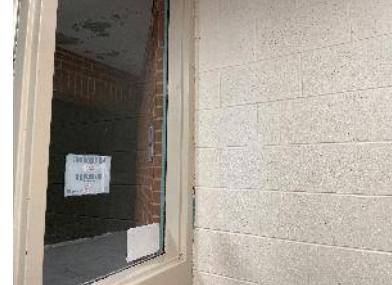
L0014	Cream/blue on concrete block	Corridor (Location 140)	0.0024

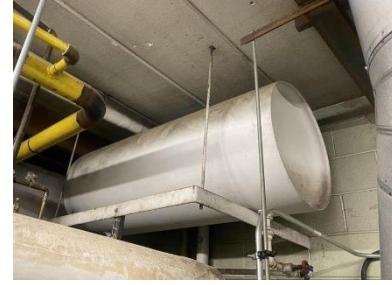
L0015	White on metal cushion tank	Mechanical Room (Location 120)	0.052

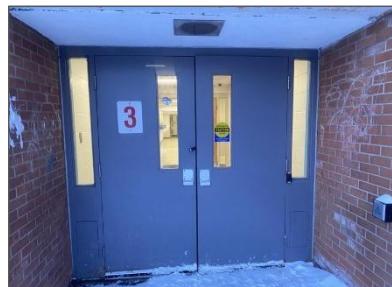
Caulking, composite of exterior door frames	1967 Era of construction	P0002	24

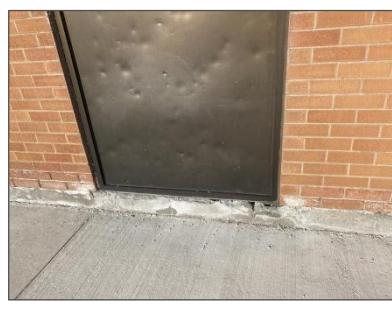
Caulking, composite of spandrel panels and exterior door frames	1959 Era of construction	P0003	0.2

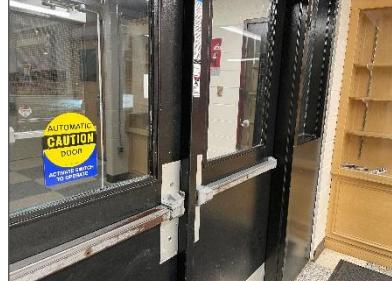
Material, Colour, Application	Sample Location (Location #)	Sample Number	PCB (mg/kg)	Photo
Caulking, composite of interior door frames	1959 Era of construction	P0004	0.7
